## **Designated Substances Survey Report**

Forensic Identification Unit (Building A) and  
Radio & Electronic Services (Building B)  
2050 Jane St, Toronto Ontario

January 12, 2018

Pinchin File: 202779

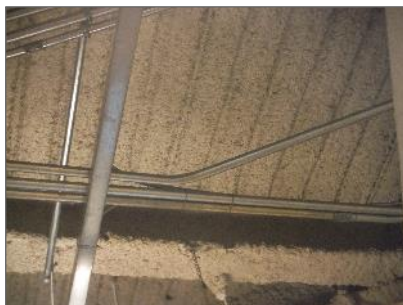
Photo 1: Non-asbestos spray-applied fireproofing on structure in the Car Bat (Location 1-001).

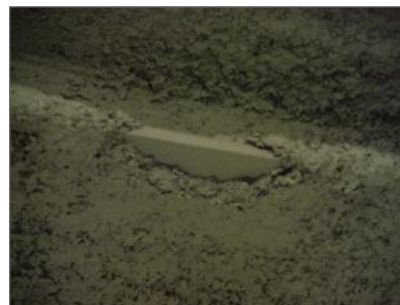
Photo 2: Non-asbestos spray-applied fireproofing on structure in the Parts Counter (Location 1-038).

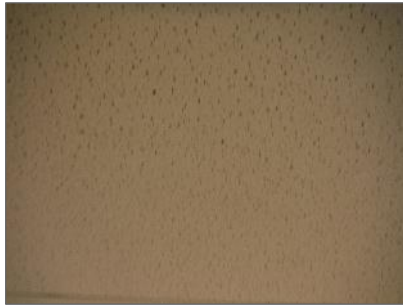
| Size, Type, Pattern, Photo # | Locations | Sample Number | Asbestos Type |
|---|---|---|---|
| ACT01 – 24" x 48", lay-in acoustic ceiling tile with random hole pattern, Photo 3 | See Survey Form in Appendix IV for locations | 2005 ECOH Management Inc. Assessment | None Detected |

Photo 3: Non-asbestos ACT01 in the Stairwell (Location 1-002).

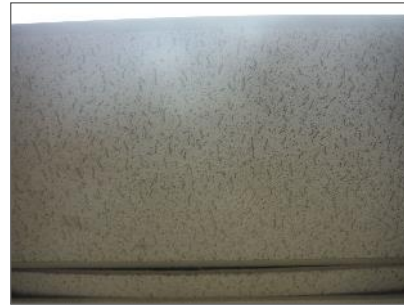
| Size, Type, Pattern, Photo # | Locations | Sample Number | Asbestos Type |
|---|---|---|---|
| ACT02 – 24" x 48", lay-in acoustic ceiling tile with random fleck and hole pattern, Photo 4 | See Survey Form in Appendix IV for locations | 2005 ECOH Management Inc. Assessment | None Detected |

Photo 4: Non-asbestos ACT02 from the Front Desk (Location 1-019).

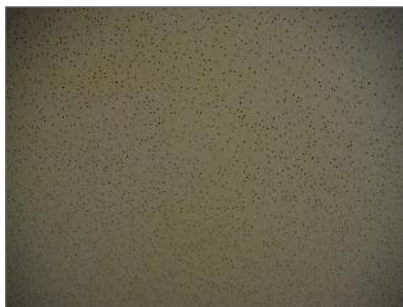
| Size, Type, Pattern, Photo # | Locations | Sample Number | Asbestos Type |
|---|---|---|---|
| ACT03 – 24" x 48", lay-in acoustic ceiling tile with random dimple and hole pattern, Photo 5 | See Survey Form in Appendix IV for locations | 2005 ECOH Management Inc. Assessment | None Detected |

Photo 5: Non-asbestos ACT03 from the Closet (Location 1-029).

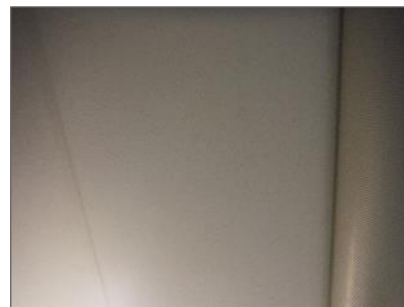
| Size, Type, Pattern, Photo # | Locations | Sample Number | Asbestos Type |
|---|---|---|---|
| ACT04 – 24" x 48", lay-in acoustic ceiling tile with random pinhole pattern, Photo 6 | See Survey Form in Appendix IV for locations | 2005 ECOH Management Inc. Assessment | None Detected |

Photo 6: Non-asbestos ACT04 from the Corridor (Location 1-006).

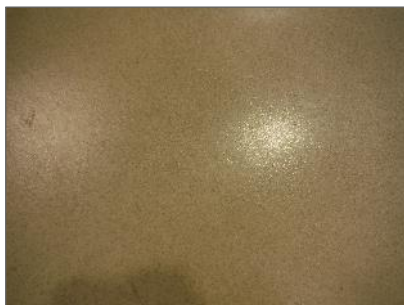
| Pattern, Colour and Photo Number | Paper Backing | Locations | Sample Number | Asbestos Type |
|---|---|---|---|---|
| VSF01 – Mixed shades of beige, Photo 7 | No | See Survey Form in Appendix IV for locations | Building A – 2014-A002A-C | None Detected |

Photo 7: Non-asbestos VSF01 in the Corridor (Location 1-013).

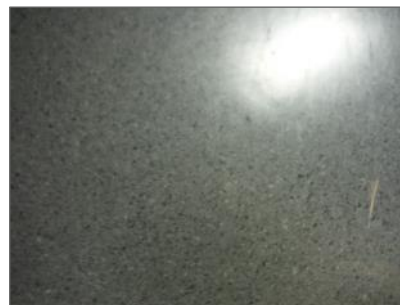
| Pattern, Colour and Photo Number | Paper Backing | Locations | Sample Number | Asbestos Type |
|---|---|---|---|---|
| VSF02 – Mixed shades of blue, Photo 8 | No | See Survey Form in Appendix IV for locations | Building A – 2014-A003A-C | None Detected |

Photo 8: Non-asbestos VSF02 in the Evidence Room (Location 1-028).

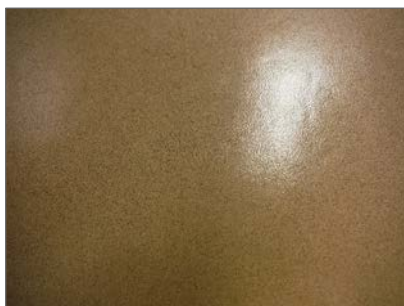
| Pattern, Colour and Photo Number | Paper Backing | Locations | Sample Number | Asbestos Type |
|---|---|---|---|---|
| VSF03 – Beige with black streaks, Photo 9 | No | See Survey Form in Appendix IV for locations | Building A – 2014-A004A-C | None Detected |

Photo 9: Non-asbestos VSF03 in the Lamination Room (Location 1-045).

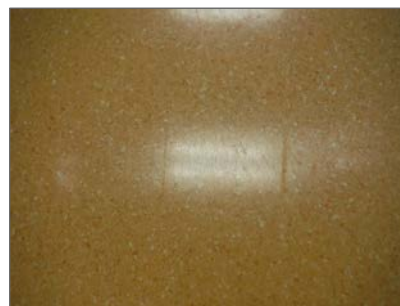
| Pattern, Colour and Photo Number | Paper Backing | Locations | Sample Number | Asbestos Type |
|---|---|---|---|---|
| VSF04 – Mixed shades of orange, Photo 10 | No | See Survey Form in Appendix IV for locations | Building A – 2014-A005A-C | None Detected |

Photo 10: Non-asbestos VSF04 in the Lunch Room (Location 1-074).

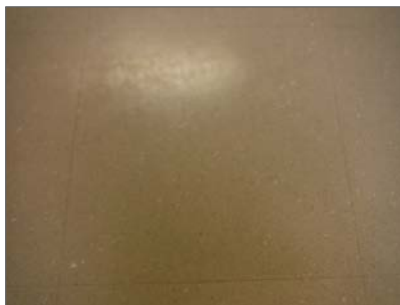
| Pattern, Colour and Photo Number | Paper Backing | Locations | Sample Number | Asbestos Type |
|---|---|---|---|---|
| VSF05 – 24" x 24" marble pattern, Photo 11 | No | See Survey Form in Appendix IV for locations | Building B – 2014-A011A-C | None Detected |

Photo 11: Non-asbestos VSF05 in the Office (Location 2-008).

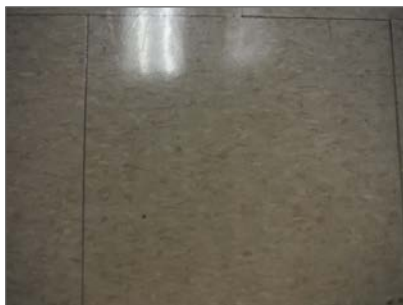
| Size, Pattern, Colour and Photo Number | Locations | Sample Number | Asbestos Type (tile) | Asbestos Type (mastic) |
|---|---|---|---|---|
| VFT01 – 12" x 12" mixed shades of beige vinyl floor tile, Photo 12 | See Survey Form in Appendix IV for locations | Building A – 2014-A001A-C | None Detected | None Detected |

Photo 12: Non-asbestos VFT01 in the Stairwell (Location 1-005).

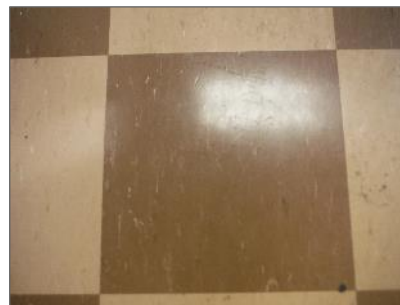
| Size, Pattern, Colour and Photo Number | Locations | Sample Number | Asbestos Type (tile) | Asbestos Type (mastic) |
|---|---|---|---|---|
| VFT02 – 12" x 12" brown vinyl floor tile with white and beige smears, Photo 13 | See Survey Form in Appendix IV for locations | Building B – 2014-A006A-C | Chrysotile | None Detected |

The vinyl floor tiles and mastic are non-friable.

Photo 13: Asbestos-containing VFT02 in the Corridor (Location 1-005).

1. Perform a pre-construction survey and remove all ACM prior to alteration or maintenance work or if ACM may be disturbed by the work.
2. Remove and dispose of mercury-containing items when taken out of service.
3. Follow appropriate safe work procedures when handling or disturbing asbestos, lead, mercury and silica.

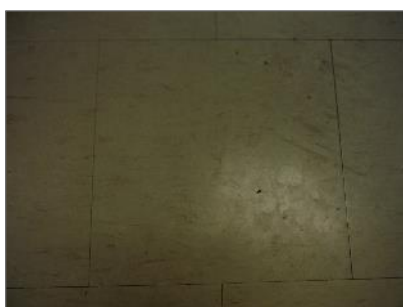
| Size, Pattern, Colour and Photo Number | Locations | Sample Number | Asbestos Type (tile) | Asbestos Type (mastic) |
|---|---|---|---|---|
| VFT03 – 12" x 12" white vinyl floor tile with black streaks, Photo 14 | See Survey Form in Appendix IV for locations | Building B – 2014-A008A-C | Chrysotile | None Detected |

Photo 14: Non-asbestos VFT03 in the Chiller Room (Location 1-012).

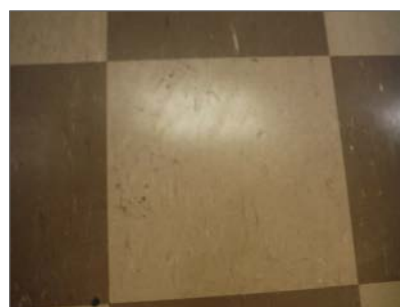
| Size, Pattern, Colour and Photo Number | Locations | Sample Number | Asbestos Type (tile) | Asbestos Type (mastic) |
|---|---|---|---|---|
| VFT04 – 12" x 12" Mixed shades of beige vinyl floor tile, Photo 15 | See Survey Form in Appendix IV for locations | Building B – 2014-A012A-C | Chrysotile | None Detected |

Photo 15: Asbestos-containing VFT04 in the Corridor (Location 1-05).

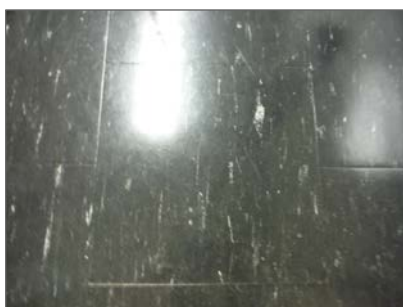
| Size, Pattern, Colour and Photo Number | Locations | Sample Number | Asbestos Type (tile) | Asbestos Type (mastic) |
|---|---|---|---|---|
| VFT05 – 12" x 12" black vinyl floor tile with white streaks, Photo 16 | See Survey Form in Appendix IV for locations | Building B – 2014-A010A-C | Chrysotile | None Detected |

Photo 16: Non-asbestos VFT05 in the Copy Room (Location 2-007).

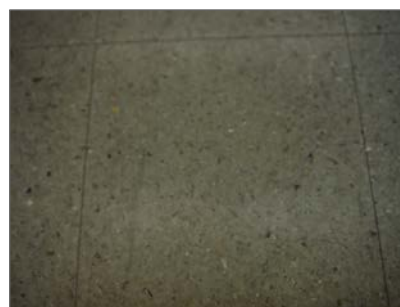
| Size, Pattern, Colour and Photo Number | Locations | Sample Number | Asbestos Type (tile) | Asbestos Type (mastic) |
|---|---|---|---|---|
| VFT06 – 12" x 12" black marble vinyl floor tile, Photo 17 | See Survey Form in Appendix IV for locations | Building B – 2014-A007A-C | None Detected | None Detected |

Photo 17: Asbestos-containing VFT06 in the Office (Location 1-013).
