## **Designated Substances Survey Report**

Forensic Identification Unit –  
Building A and Radio & Electronic  
Services – Building B  
2050 Jane Street, Toronto, ON

November 25, 2015

Pinchin File: 103037

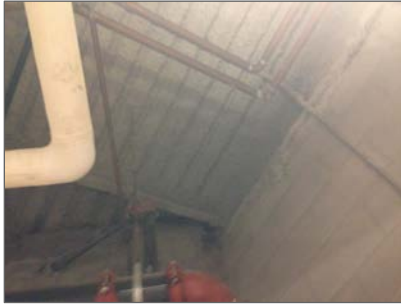
Spray-applied fireproofing and overspray present on the structure of Buildings A and B was previously sampled (ECOH Management Inc. 2005) and found not to contain asbestos.

Sprayed fireproofing Building A

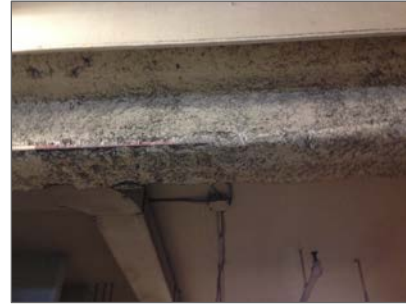
Sprayed fireproofing Building B

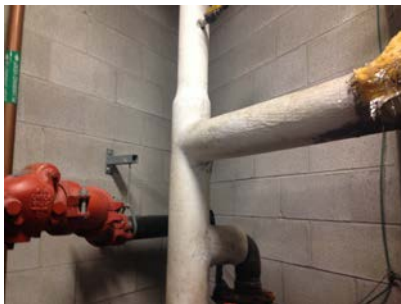
Non-asbestos insulation (e.g. fiberglass) is present on pipes throughout the assessed area.

Photo #3: Typical non-asbestos fiberglass pipe insulation.

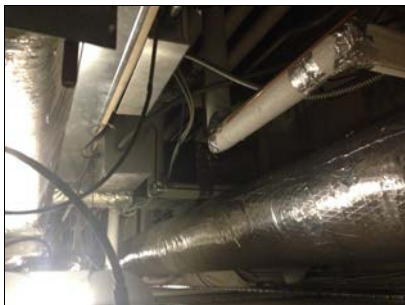
Ducts are either uninsulated or insulated with non-asbestos fiberglass and jacketed with foil.

Typical non-asbestos fiberglass duct insulation

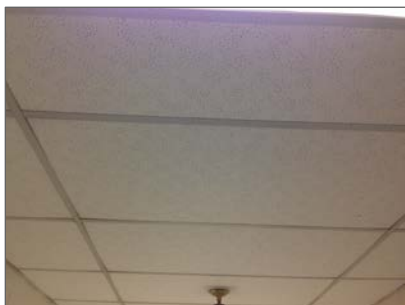
ACT01

| Size, Type, Pattern, Photo # | Sample Number or Date Code | Asbestos Type |
|---|---|---|
| ACT01, 24"x48", lay-in, random holes | Building B (ECOH Management Inc. 2005) | None detected |

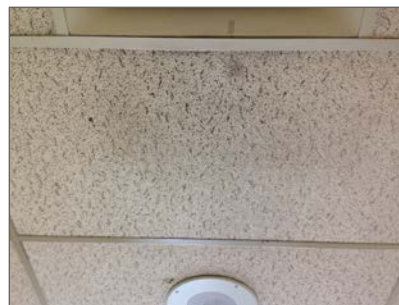
ACT02

| Size, Type, Pattern, Photo # | Sample Number or Date Code | Asbestos Type |
|---|---|---|
| ACT02, 24"x48", lay-in, random fleck and holes | Building B (ECOH Management Inc. 2005) | None detected |

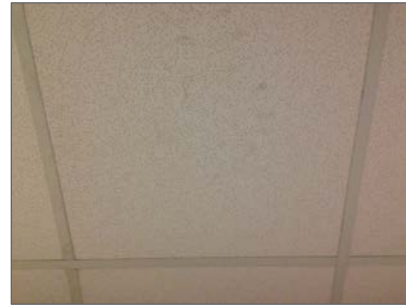
ACT04

| Size, Type, Pattern, Photo # | Sample Number or Date Code | Asbestos Type |
|---|---|---|
| ACT04, 24"x48", lay-in, random pinhole pattern | Building A (ECOH Management Inc. 2005) | None detected |

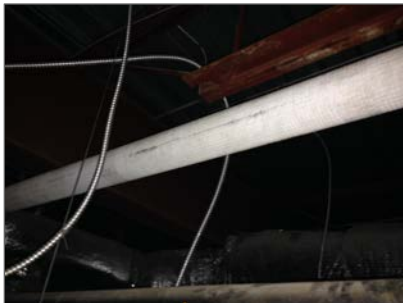
Transite pipe is present as rain water leaders in Building B. Transite is assumed to contain asbestos based on visual observation. Transite is non-friable and in good condition.

Asbestos-containing Transite pipe in Building B.

1. Perform a pre-construction survey and remove all ACM prior to alteration or maintenance work or if ACM may be disturbed by the work.
2. Remove and dispose of mercury-containing items when taken out of service.

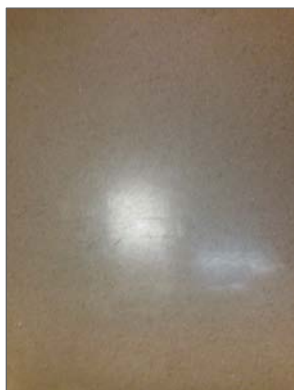
VSF01

| Pattern, Colour and Photo Number | Paper Backing (Yes/No) | Sample Number | Asbestos Type |
|---|---|---|---|
| VSF01: Mixed shades of beige | No | Building A, 2014-A002A-C | None detected |

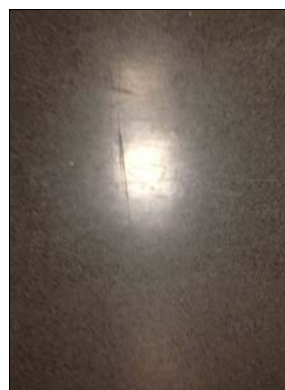
VSF02

| Pattern, Colour and Photo Number | Paper Backing (Yes/No) | Sample Number | Asbestos Type |
|---|---|---|---|
| VSF02: Mixed shades of blue | No | Building A, 2014-A003A-C | None detected |

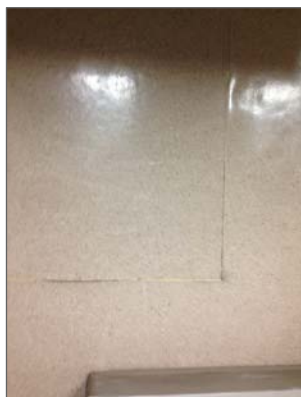
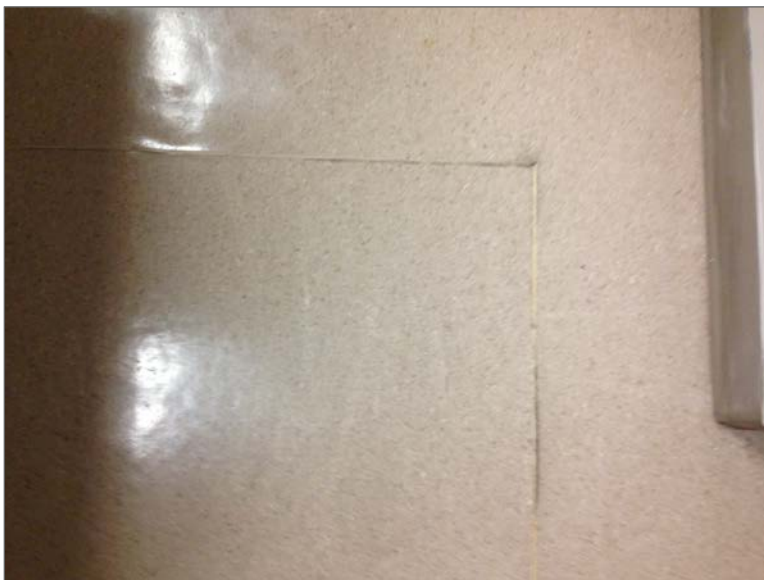
VSF03

| Pattern, Colour and Photo Number | Paper Backing (Yes/No) | Sample Number | Asbestos Type |
|---|---|---|---|
| VSF03: Beige with black streaks | No | Building A, 2014-A004A-C | None detected |

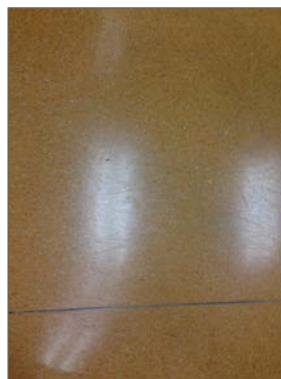
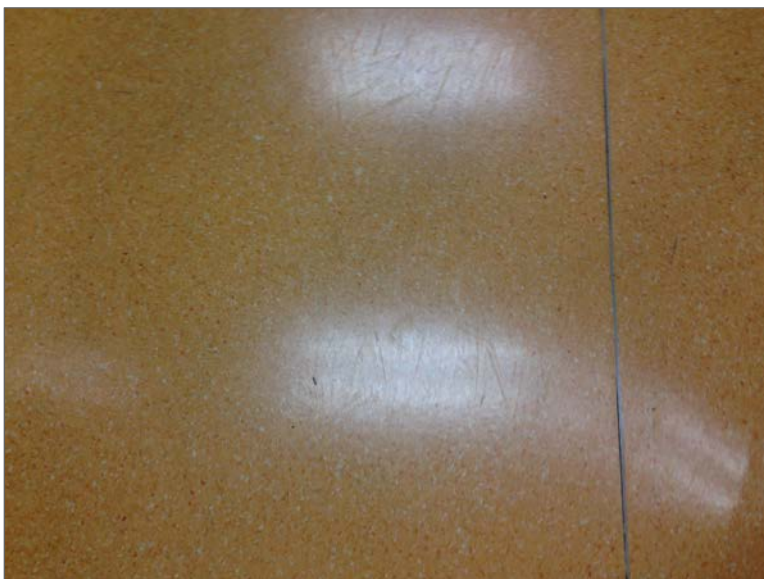
VSF04

| Pattern, Colour and Photo Number | Paper Backing (Yes/No) | Sample Number | Asbestos Type |
|---|---|---|---|
| VSF04: Mixed shades of orange | No | Building A, 2014-A005A-C | None detected |

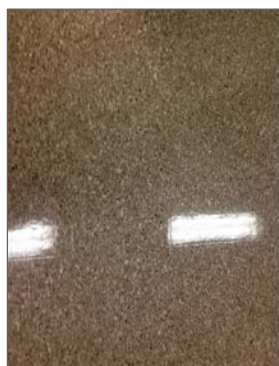
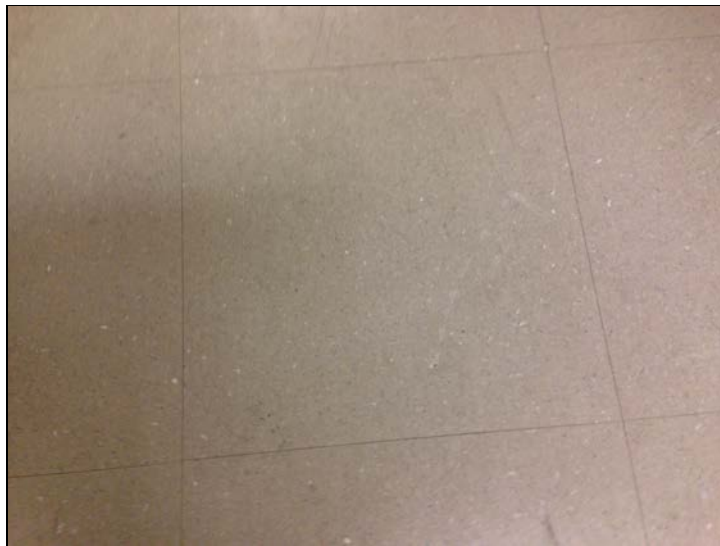
VST05

| Pattern, Colour and Photo Number | Paper Backing (Yes/No) | Sample Number | Asbestos Type |
|---|---|---|---|
| VSF05: 24"x24" Marble Pattern | No | Building B, 2014-A011A-C | None detected |

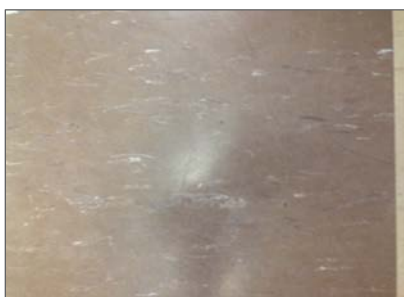
VFT02

| Size, Pattern, Colour and Photo Number | Sample Number | Asbestos Type (tile) | Asbestos Type (mastic) |
|---|---|---|---|
| VFT02: 12"x12", brown with white and beige smears | Building B - 2014-A006A-C | 2% Chrysotile | None detected |

The vinyl floor tiles and mastic are non-friable and are in good condition.

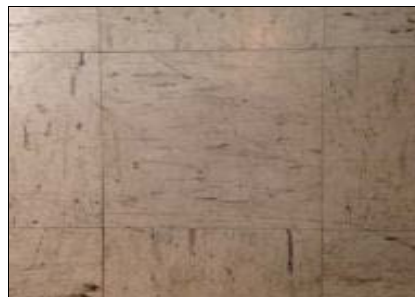
VFT03

| Size, Pattern, Colour and Photo Number | Sample Number | Asbestos Type (tile) | Asbestos Type (mastic) |
|---|---|---|---|
| VFT03: 12"x12", white with black streaks | Building B - 2014-A008A-C | 3% Chrysotile | None detected |

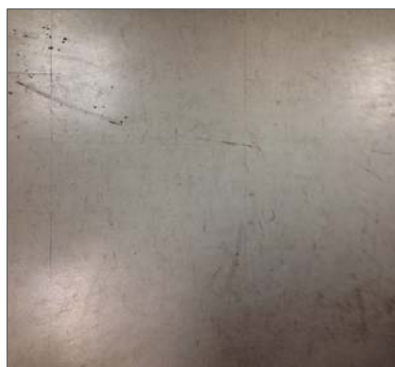
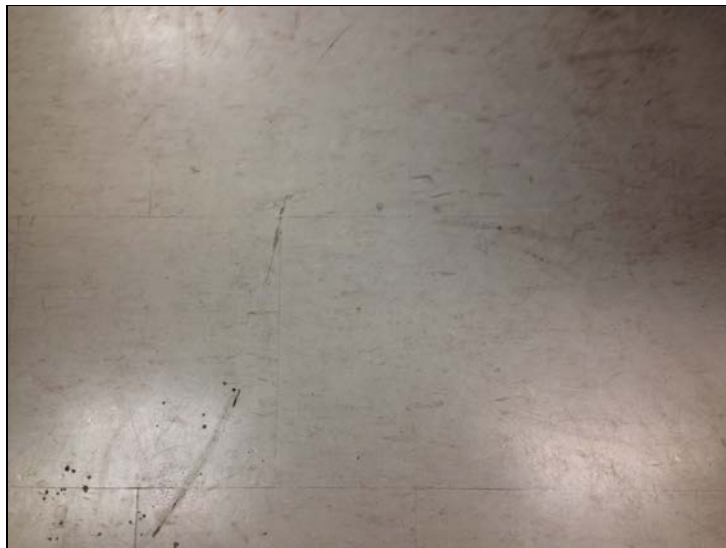
VFT04

| Size, Pattern, Colour and Photo Number | Sample Number | Asbestos Type (tile) | Asbestos Type (mastic) |
|---|---|---|---|
| VFT04: 12"x12", mixed shades of beige | Building B - 2014-A012A-C | 2% Chrysotile | None detected |

| Location Number | Location Name | Building System | Potential ACM Observed | Potential Hazardous Materials | Sample ID | Analytical Result | Quantity | Condition | Notes/Required Action |
|---|---|---|---|---|---|---|---|---|---|
| 2-013 | Repair Office | Floor | Vinyl Floor Tiles (VFT) | Asbestos | 2014 A012A-C | 2% Chrysotile | 25 m2 | Good | VFT-04, 12"x12" mixed shades of beige, tile only acm |

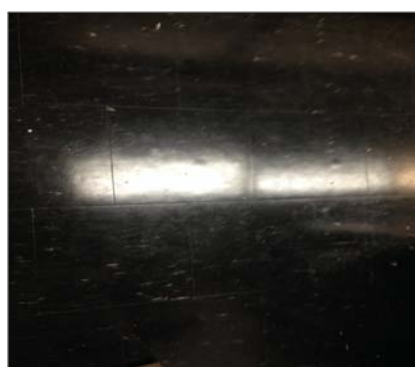
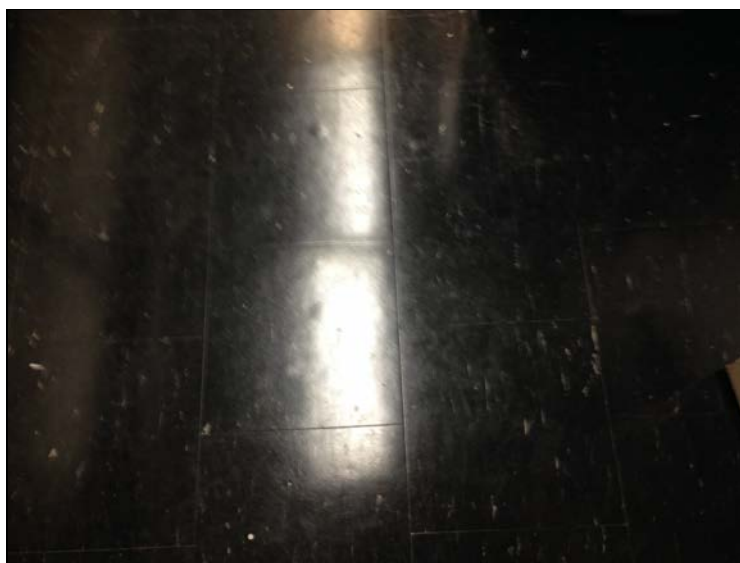
VFT05

| Size, Pattern, Colour and Photo Number | Sample Number | Asbestos Type (tile) | Asbestos Type (mastic) |
|---|---|---|---|
| VFT05: 12"x12", black with white streaks | Building B - 2014-A010A-C | 3% Chrysotile | None detected |

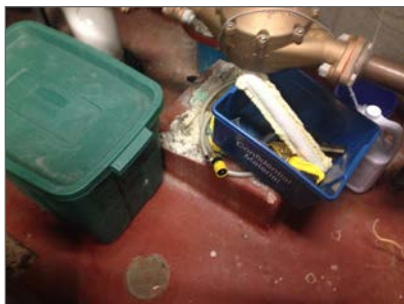
| Sample Number | Colour, Substrate Description | Locations | Lead (%) |
|---|---|---|---|
| 2015-L001 | Red on concrete floor | Building A Mechanical Room (1-007) | <0.007 |

Red paint on concrete floor in Location 1-007 (Sample: 2015-L001).

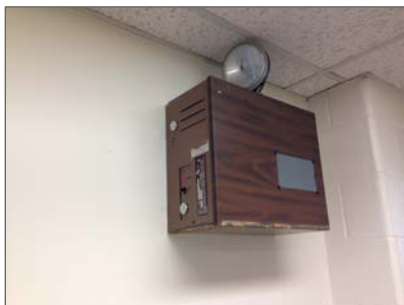
Lead-containing batteries may be present in emergency lighting present throughout both buildings.

Emergency lighting with lead-containing battery

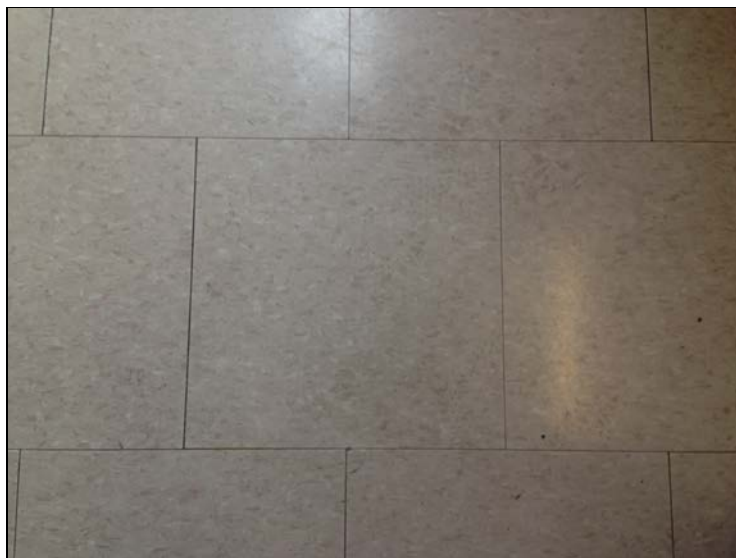
Photo #18: VFT01

| Size, Pattern, Colour and Photo Number | Sample Number | Asbestos Type (tile) | Asbestos Type (mastic) |
|---|---|---|---|
| VFT01: 12"x12", mixed shades of beige | Building A - 2014-A001A-C | None detected | None detected |
