## **Designated Substance Survey Report**

Toronto Police Services,  
32 Division  
30 Eglerslie Avenue,  
Toronto, Ontario

July 24, 2023

Pinchin File: 309046.003.0008

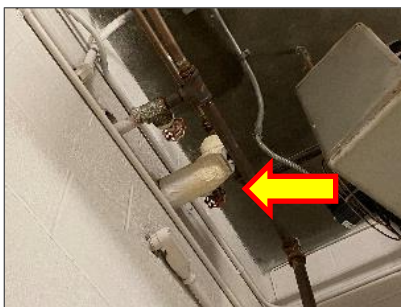
- Parging cement insulation on 1 pipe fitting, in fair condition, in the Sally Port.

Parging cement, previously determined to contain **chrysotile asbestos** (sampled in 1998 by T. Harris (sample 1)), was abated from all accessible pipe fittings in 2018 (Pinchin File No. 214847). During this survey Pinchin observed parging cement, previously not identified, in the Sally Port (Loc. 1-091). The parging cement, present on one pipe elbow, was observed in fair condition and is presumed to contain asbestos. Parging cement is a non-friable insulation.

Assumed asbestos-containing parging cement pipe insulation on fitting in Sally Port, Loc. 1-091.

| Material, Quantity & Condition | Location | Recommended Procedure |
|---|---|---|
| 1 pipe fitting in fair condition with asbestos containing parging cement. | Sally Port, Loc. 1-091 | Remove following Type 2 Glove bag Procedures as per O. Reg. 178/05. |

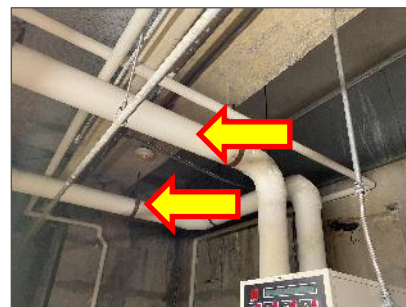
Pipes insulated with fibreglass in Storage Room, Loc. B-020.

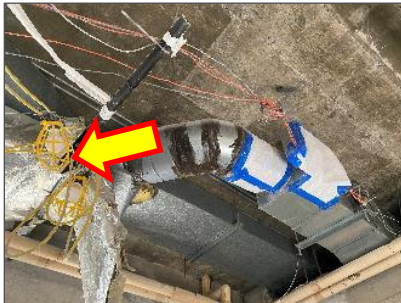
Grey duct mastic, present on ducts and covered by fiberglass insulation is presumed to contain asbestos until proved by laboratory analyses. Grey mastic was not sampled due to elevated heights.

Grey duct insulated with fibreglass and jacketed in foil, Washroom, Loc. 1-50.

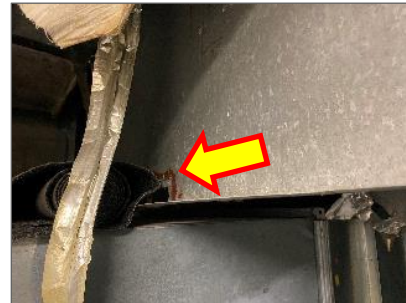
Red duct mastic, previously determined to contain **chrysotile asbestos** (Pinchin File No. 239820, samples A0005A-C), is present on seams of the duct and diffuser connections. Duct mastic is a non-friable material and in good condition.

Asbestos-containing duct mastic on ducts, Mechanical Room, Loc. B-004.

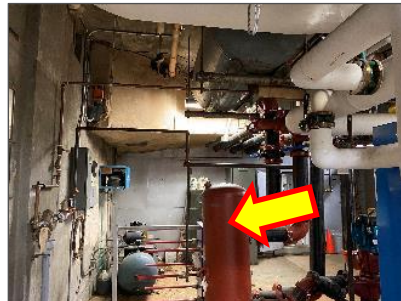
Uninsulated compressor tank, Mechanical Room (location B-004).

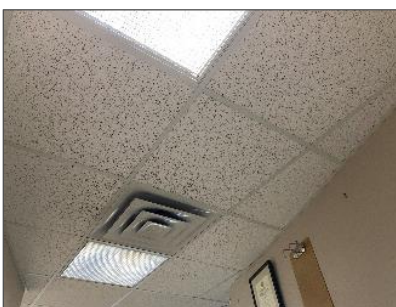
Non-asbestos ACT03.

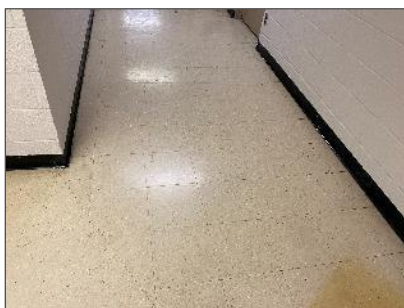
Non-asbestos VFT01.

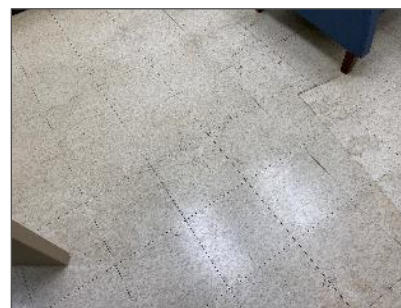
Non-asbestos VFT02.

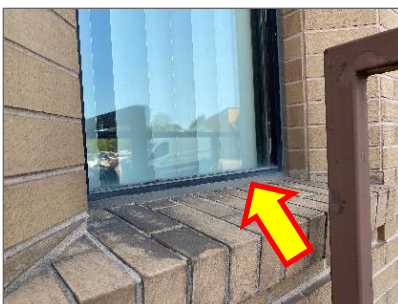
\*Caulking was sampled and confirmed to contain chrysotile asbestos. Caulking is a non-friable and in good condition.

Asbestos-containing exterior grey caulking, Exterior, Loc. 0-00.

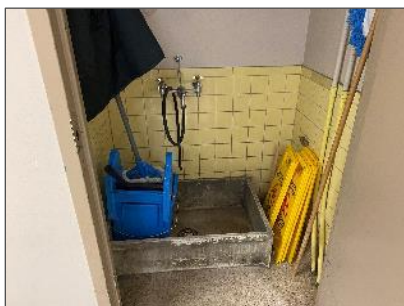
Previous observation - Ceramic tiles with asbestos-containing thin-set present in Janitor's Room, Loc. B-006.

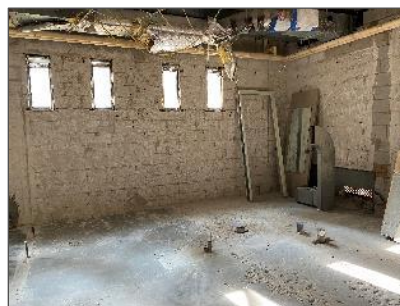
1-050, 1-051, 1-052, 1-054. These rooms are currently under renovation (block walls were exposed at the time of the reassessment). Pinchin is not aware of a report documenting the removal of this material.

Current observation - Concrete block walls with no remaining ceramic tile or thinset, Washroom, Loc. B-006.
