# **Designated Substances Survey Report**

32 Division  
30 Ellerslie Ave., Toronto, ON

**The City of Toronto**

December 4, 2015

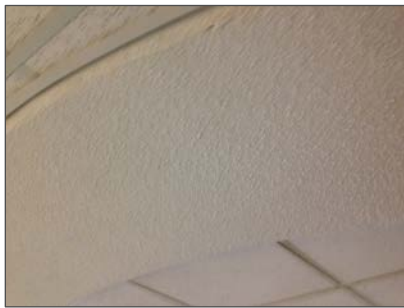
Texture finish, present on drywall ceilings on the first floor, was previously sampled (1998, 2006) and found not to contain asbestos.

Non-asbestos texture finish

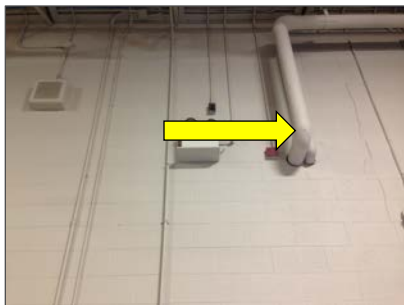
Parging cement, previously sampled (1998) and found to contain chrysotile asbestos, is present on pipe fittings (elbows, valves, tees, hangers etc.) on the hot water heating systems. Parging cement is a friable insulation, jacketed with canvas and is in good condition. Refer to the Survey Form in Appendix V for locations, quantities and condition of asbestos-containing parging cement.

Asbestos-containing parging cement

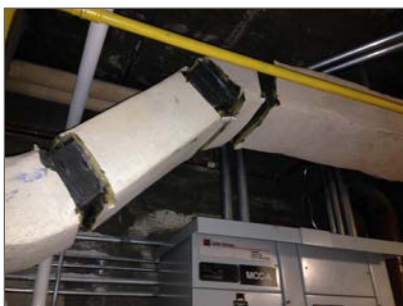
Ducts are either uninsulated or insulated with non-asbestos fibreglass and jacketed with either canvas or foil.

Non-asbestos fibreglass duct insulation

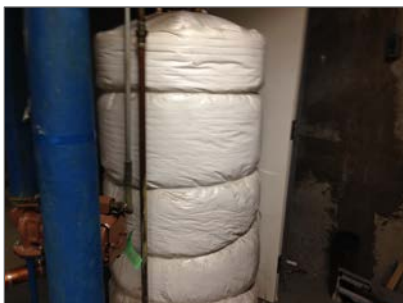
Fibreglass insulation on tank

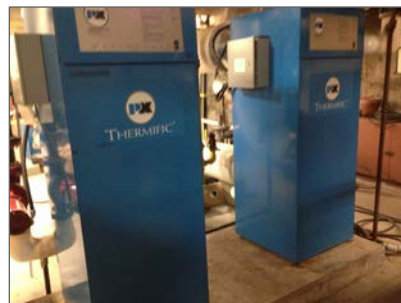
Un-insulated equipment

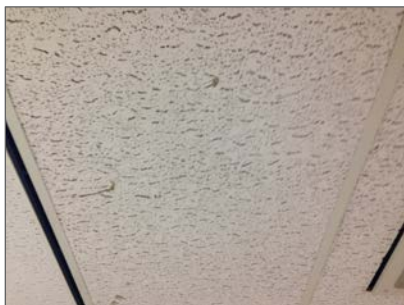
ACT01

| Size, Type, Pattern | Sample Number or Date Code | Asbestos Type |
|---|---|---|
| ACT01: 24"x48", lay-in, width wise fissure and pinhole | 11087-B42-01 & 02 and sample 1998 - 4 | None detected |

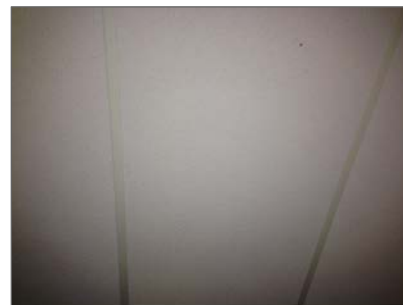
ACT02

| Size, Type, Pattern | Sample Number or Date Code | Asbestos Type |
|---|---|---|
| ACT02: 24"x48", lay-in, random pinhole pattern | 2015-A0004A-C | None detected |

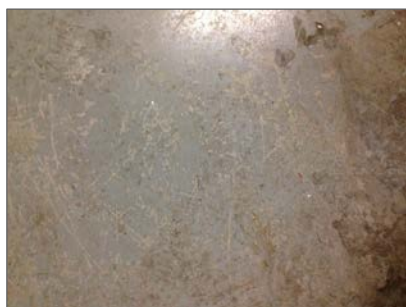
One paint chip sample was collected from an interior painted finish in poor condition, and found to contain less than the City of Toronto action level of 0.1% lead. All other paints were in good condition (i.e. not flaking, peeling or delaminating). Paints not sampled are assumed to contain lead. Appendix II-B presents the analytical results.

| Sample Number | Colour, Substrate Description | Location | Lead (%) |
|---|---|---|---|
| 2015-L001 | Grey on concrete floor | B-004 – Mechanical Room | 0.084 |

Grey paint on concrete floor

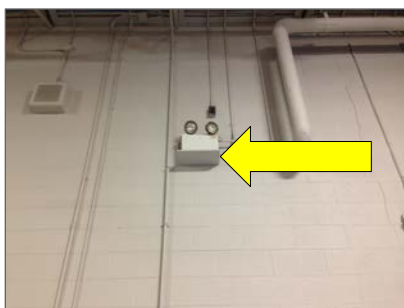
Lead-containing batteries may be present in emergency lighting.

Battery operated emergency

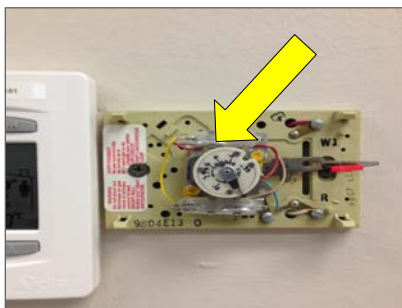
Mercury is present as a liquid in thermostats found in Location 2-102.

Mercury-containing thermostat

Recycle and reclaim mercury from fluorescent light tubes and thermostats when taken out of service. Do not break lamps or separate liquid mercury from components. Light tubes are accepted free of charge at many local recycling depots. Liquid mercury is classified as a hazardous waste and must be disposed of in accordance with local regulations.

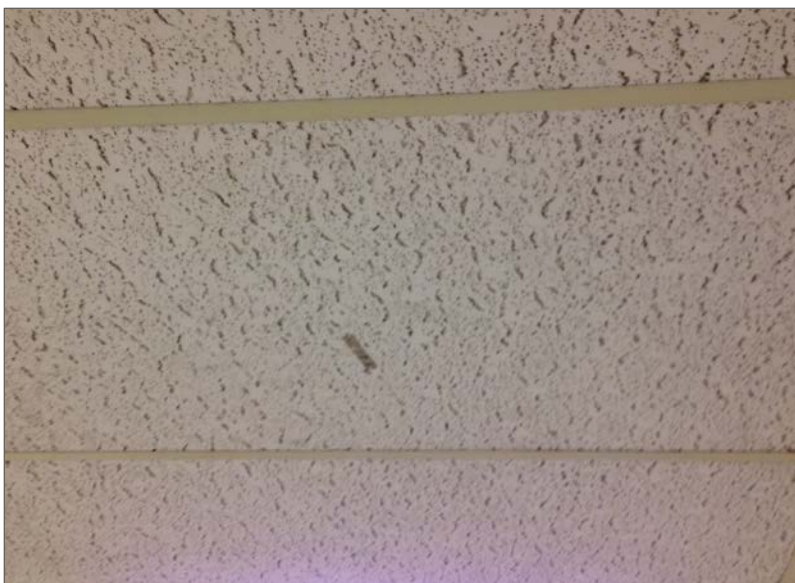
ACT03

| Size, Type, Pattern | Sample Number or Date Code | Asbestos Type |
|---|---|---|
| ACT03: 24"x48", lay-in, random fleck and hole | 2015-A0006A-C | None detected |

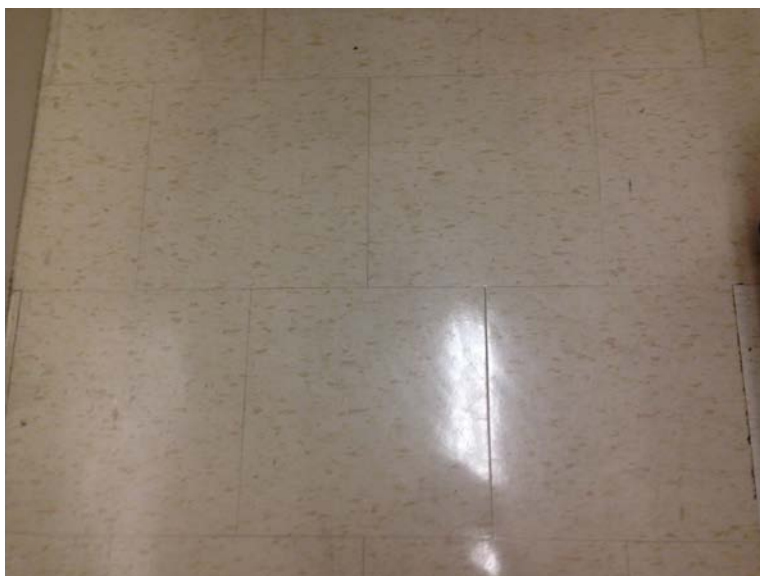
VFT06

| Size, Pattern, Colour | Sample Number | Asbestos Type (tile) | Asbestos Type (mastic) |
|---|---|---|---|
| VFT06: 12"x12" beige and brown smears, yellow mastic | 2015-A0008A-C | None detected | None detected |
