## **Designated Substances Survey Report**

Police Warehouse & Office  
Building  
330 Progress Ave., Toronto, ON

December 9, 2015

Pinchin File: 103037

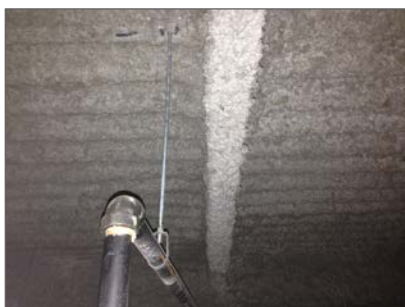
Non-asbestos fireproofing and overspray is present on the structure throughout the office area (Samples: 2015-A0002A-G).

Photo #1: Non-asbestos spray fireproofing

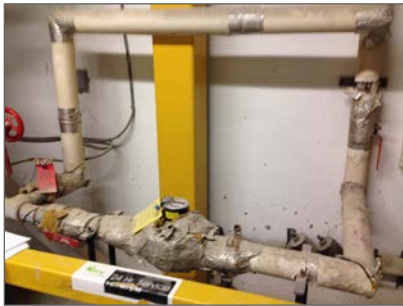
Non-asbestos insulation (e.g. fiberglass) is present on pipes throughout the assessed area.

Photo #2: Non-asbestos fiberglass pipe insulation

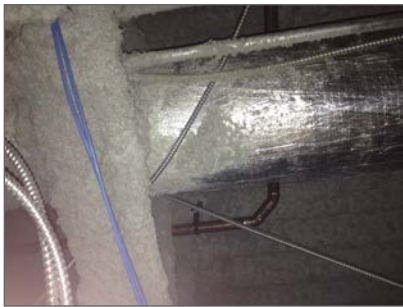
Ducts are either uninsulated or insulated with non-asbestos fiberglass and jacketed with foil.

Photo #3: Non-asbestos fiberglass duct insulation

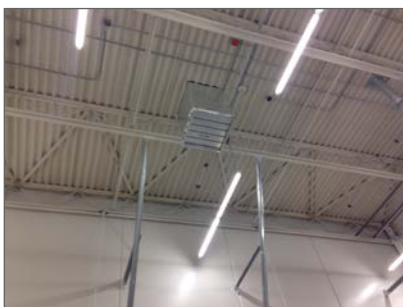
Mechanical equipment is either uninsulated or insulated with non-asbestos fiberglass

Photo #4: Non-asbestos fiberglass mechanical insulation

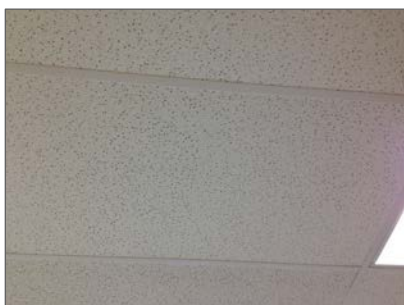
| Size, Type, Pattern, Photo # | Sample Number or Date Code | Asbestos Type |
|---|---|---|
| ACT01: 24"x48", lay-in, pinholes and pocks, Photo #5 | 2015-A0001A-C<br>04/11/13 date stamp | None detected |

Photo #5: ACT01, non-asbestos acoustic ceiling tiles, 24"x48" pinholes and pocks (Samples: 2015-A0001A-C)

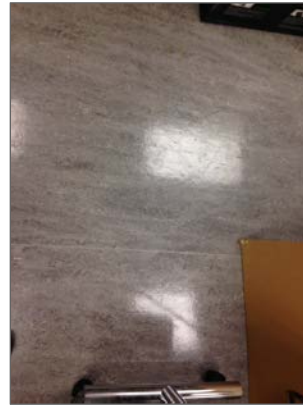
Photo 7: VSF02

| Pattern, Colour and Photo Number | Paper Backing (Yes/No) | Locations (Quantity) | Sample Number | Asbestos Type |
|---|---|---|---|---|
| VSF02 – grey | Unknown | Refer to Survey Form in Appendix V | Not sampled | Assumed |

The vinyl sheet flooring is non-friable but can become friable upon removal. Vinyl sheet flooring is in good condition.

Remove all asbestos-containing materials (ACM) prior to alteration or maintenance work or if ACM may be disturbed by the work. Follow appropriate asbestos precautions for the classification of work being performed.

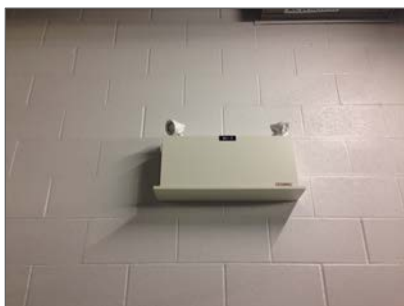
Lead-containing batteries may be present in emergency lighting present throughout building.

Photo #8: Emergency lighting with lead-containing battery

Lead-containing items (lead-acid batteries) should be recycled when taken out of service.
