# **Designated Substances Survey Report**

22 Division

3699 Bloor St. West, Toronto, ON

December 7, 2015

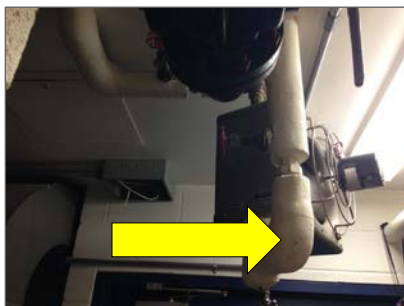
Parging cement, containing chrysotile asbestos, is present on pipe fittings (elbows, valves, tees, hangers etc.) on hot water heating and domestic water systems (samples 1087-B15-01). Parging cement is a friable insulation, jacketed with canvas and is in good condition. Refer to the Survey Form in Appendix V for locations of asbestos-containing parging cement.

Asbestos-containing parging cement fittings

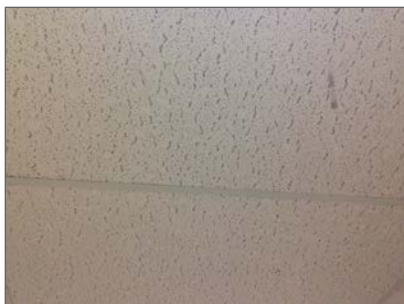
ACT02

| Size, Type, and Pattern | Sample Number or Date Code | Asbestos Type |
|---|---|---|
| ACT02: 24"x48", lay-in, width-wise fissures and pinholes | 11087-B15-07 to 12 | None detected |

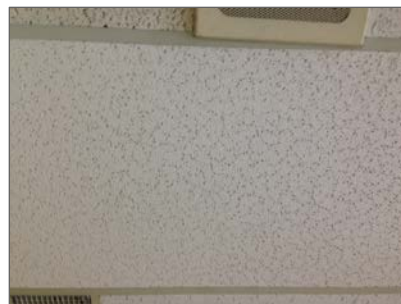
ACT03

| Size, Type, and Pattern | Sample Number or Date Code | Asbestos Type |
|---|---|---|
| ACT03: 24"x48", lay-in, random dimple and hole | 2013-0005A-C | None detected |

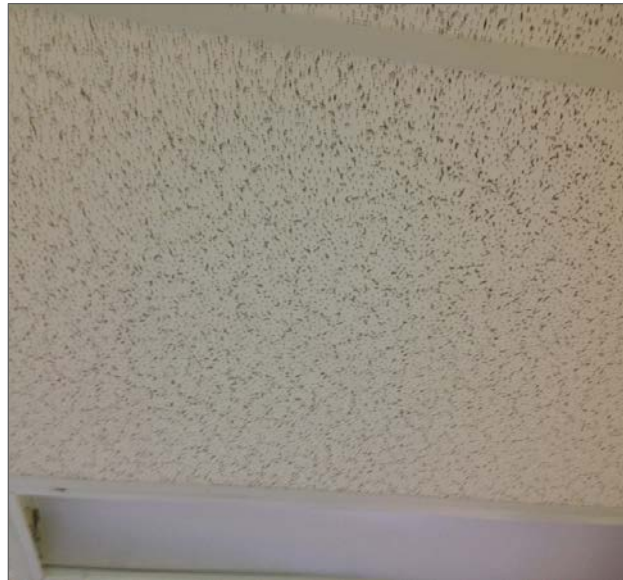
ACT04

| Size, Type, and Pattern | Sample Number or Date Code | Asbestos Type |
|---|---|---|
| ACT04: 24"x48", lay-in, fissure and hole | 2013-0001A-C | None detected |
