# **Designated Substances Survey Report**

Police Headquarters  
40 College Street, Toronto, Ontario

December 10, 2015

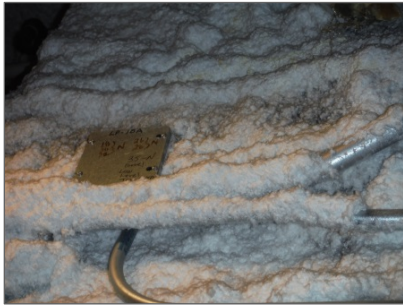
Non-asbestos fireproofing and overspray is present on the structure throughout the Basement and in select areas on the 1<sup>st</sup> floor (samples 2012-A0001A-G).

Non-asbestos sprayed fireproofing

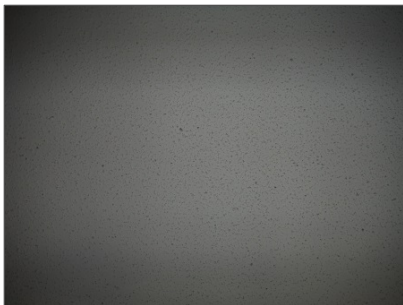
Texture finish is present on concrete walls in the Basement Parking Garages (samples 2013-A0023A-C and 2015-A0023D-G). No asbestos was detected in the texture coat samples.

Non-asbestos texture finish

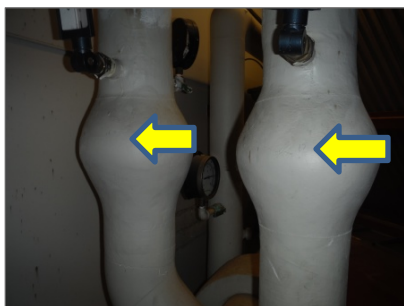
Non-asbestos paring cement (previously sampled) insulation is present on pipe fittings (elbows, valves, tees, hangers etc.) is present in the Penthouse Mechanical Rooms.

Non-asbestos paring cement

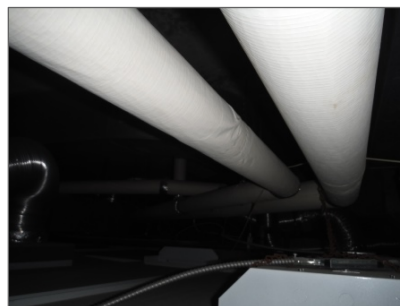
All remaining pipes are either not insulated or insulated with non-asbestos fibreglass insulation.

Non-asbestos fiberglass insulation

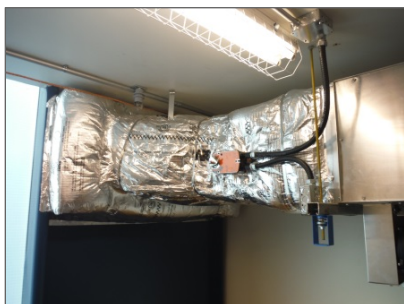
Ducts are either uninsulated or insulated with non-asbestos fiberglass and jacketed with either canvas or foil.

Non-asbestos fiberglass insulated ducts jacketed with foil

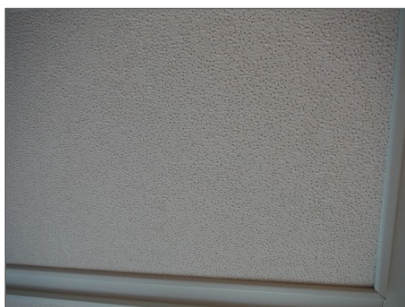
Ceiling tiles are considered to be potentially friable and are in good condition.

Photo 01 – Non-asbestos ACT 01

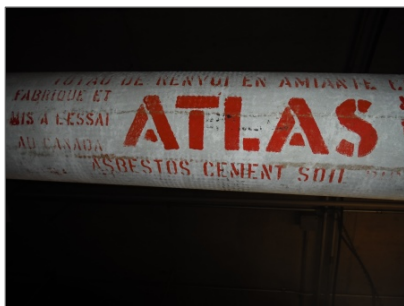
Transite pipe is present as rain water leaders throughout the building. Transite is assumed to contain asbestos based on visual observation. Transite is non-friable and in good condition.

Asbestos cement (Transite) as rain water leader.

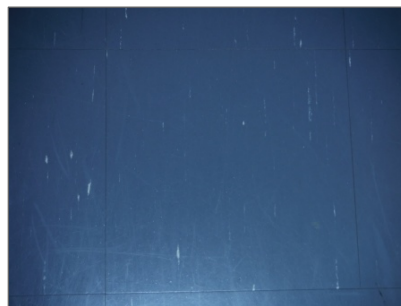
Photo 03 – Non-asbestos VFT-02

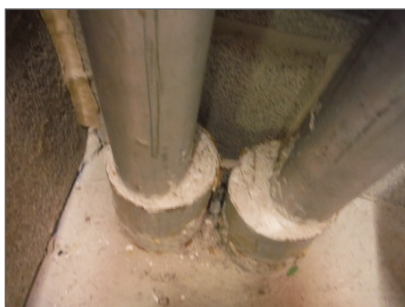
Non-asbestos firestopping (samples 2015-A0032A-C) is present in Mechanical Closets throughout the building at pipe and conduit penetrations.

Non-asbestos firestopping

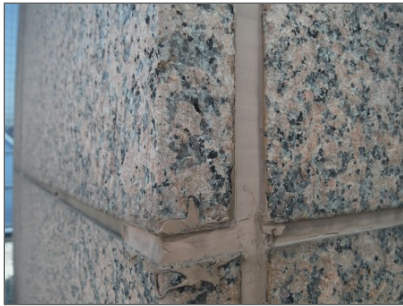
Non-asbestos light brown caulking

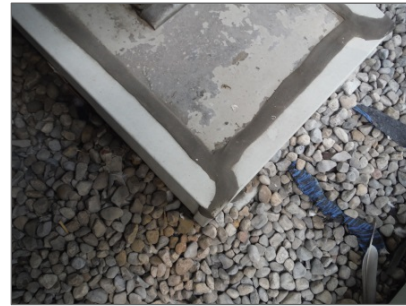
| Colour | Locations (Quantity) | Sample Number | Asbestos Type |
|---|---|---|---|
| Grey | *See Survey Form in Appendix V for Locations | 2015-A0035A-C | None Detected |

Non-asbestos grey caulking

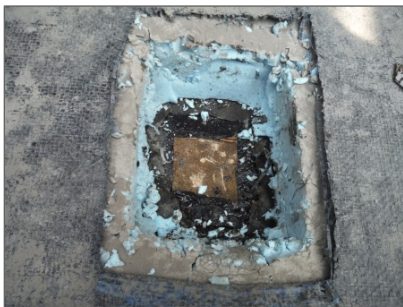
Built-up roofing is present on the roof over the entire building. The built up roofing materials do not contain asbestos (samples 2015-A0031A-C).

Cross-section of non-asbestos roofing materials

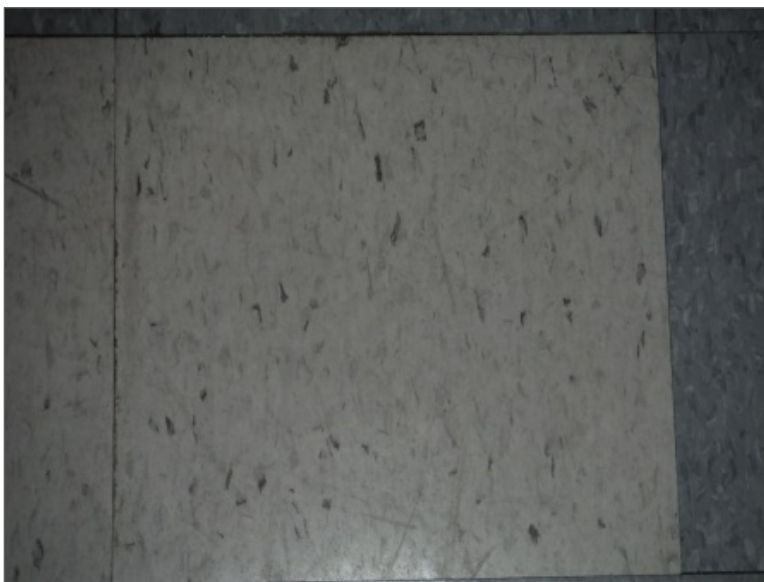
Photo 04 – Non-asbestos VFT-03

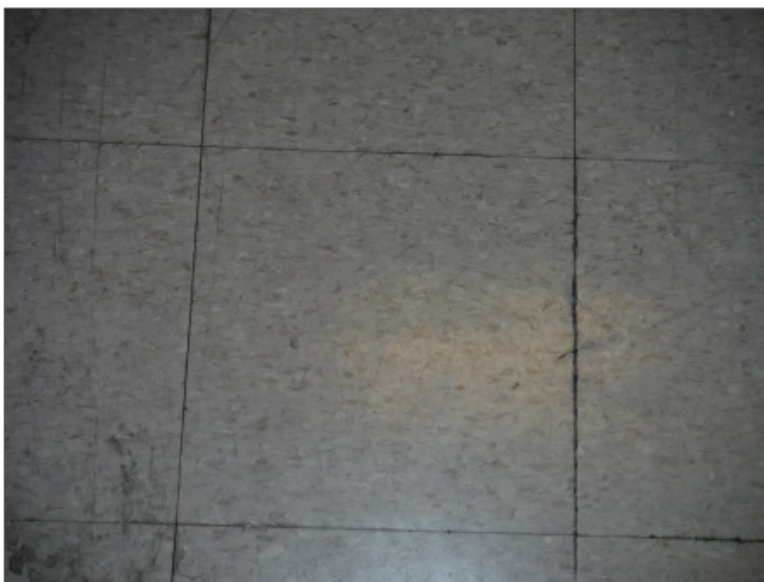
Photo 05 – Non-asbestos VFT-04

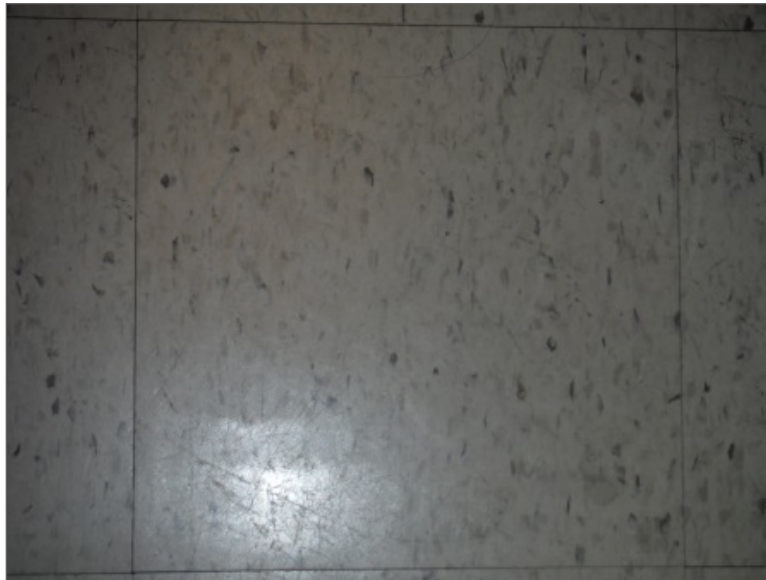
| Size, Pattern, Colour and Photo Number | Locations (Quantity) | Sample Number | Asbestos Type (tile) | Asbestos Type (mastic) |
|---|---|---|---|---|
| VFT-05 – 12"x12", grey with white and black smears, Photo 06 | *See Survey Form in Appendix V for Locations | 2013-A0028A-C | None Detected | None Detected |

Photo 06 – Non-asbestos VFT05

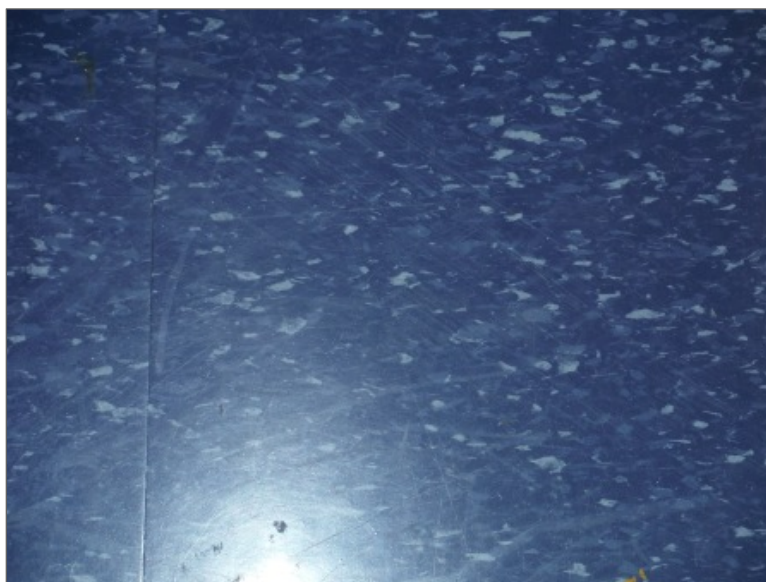
| Size, Pattern, Colour and Photo Number | Locations (Quantity) | Sample Number | Asbestos Type (tile) | Asbestos Type (mastic) |
|---|---|---|---|---|
| VFT-06 – 12"x12", blue with white streaks, Photo 07 | *See Survey Form in Appendix V for Locations | 2013-A0030A-C | None Detected | None Detected |

Photo 07 – Non-asbestos VFT-06
