# **Designated Substances Survey Report**

51 Division

51 Parliament St., Toronto, ON

December 9, 2015

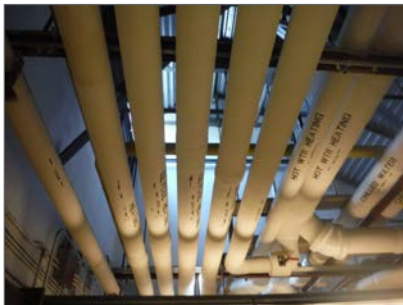
Non-asbestos insulation (e.g. fiberglass) is present on pipes throughout the assessed area.

Typical non-asbestos fiberglass pipe insulation.

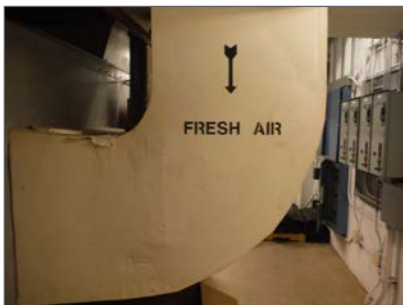
Ducts are either uninsulated or insulated with non-asbestos fiberglass and jacketed with canvas.

Duct insulated with non-asbestos fiberglass

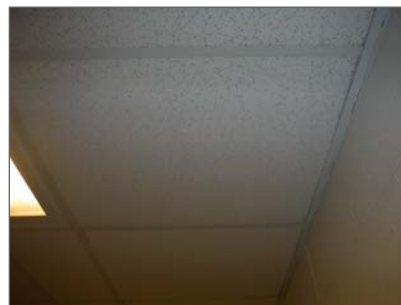
ACT02

| Size, Type, and Pattern | Sample Number or Date Code | Asbestos Type |
|---|---|---|
| ACT02: 24"x48", lay-in, random dimple and hole | 2014-A0004A-C | None detected |

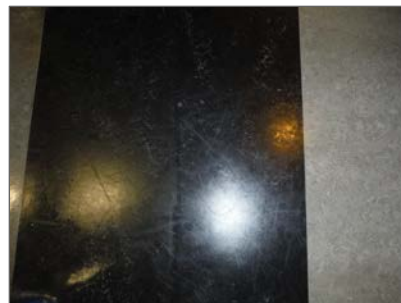
VSF-02

| Pattern and Colour | Paper Backing (Yes/No) | Sample Number | Asbestos Type |
|---|---|---|---|
| VSF-02: Black | No | 2014-A0001A-C | None detected |
