## **SURVEY FOR DESIGNATED SUBSTANCES AND HAZARDOUS MATERIALS**

**COMMUNICATION, TRAFFIC, COMPUTER CENTRE AND PARKING GARAGE  
703 DON MILLS ROAD  
TORONTO, ONTARIO**

**Prepared for:**  
**City of Toronto**  
Corporate Real Estate Management  
**Attention: Inder Bhamra**

**ECOH Project No.: 29129.04-14**  
**December 19, 2025**

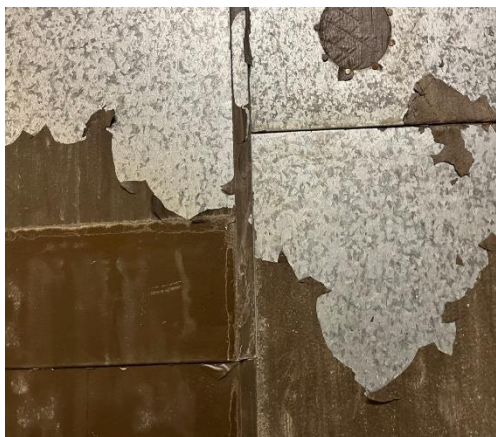
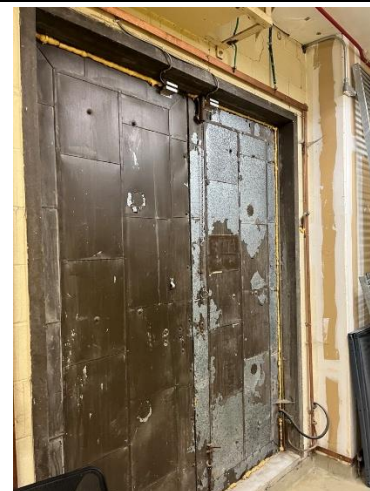
| Photos are representative of flaking paint observed on the Electrical Room fire door.<br><br>Surface scrape approximately forty (40) square feet of lead-based paint. | | |

| TABLE 3: Recommendations for Corrective Action - Lead | | | |
|---|---|---|---|
| B-02 | Electrical Room | 40 SF of Brown Paint on Fire Door – POOR Condition | REMOVE (Class 2a) |

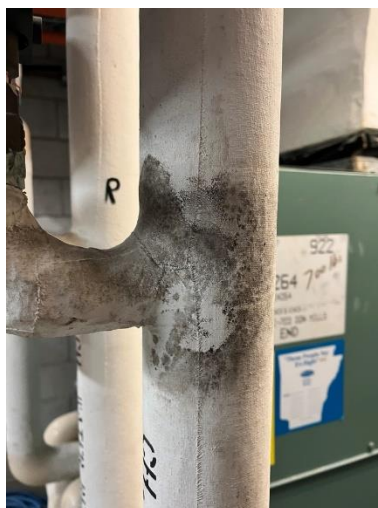
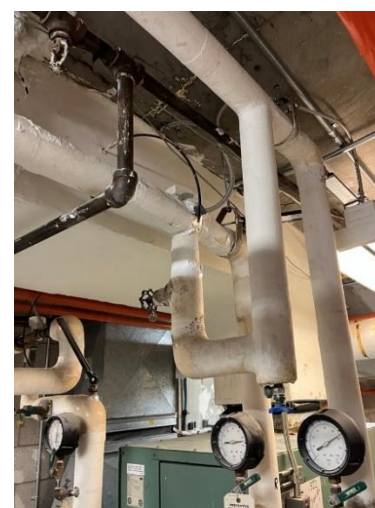
| <b>Photo No. 2.</b> | | |

| Mould growth observed on non-asbestos fibreglass insulation on piping.<br><br>Remove and dispose of fourteen (14) linear feet of mould-affected pipe insulation. Reinstatement required. | | |

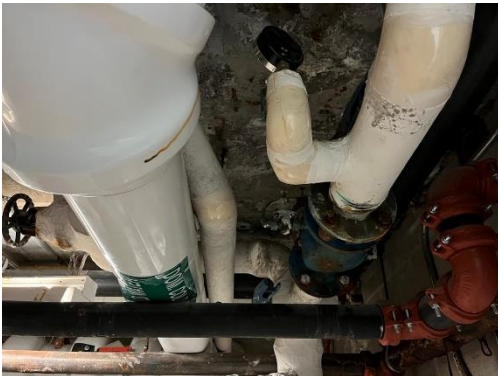
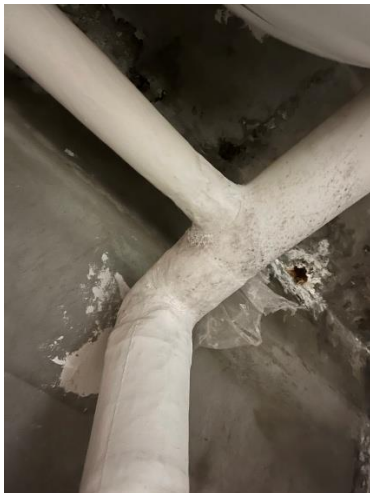
| <b>Details:</b> | | | Mould growth observed on non-asbestos fibreglass insulation on piping.<br><br>Remove and dispose of fifteen (15) linear feet of mould-affected pipe insulation. Reinstatement required. | |

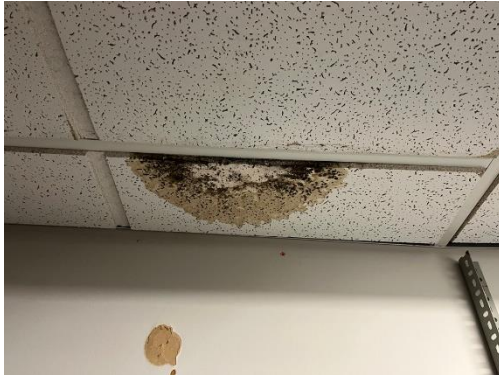
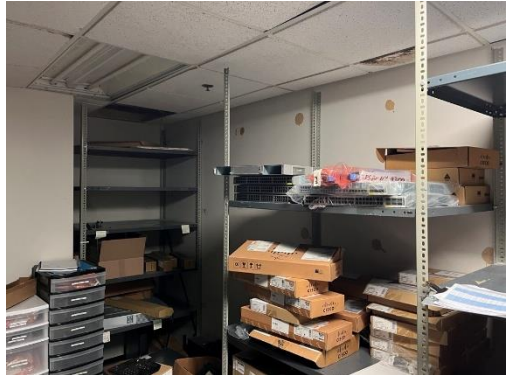
| <b>Location:</b> Loc B-36<br><b>Name:</b> Network Storage Room | | | |

| <b>Details:</b> | | One (1) water damaged non-asbestos ceiling tile observed.<br><br>Remove and replace one (1) ceiling tile. | |

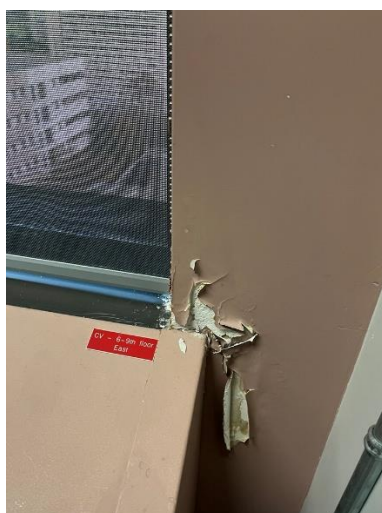
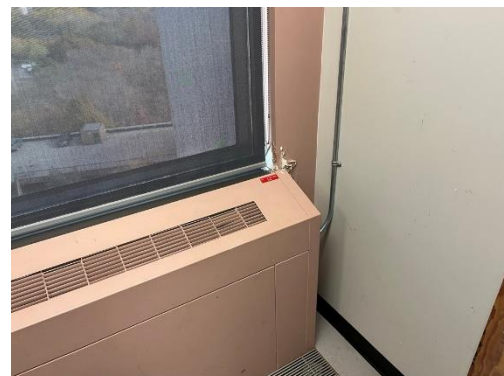
| Four (4) square feet of damaged drywall with asbestos-containing joint compound was observed.<br><br>Remove and repair four (4) square feet of drywall. | | |

| TABLE 2: Recommendations for Corrective Action - Asbestos | | | |
|---|---|---|---|
| 9-18 | Radio Computer Room | 4 SF of damaged asbestos-containing drywall – POOR Condition | REMOVE (Type 1) |

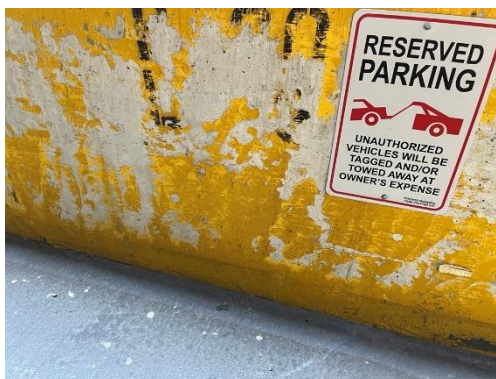
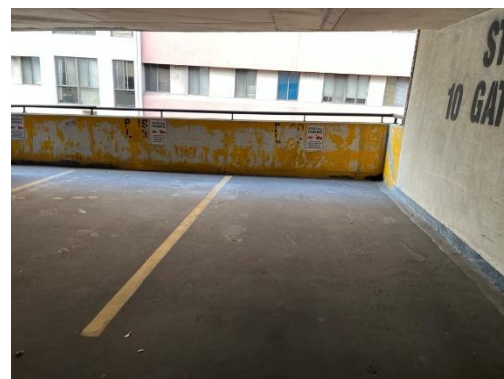
| <b>Photo No. 8.</b> | | |

| Photos are representative of flaking paint observed on the columns and walls<br><br>Surface scrape approximately five hundred (500) square feet of lead-based paint. | | |

| TABLE 3: Recommendations for Corrective Action - Lead | | | |
|---|---|---|---|
| L-306 | Parking Garage | 500 SF of peeling yellow paint on wall - POOR Condition | REMOVE (Class 2a) |
