**GENERAL INFORMATION**

| Roof Name | 314 |
| Service Activity Type | Inspection |
| Service Activity Date | 19/07/16 |

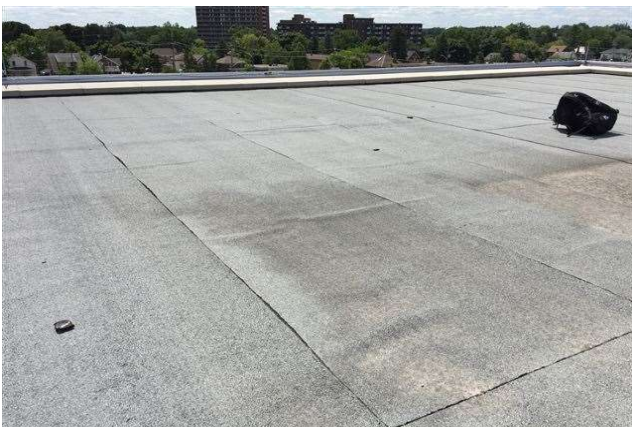
Membrane ridging  
Damaged membrane. Appears that something was cut on the membrane.  
Minor Granule loss

Ridging

Continue to maintain.

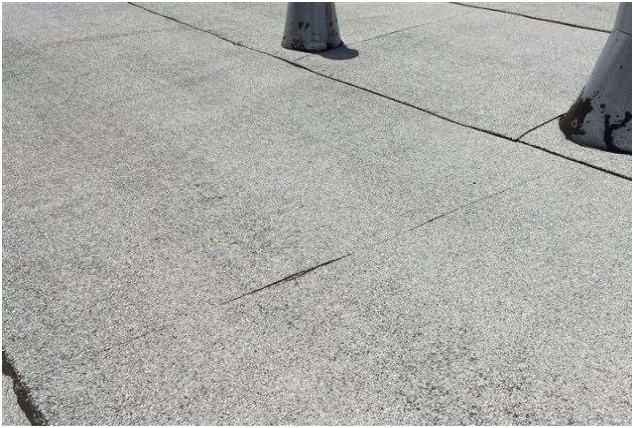
Damaged membrane

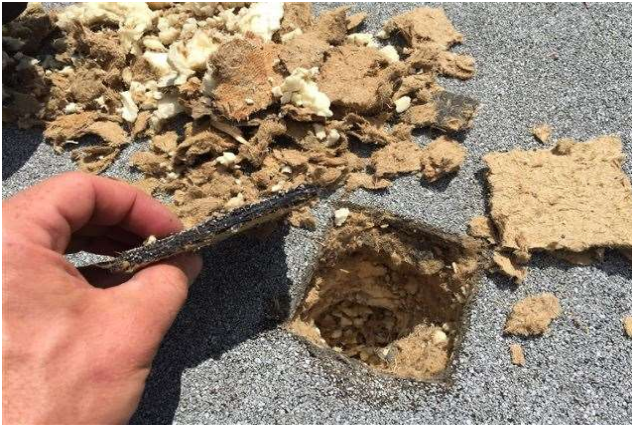
Core cut
