## **ADDENDUM NO. 2**

**BID CALL NO. T2021-173**

### **CONSTRUCTION OF FIRE STATION 201 AT 25 RUTHERFORD ROAD SOUTH**

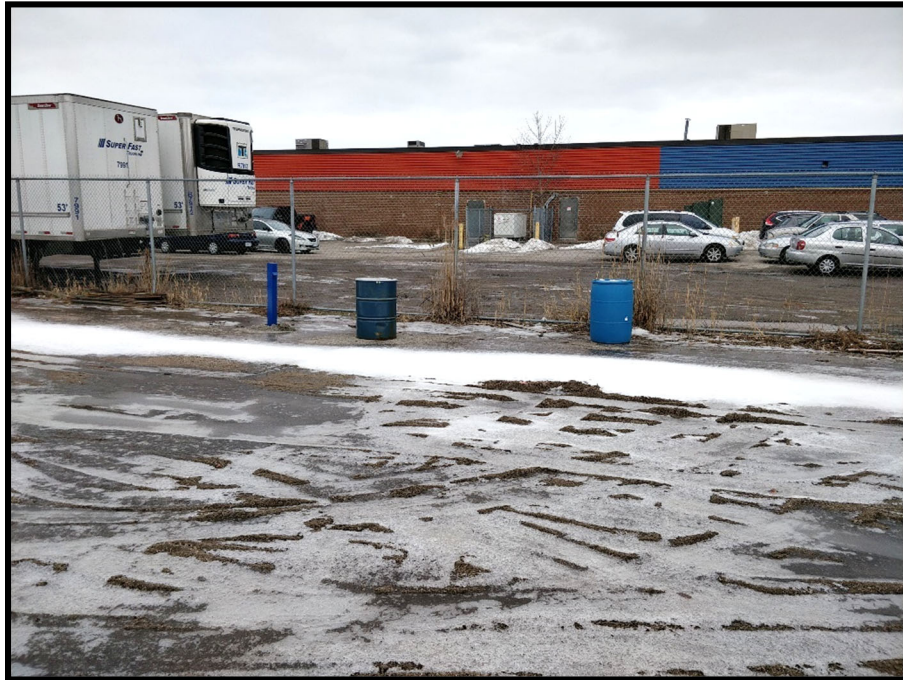
Photograph 5: Looking north towards monitoring well BH19-2. One steel and one plastic drums were observed.

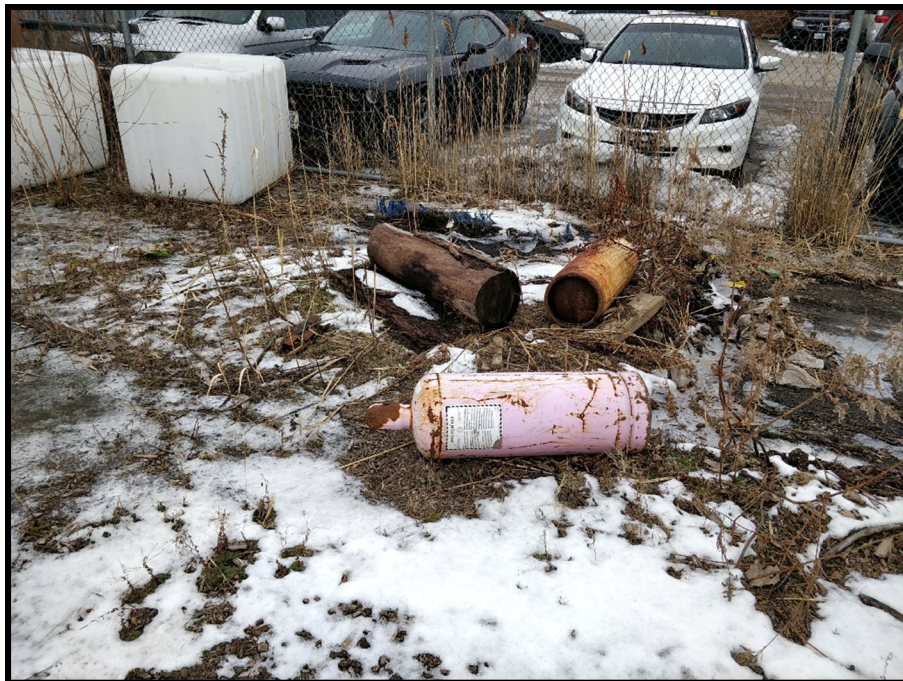
Photograph 6: Two gas cylinder tanks were noted east of the shed (looking north)

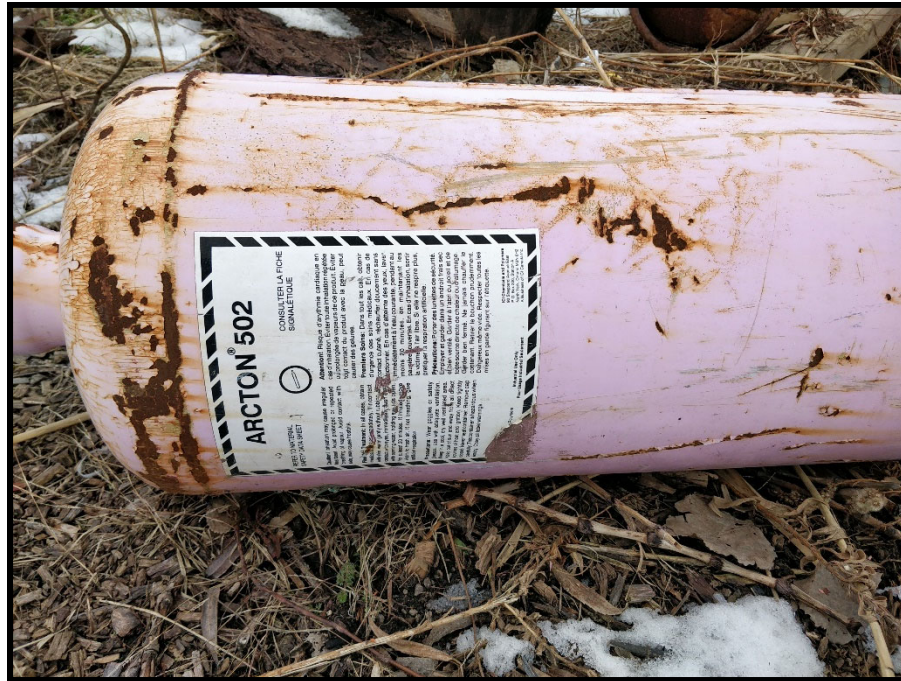
Photograph 7: Safety Data Sheet (SDS) label noted on one of the gas cylinder tanks.

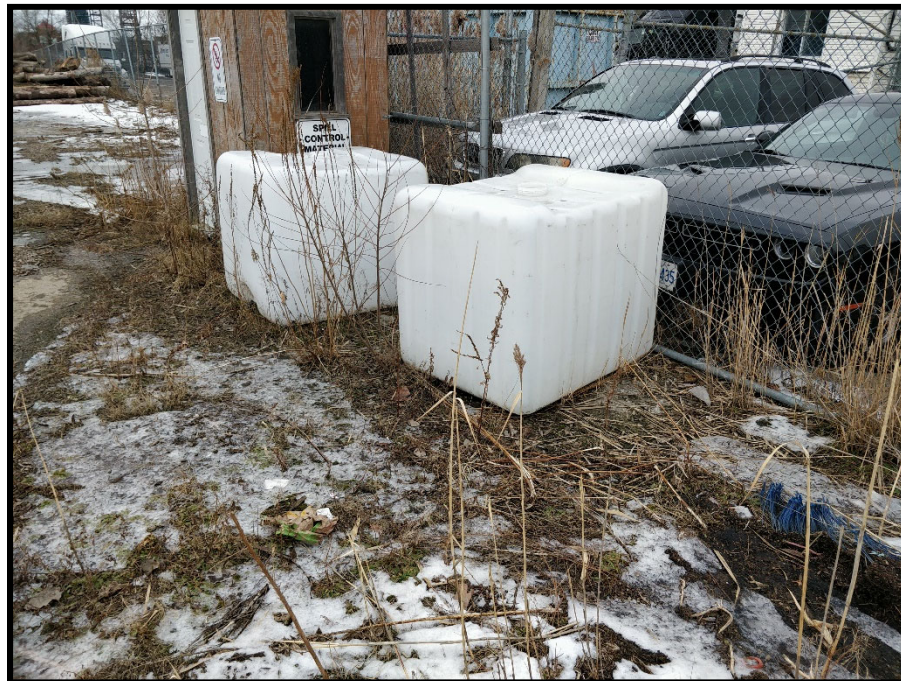
Photograph 8: Empty plastic totes located adjacent north boundary of the Site.

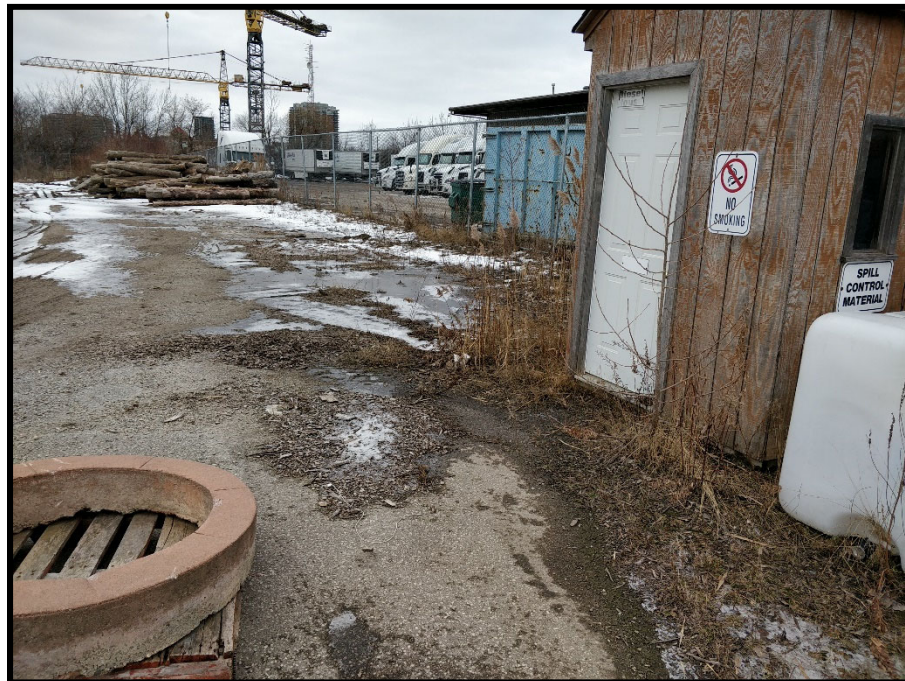
Photograph 10: Looking west from the shed. A wooden pallet and concrete ring were noted.

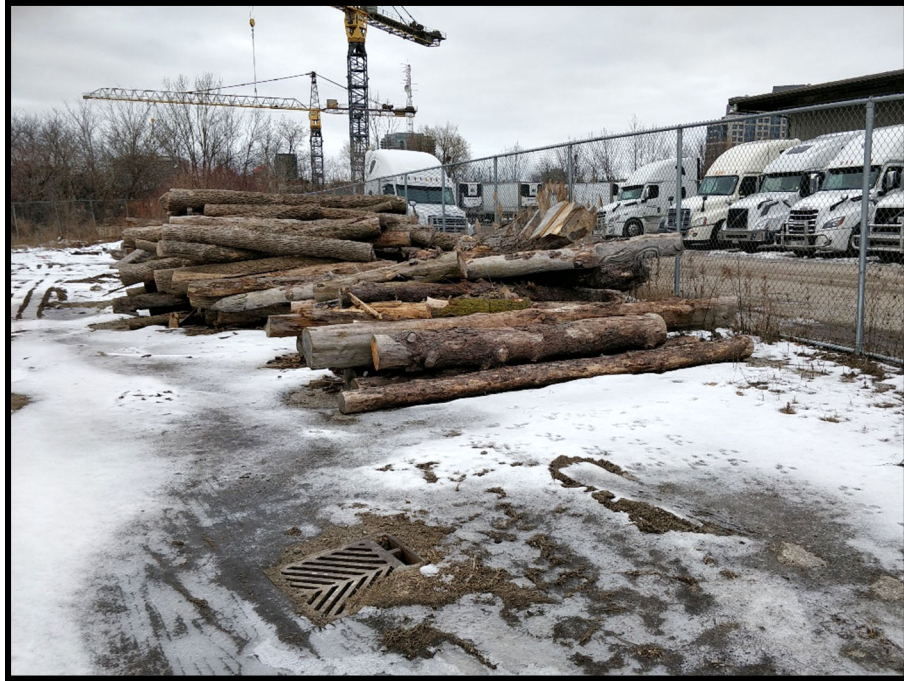
Photograph 11: A pile of wood logs were noted in the northwest portion of the site.

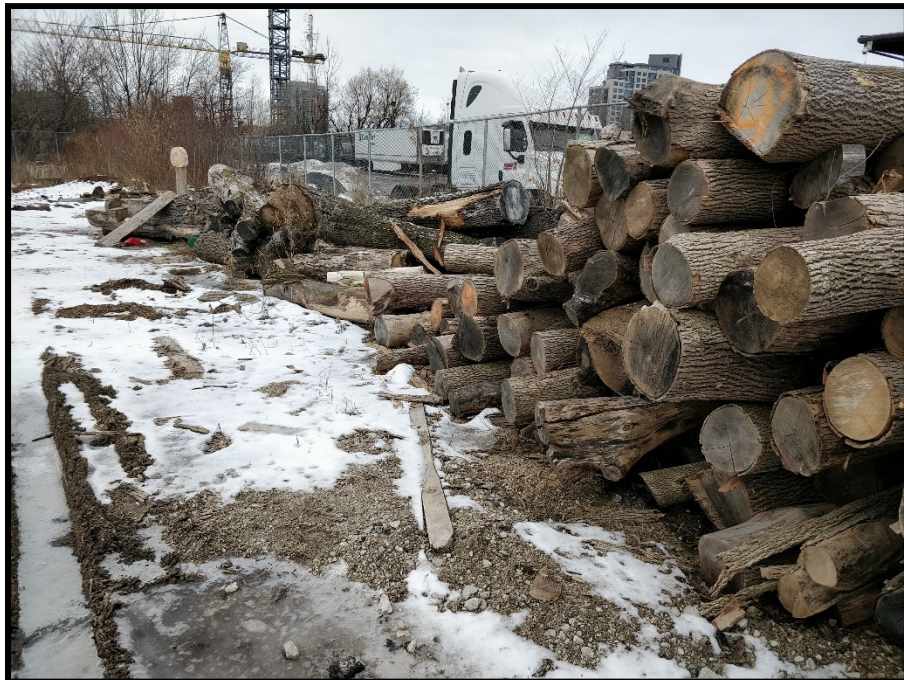
Photograph 12: View of the pile of wood logs.
