ARBORIST REPORT

VAUGHAN FIRE STATION 7-12 9541 WESTON ROAD

VAUGHAN FIRE STATION 7-12

MARCH 2022
LGL PROJECT TA9196

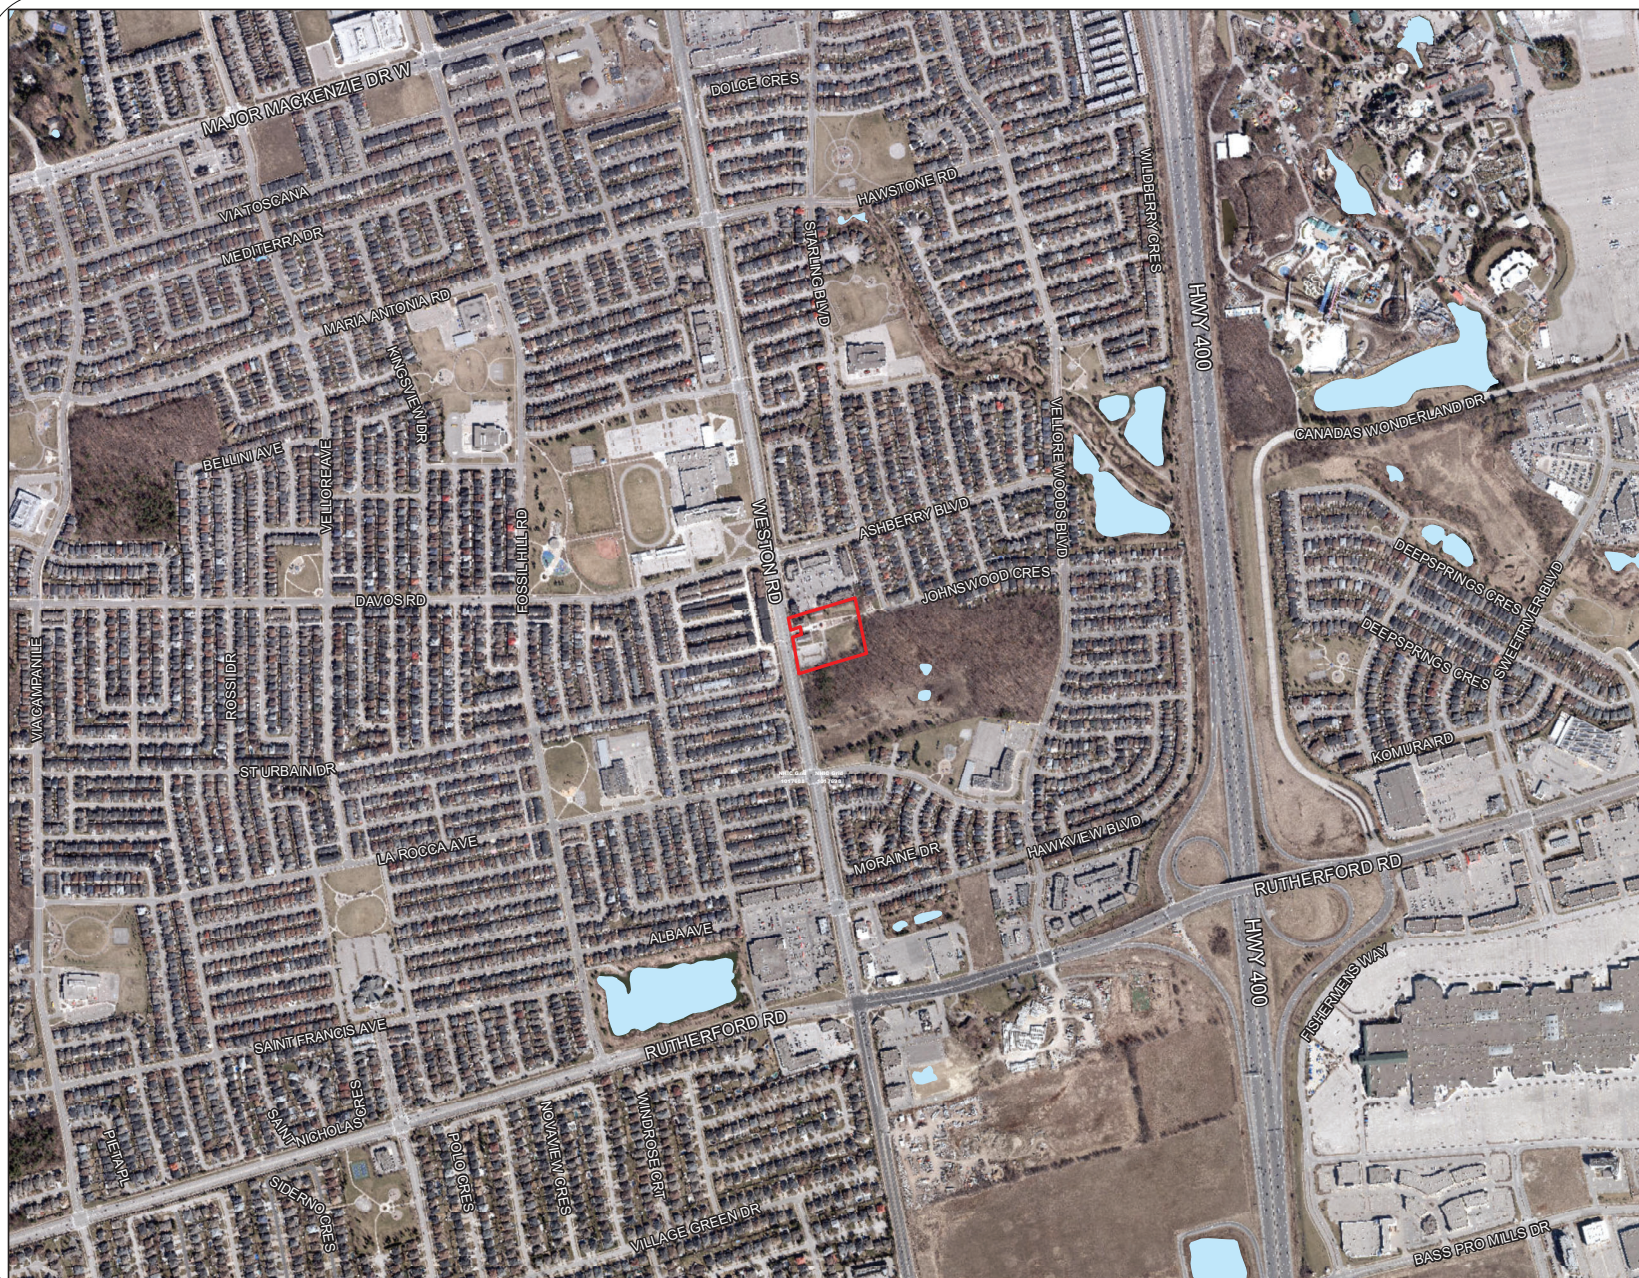
This Arborist Report documents the results of the tree inventory conducted in February 2022 and includes an impact assessment which provides recommendations for tree protection, removals and mitigation measure. The impact assessment and mitigation is based on a review of the grading limits provided by Thomas Brown Architects.

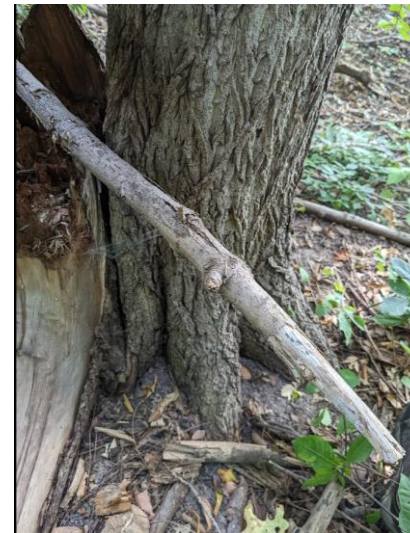
Photo 12: Tree 183 failed stem, live buttress and bole.

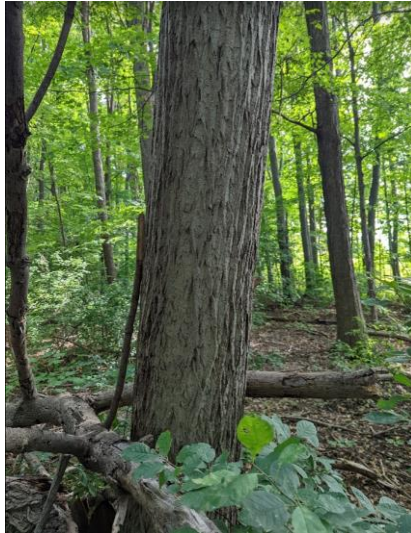
Photo 13: Tree 183 main living stem.

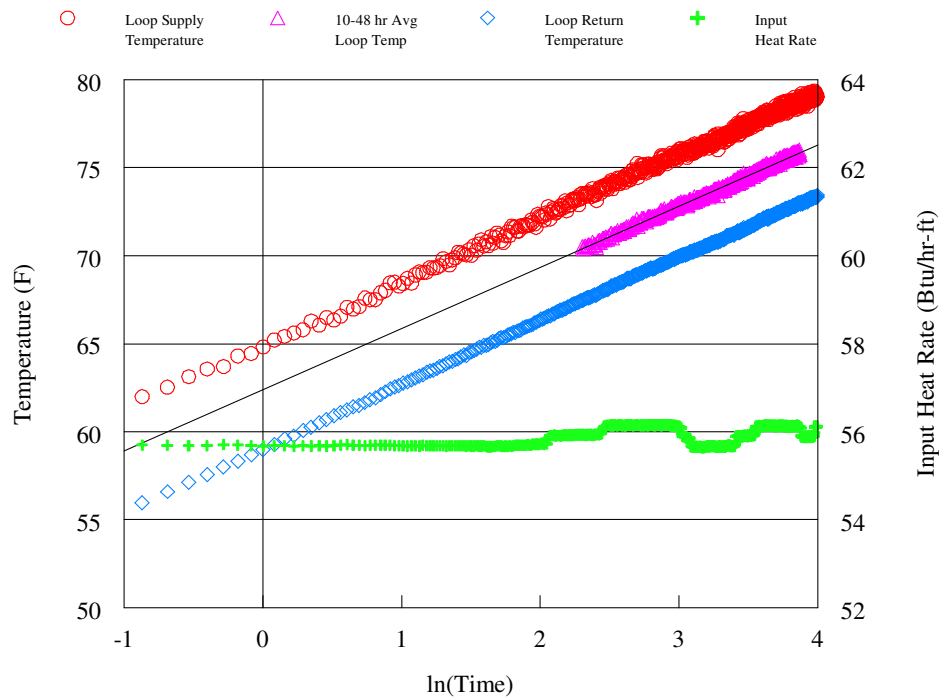
FIG. 2: TEMPERATURE & HEAT RATE VS NATURAL LOG OF TIME
