Phase One Environmental Site Assessment

9541 Weston Road, Vaughan, Ontario

City of Vaughan
Final Report
Reference No.02112512.000

June 22, 2022
01-02112512.000-0100-EN-004-00

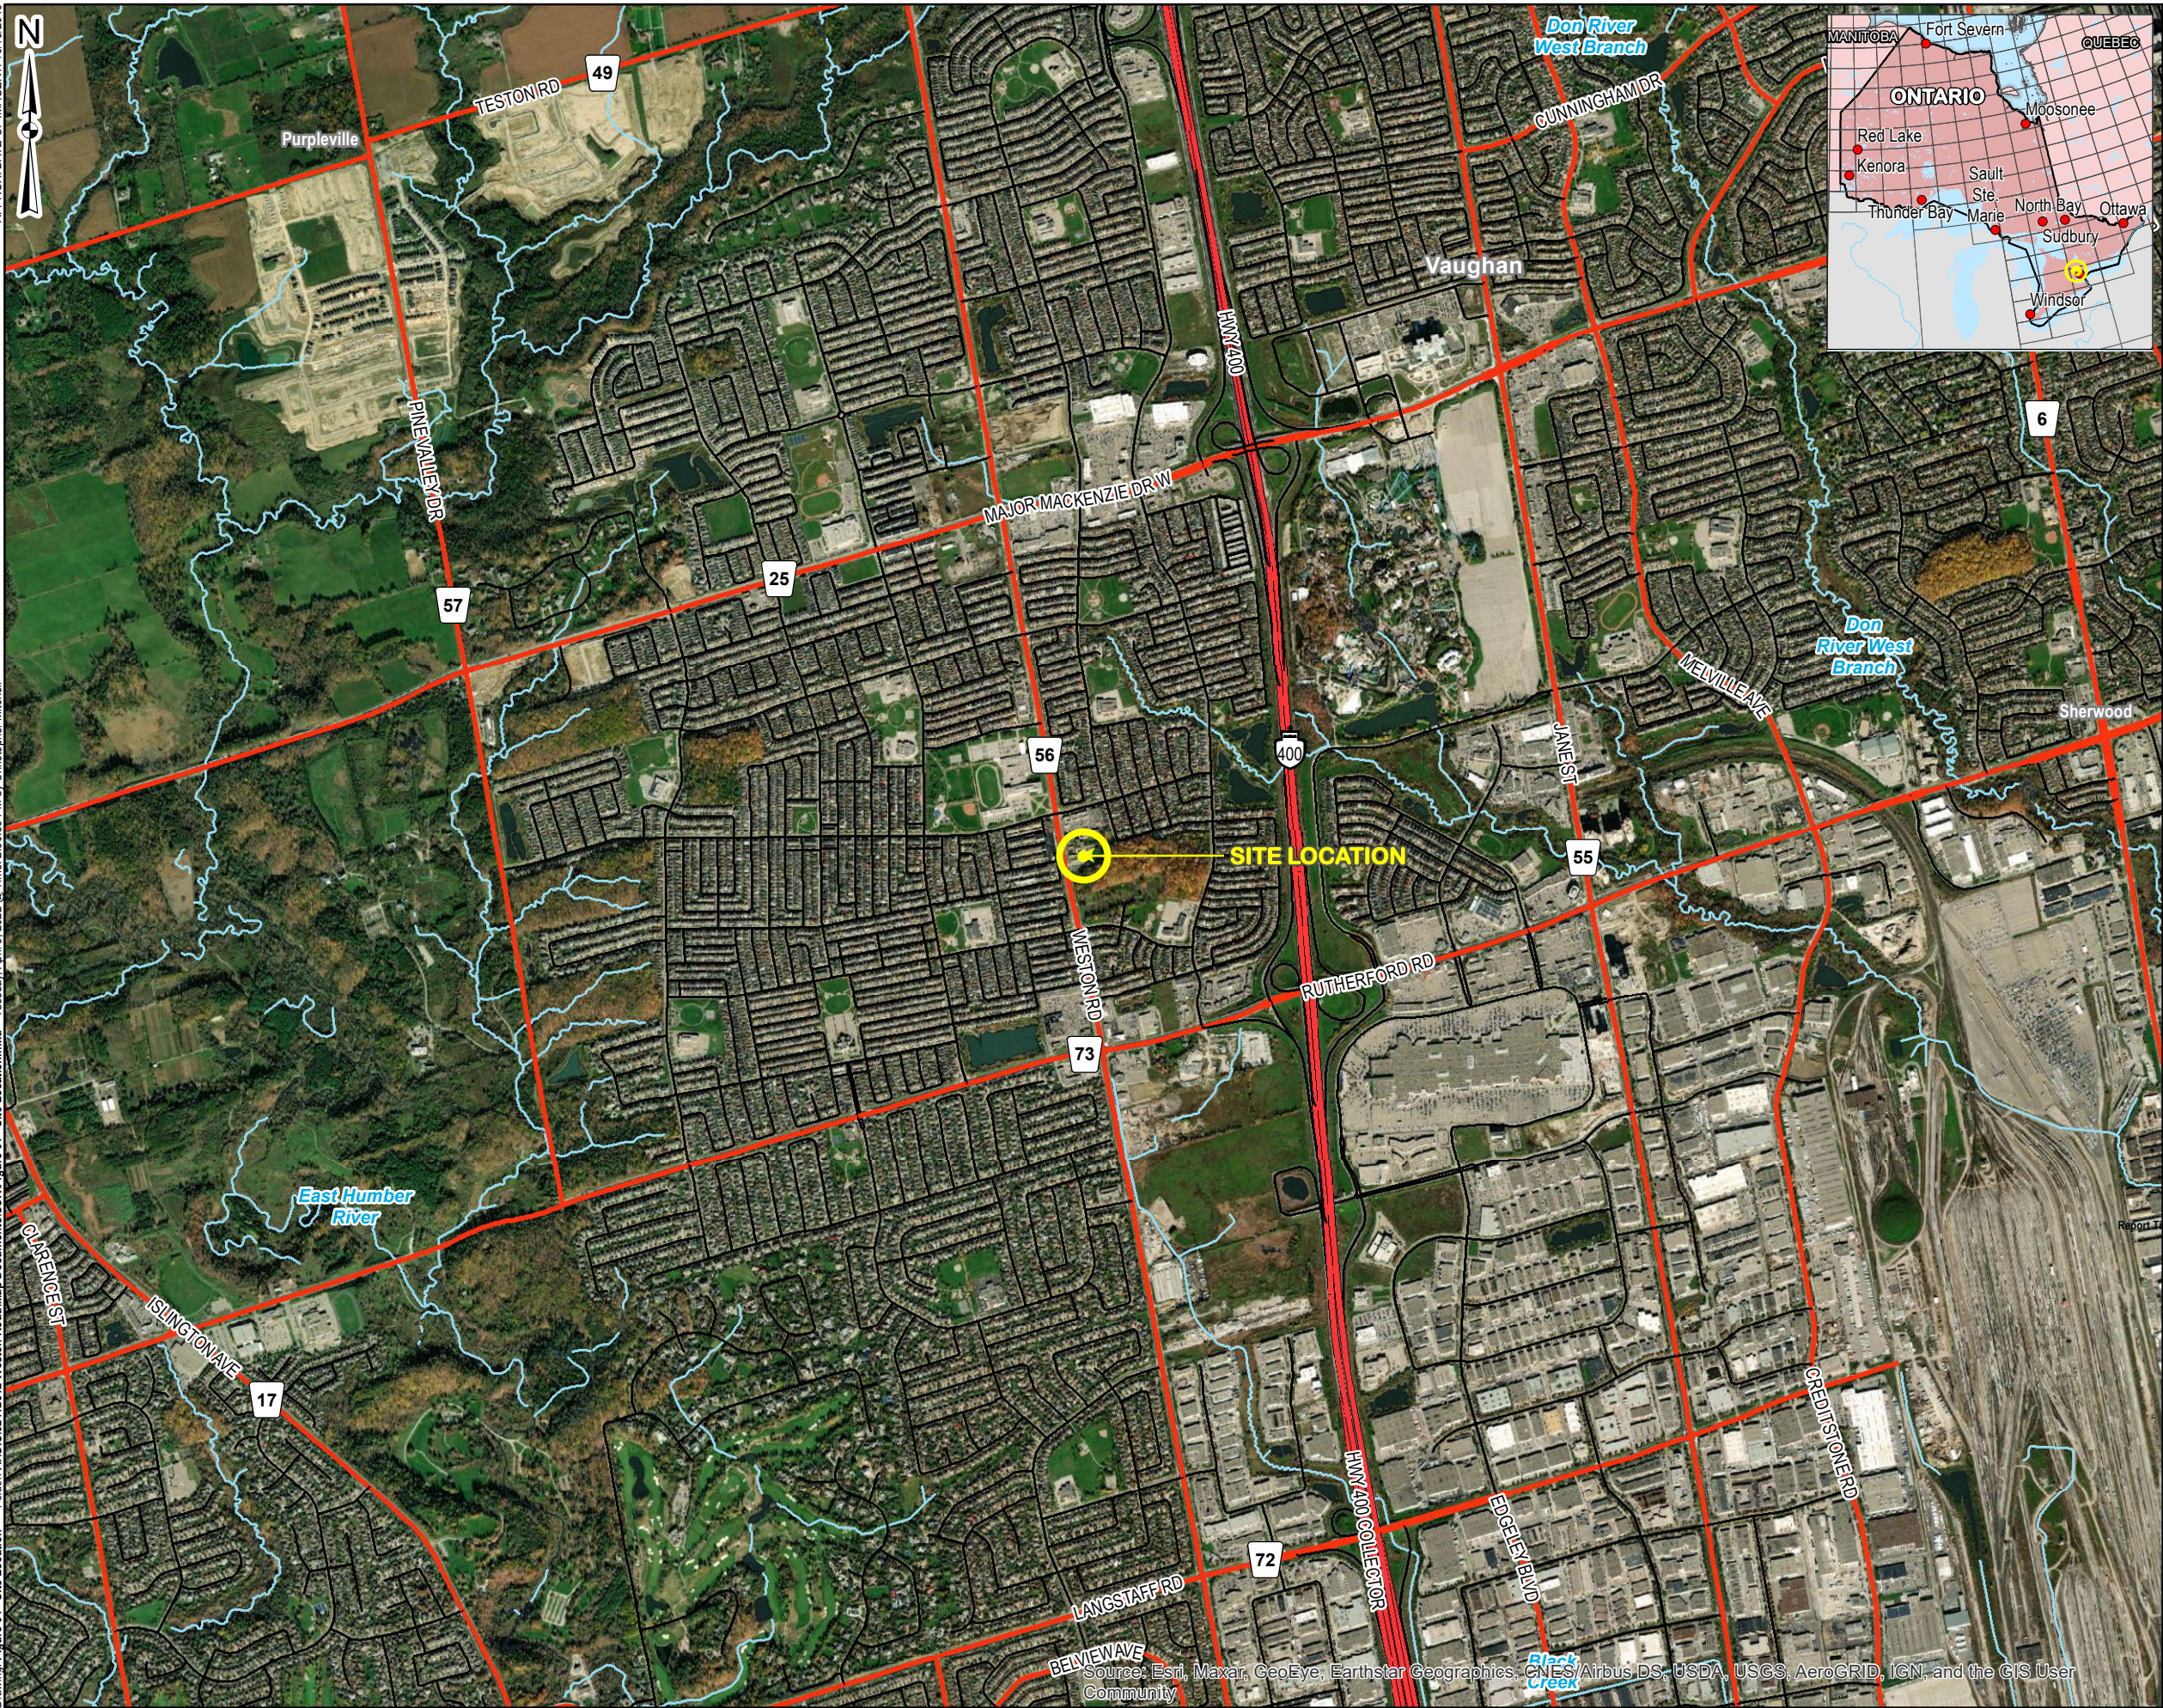
Englobe Corp. (Englobe) was retained by the City of Vaughan (hereinafter referred to as the “Client”) to complete a Phase One Environmental Site Assessment (Phase One ESA) for the property located at 9541 Weston Road in Vaughan, Ontario (hereinafter referred to as “Site” or “Phase One Property”). The location of the Site is shown on the Site Location Plan, Figure 1 in Appendix A.

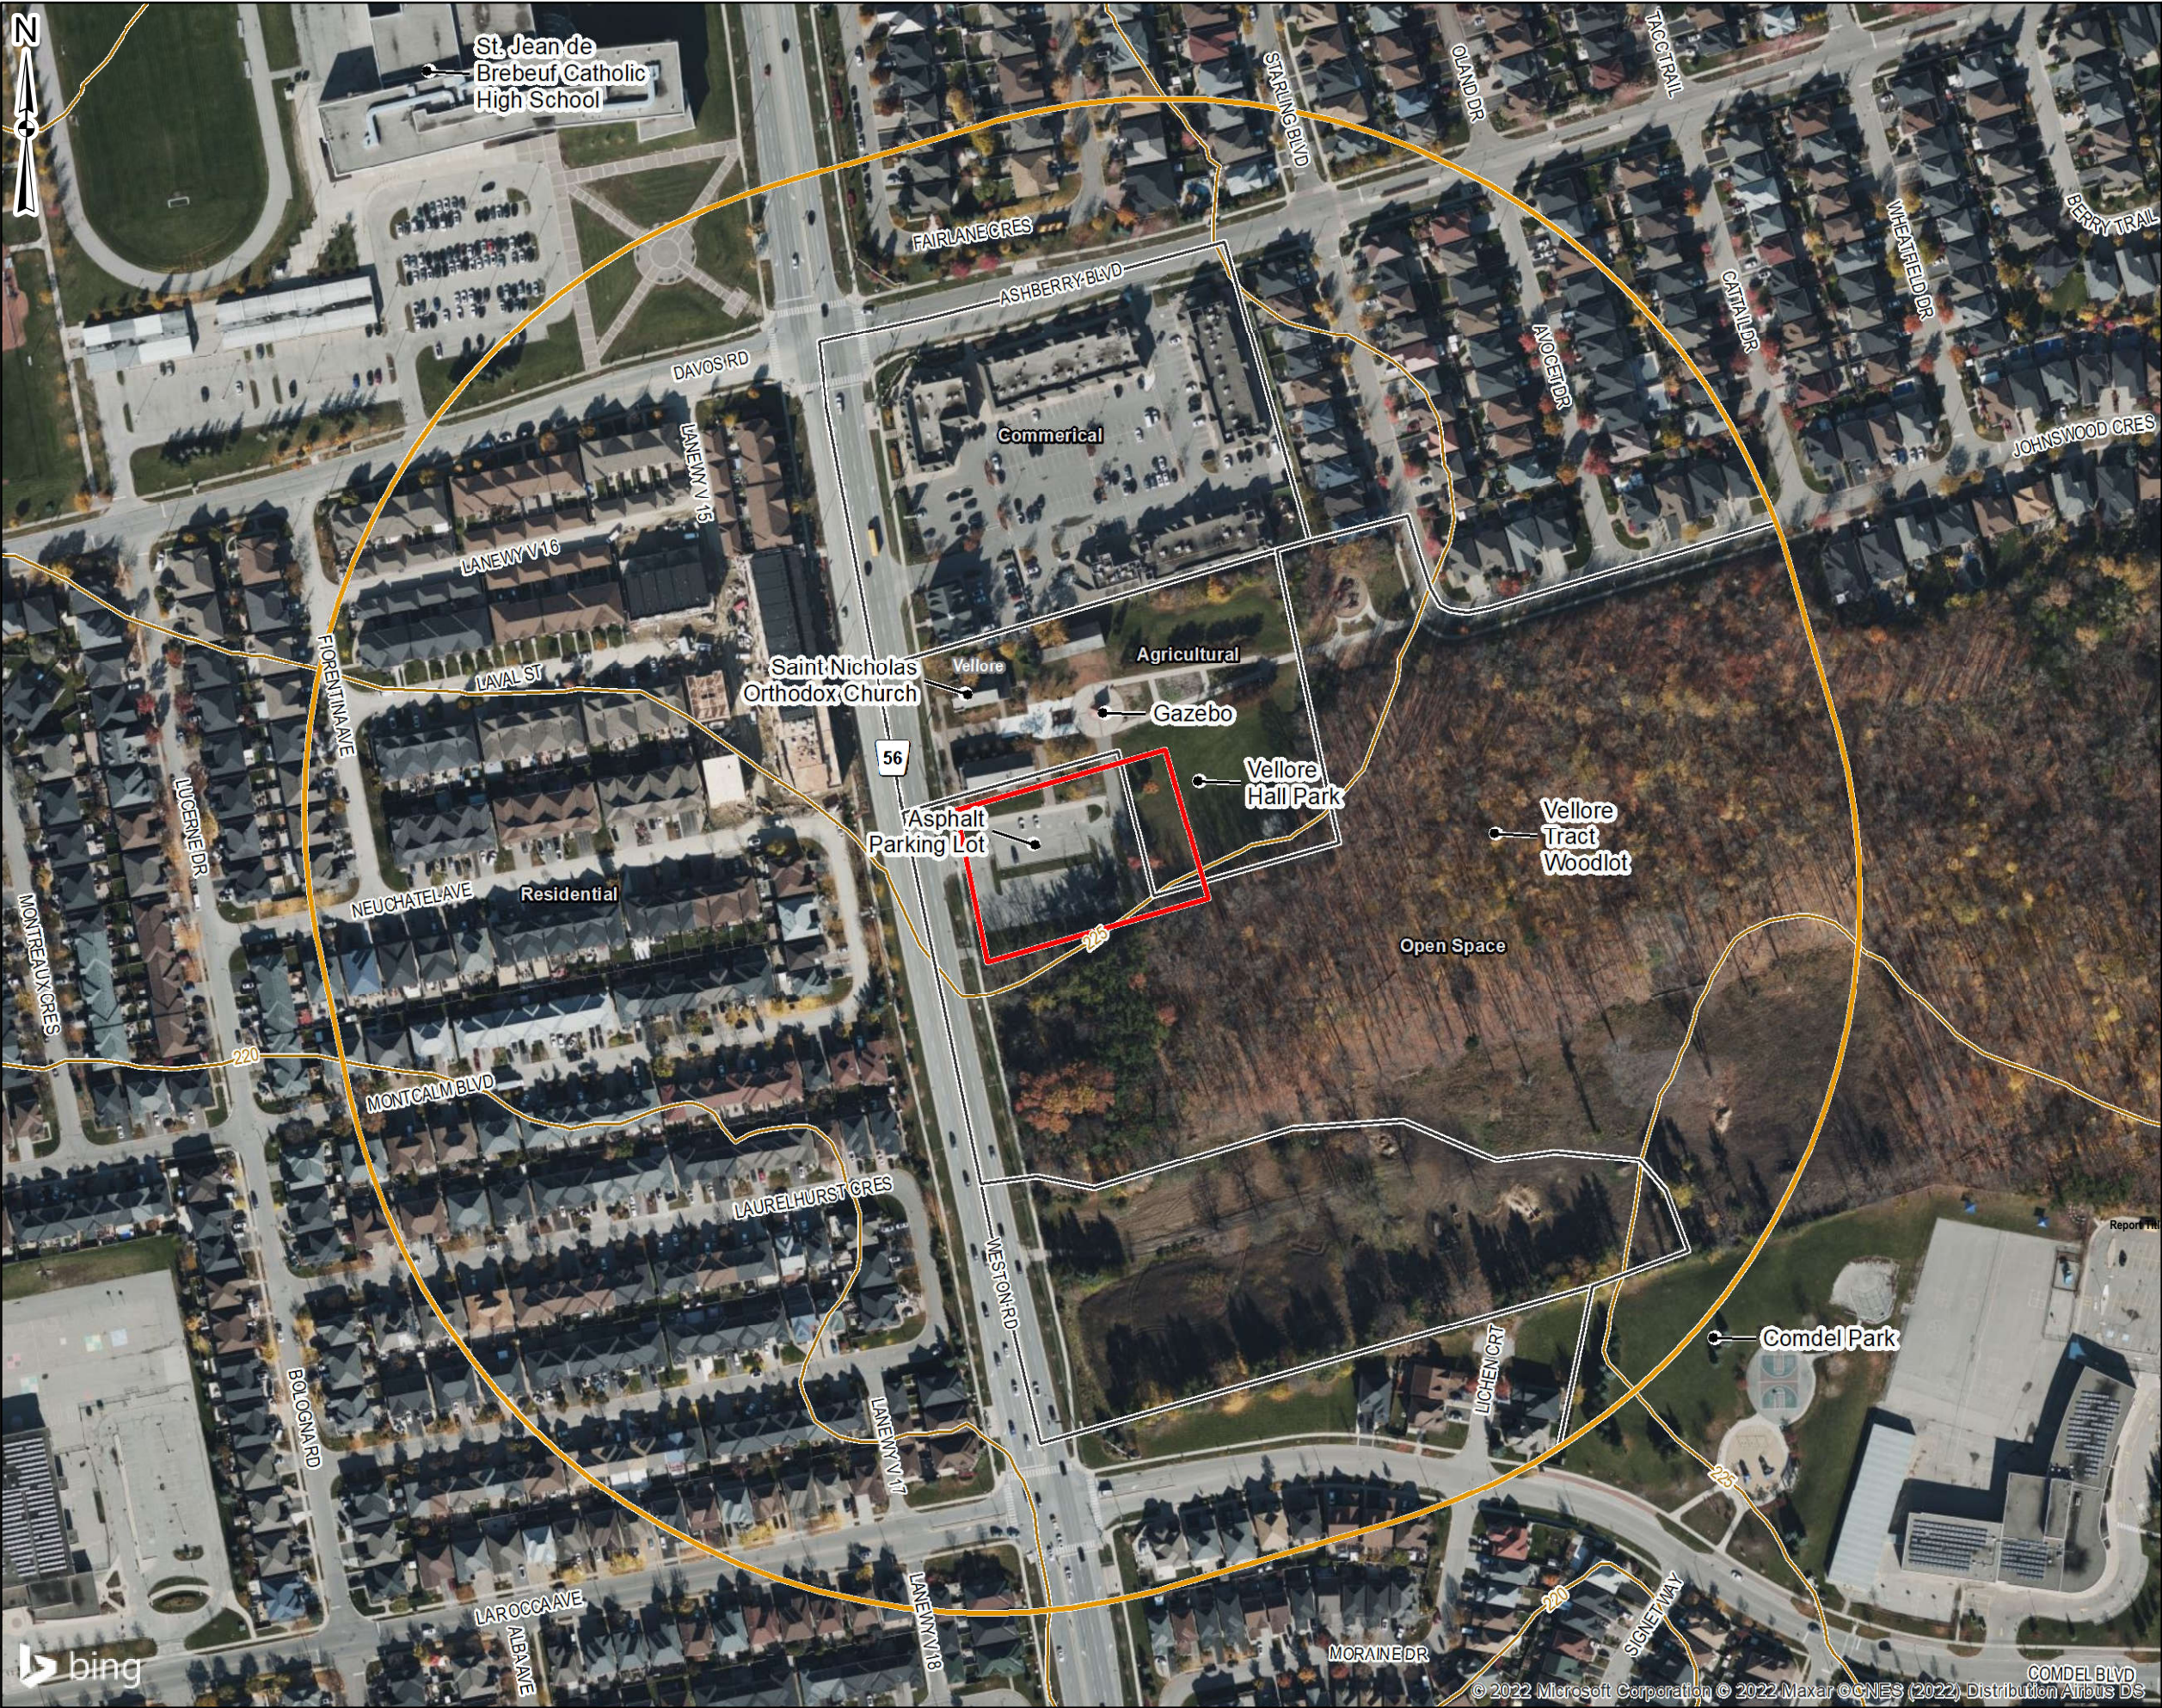
The Site is located on the east side of Weston Road, approximately 200 meters (m) south of the intersection of Weston Road and Ashberry Boulevard in the City of Vaughan, Ontario. It is an irregularly shaped parcel of land with approximately 4,092 m² in area, which is currently occupied with an asphalt paved parking lot and grassed area. The Site is surrounded by residential, commercial community and institutional buildings to the north and west, and woodlands to the south and east. Weston Road is adjacent to the west of the Site. The Site and surrounding properties are shown on the Site and Surrounding Land Use Plan, Figure 2 in Appendix A.

The neighbouring properties adjoining and surrounding the Site were observed during the Site reconnaissance from accessible public locations. These properties are identified on the Site and Surrounding Land Use Plan, Figure 2, contained in Appendix A, and are summarized in Table 9.

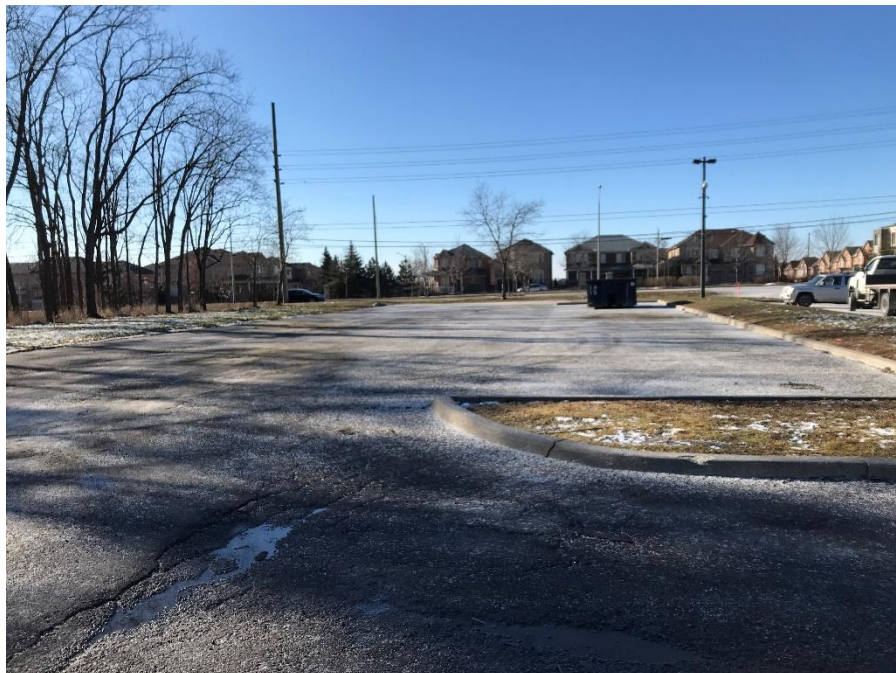
Photograph 1: View of the Site, standing on parking lot, looking west
