RE: Bulk Asbestos Sampling
Building A-243, Paint Booth
Canadian Forces Base Borden
Borden, ON
Our Ref.: 128-P-0015403-0-10-GA-L-0001-00

Englobe Corp. ("Englobe") was retained by PWGSC to collect concrete samples from two trenches within the Paint Booth of Building A-243, 17 Hangar Road. The samples were collected on April 23, 2018 at the direction of Mr. Boyce Parrill, on behalf of Real Properties Operations Detachment, Canadian Forces Base Borden (the "Client").

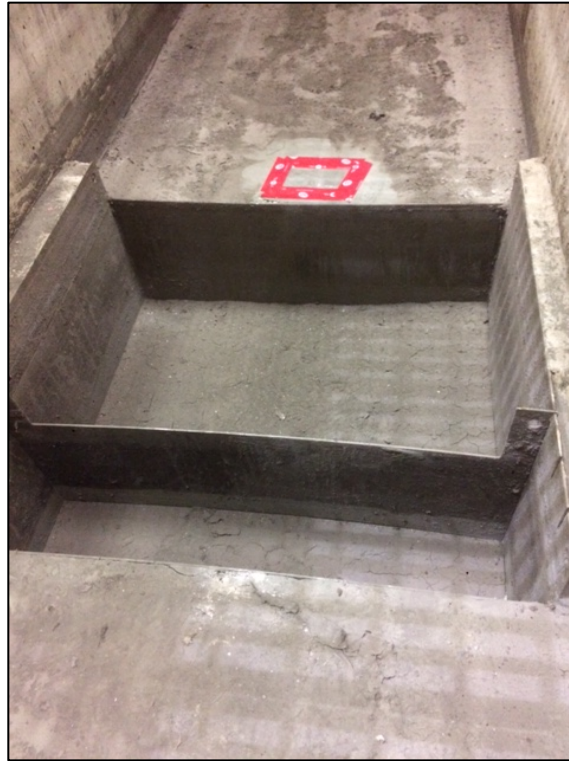
Sample ID	Sample Description	Sample Location	Ontario Regulation 278/05 Criteria (% by dry weight)	Result
1A	Trench 1 (Left side Trench)	Base of stairway	0.5%	None Detected
1B		Stairway		None Detected
1C		Top of Wall near Stairway entrance		None Detected

Photograph 01: Trench 1, left sided trench (from overhead doors)

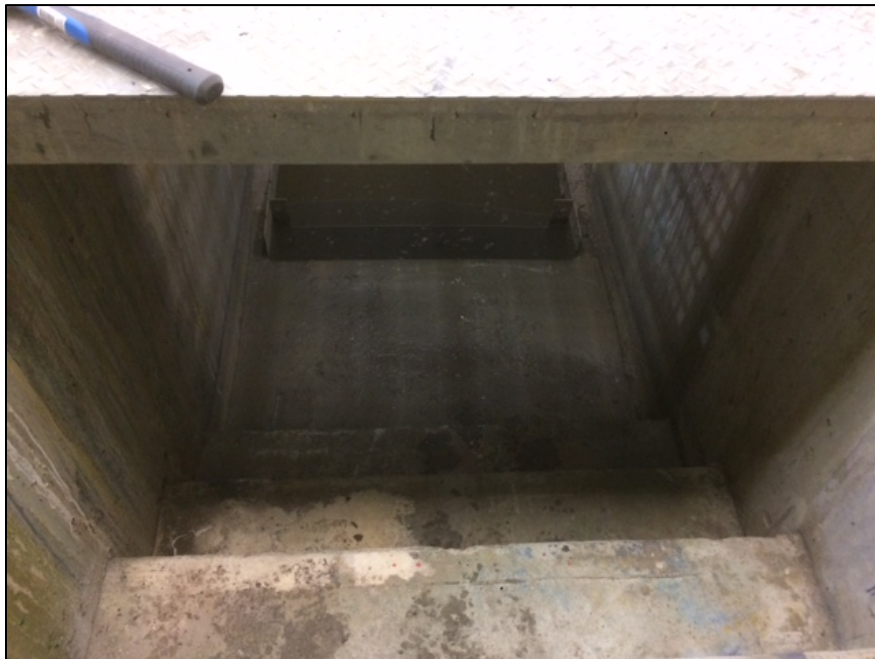
Sample ID	Sample Description	Sample Location	Ontario Regulation 278/05 Criteria (% by dry weight)	Result
2A	Trench 2 (Right side Trench)	Stairway		None Detected
2B		Stairway		None Detected
2C		Wall of Stairway		None Detected

Photograph 02: Trench 2, right side trench (from overhead doors)
