Geotechnical Investigation for Pleasant View Library Expansion at 575 Van Horne Avenue, Toronto, ON.

Prepared For:
Toronto Public Library

Project Number:
ET23-1017A

Date Submitted:
April 19, 2023

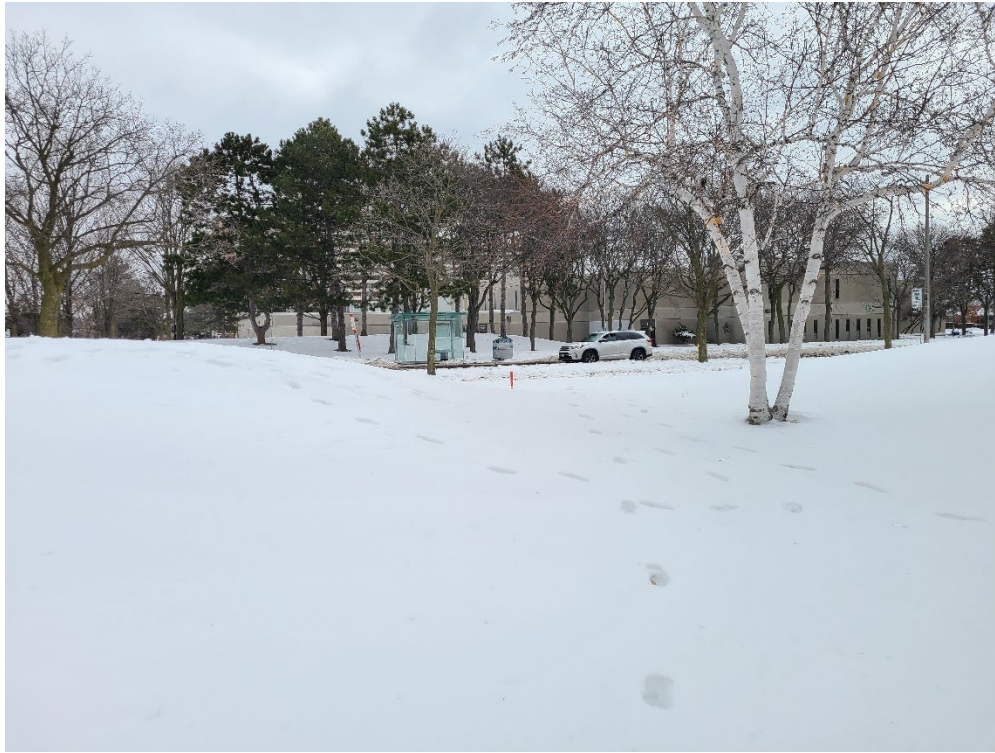
Picture 1: BH1 (March 2, 2023).

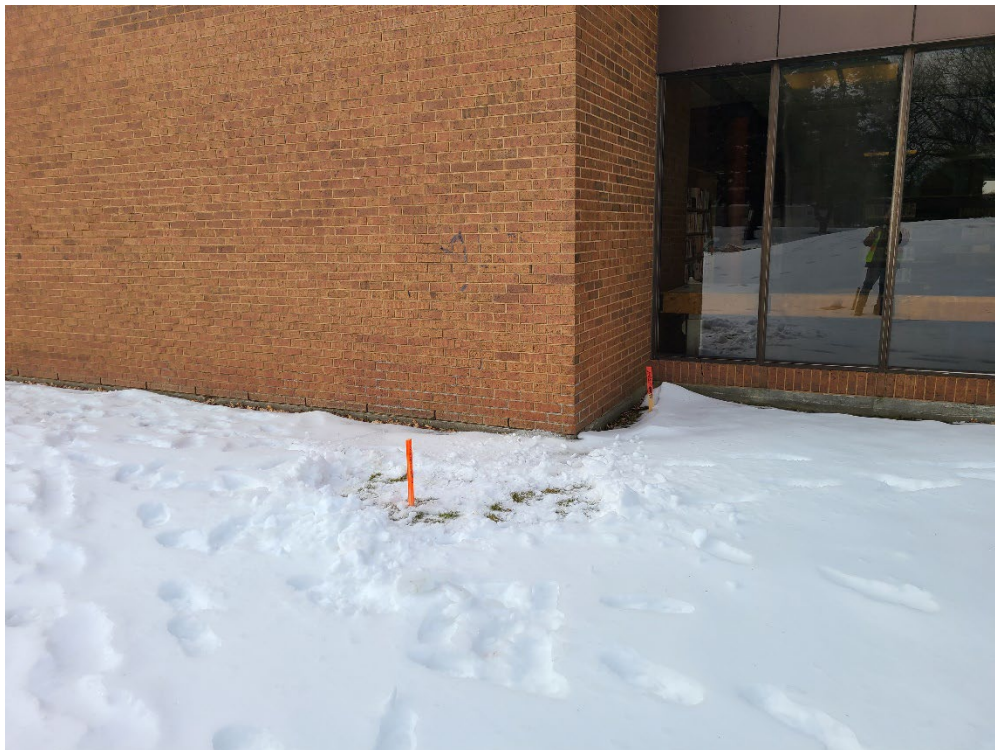
Picture 2: BH2 (March 2, 2023).

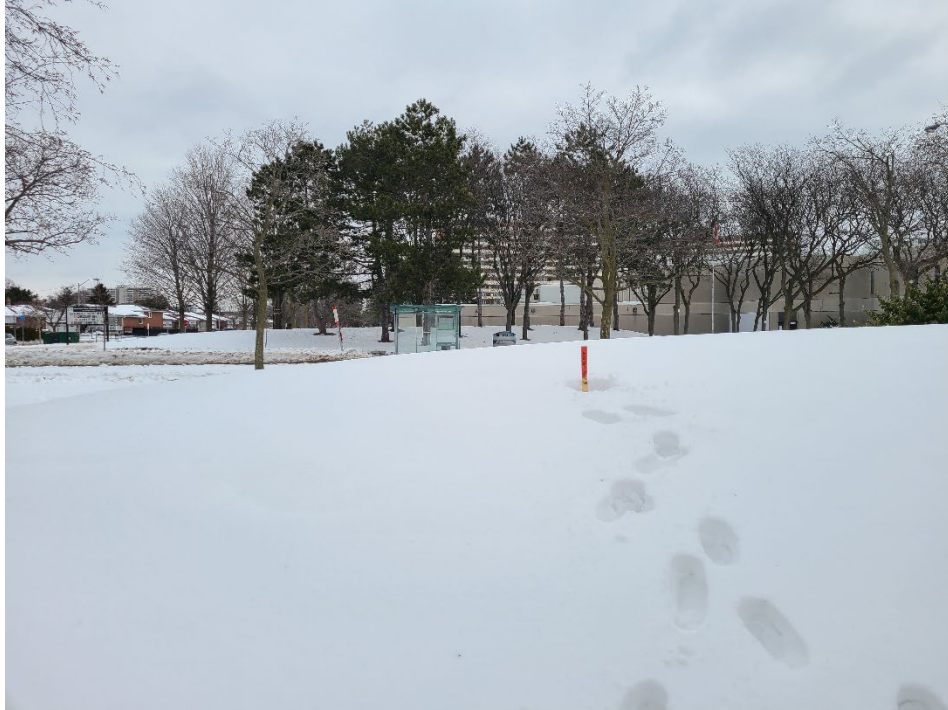
Picture 3: TP 3 (March 2, 2023).

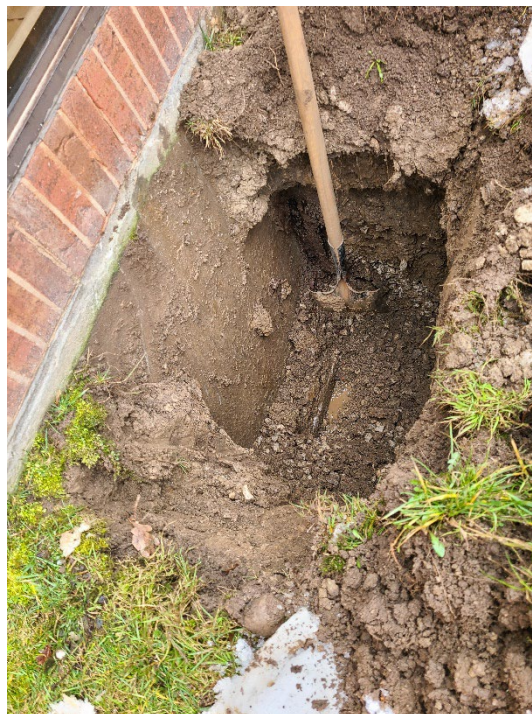
Picture 3: Test Pit TP1 (March 17, 2023).

Three (3) Test Pits (TP1 to TP3) were dug adjacent to the perimeter foundation walls of the existing building, two (2) at east side and one at northwest corner. All test pits (approximately 1m by 1m in plan) were extended to underside of the footings. The measured footing thicknesses and lateral projection are shown in Table 2.

Test Pit No.	Depth to Underside of Footing ⁽¹⁾	Footing Thickness (mm)	Lateral Projection (mm)
TP1	1.38m	180mm	150mm
TP2	1.20m	100mm	100mm
TP3	1.30m	200mm	125mm

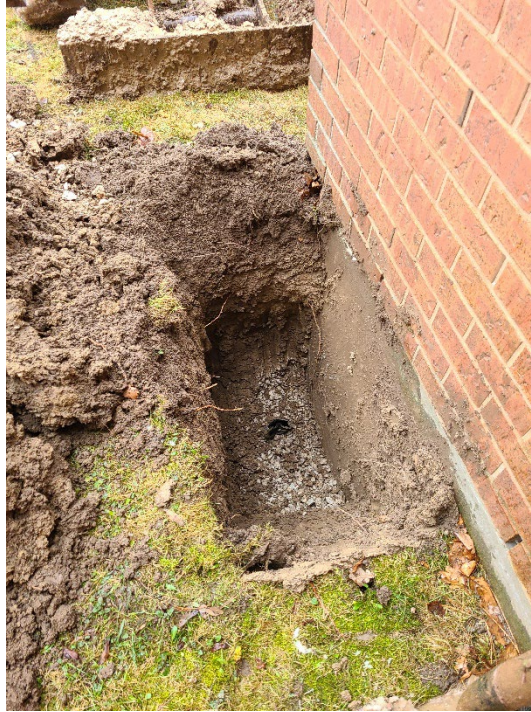
Picture 3: Test Pit TP2 (March 17, 2023).

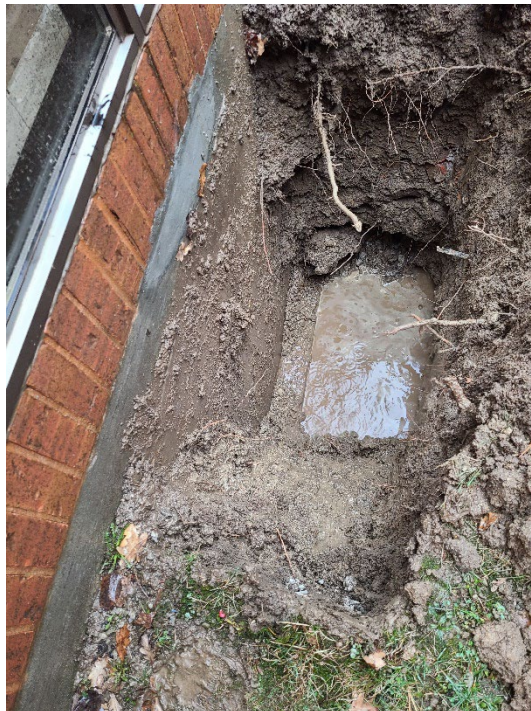
Picture 3: Test Pit TP3 (March 17, 2023).

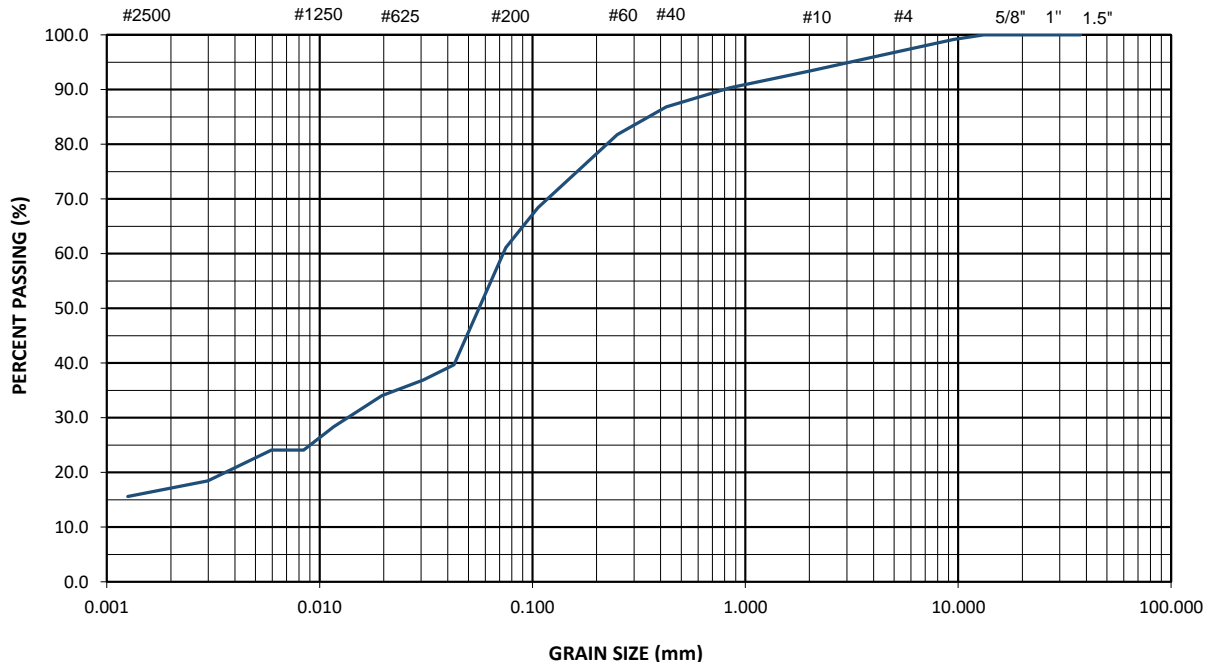
CLAY AND SILT			SAND			GRAVEL	
			Fine	Medium	Coarse	Fine	Coarse
%	16.8	44.3	25.7	6.5	3.2	3.4	0.0

Three (3) representative samples of sandy silt till recovered from the SPT spoons were selected for complete grain size analysis. The results are shown in Table 1 below.

BH No.	Sample ID	Depth (m)	Size Distribution Grain (%)			
			Gravel	Sand	Silt	Clay
BH1	SS3	1.5m - 2.1m	3	36	44	17
BH2	SS3	2.5m - 3.1m	6	34	50	10
BH3	SS4	2.2m - 2.8m	3	36	42	19

The grain size distribution curves are shown in Appendix D.

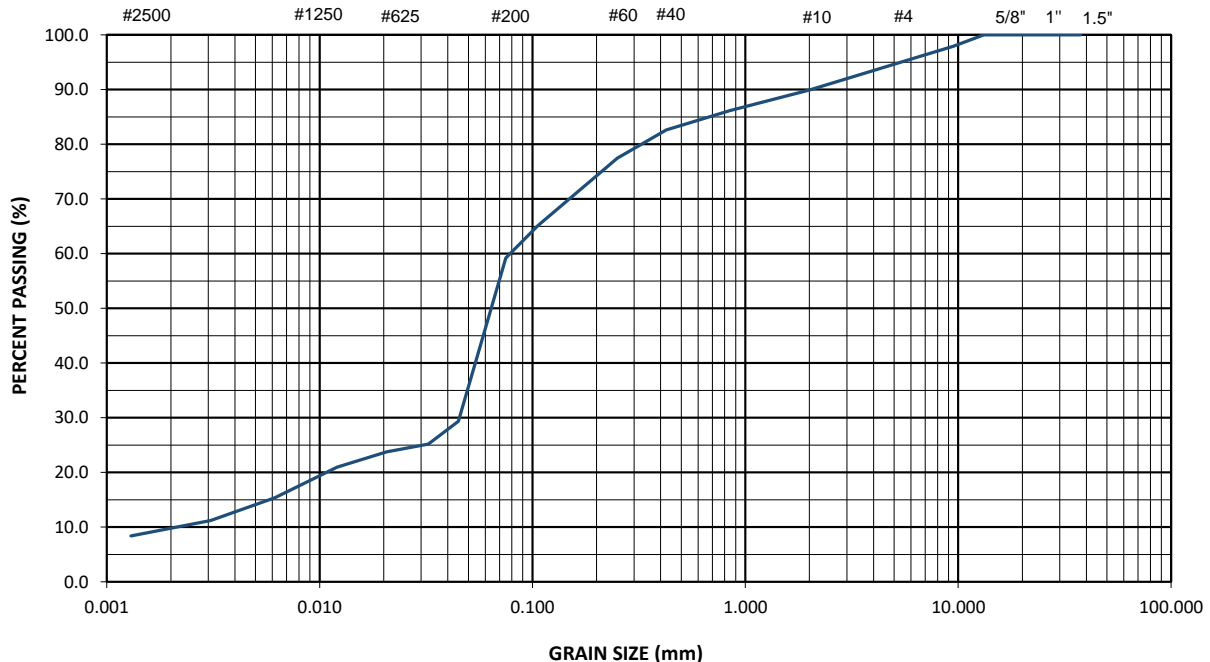
CLAY AND SILT			SAND			GRAVEL	
			Fine	Medium	Coarse	Fine	Coarse
%	9.5	49.7	23.4	7.3	4.4	5.6	0.0

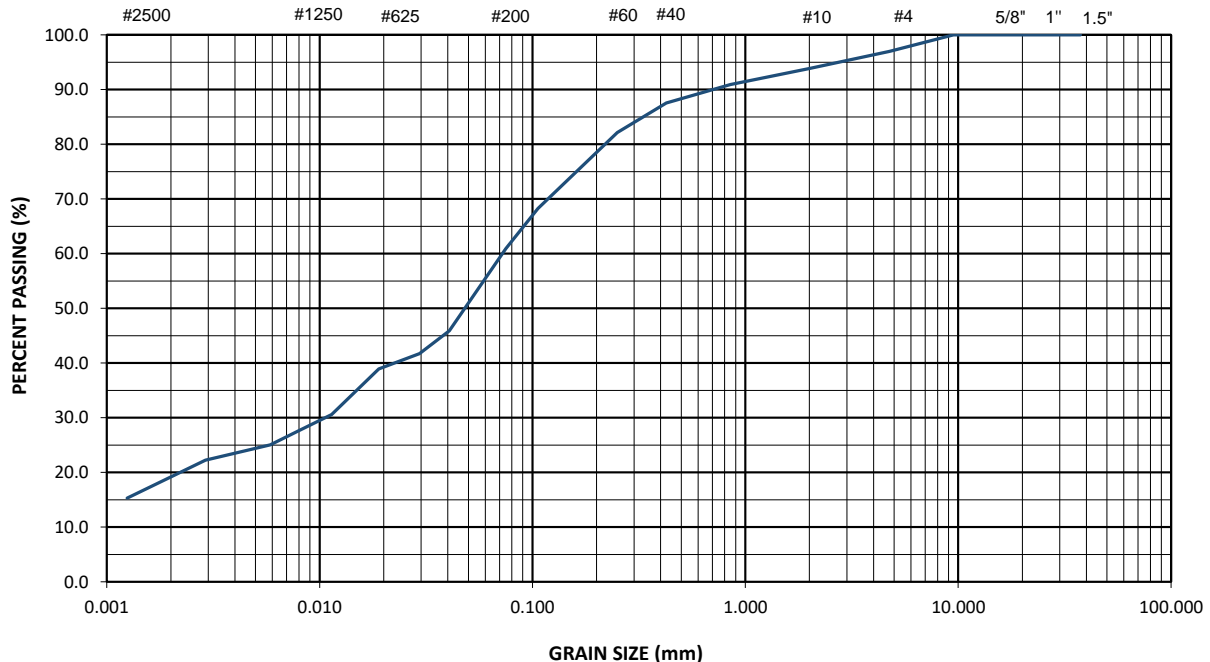
CLAY AND SILT			SAND			GRAVEL	
			Fine	Medium	Coarse	Fine	Coarse
%	18.5	42.4	26.6	6.3	3.1	3.0	0.0
