**Assessment of Past Uses:
York Region North Road Operations Centre at 3525 Baseline Rd,
Georgina, ON**

GEC Architecture on behalf of The Regional Municipality of York
430-179 John Street
Toronto, Ontario
M5T 1X4

ET24-1438B

March 11, 2025

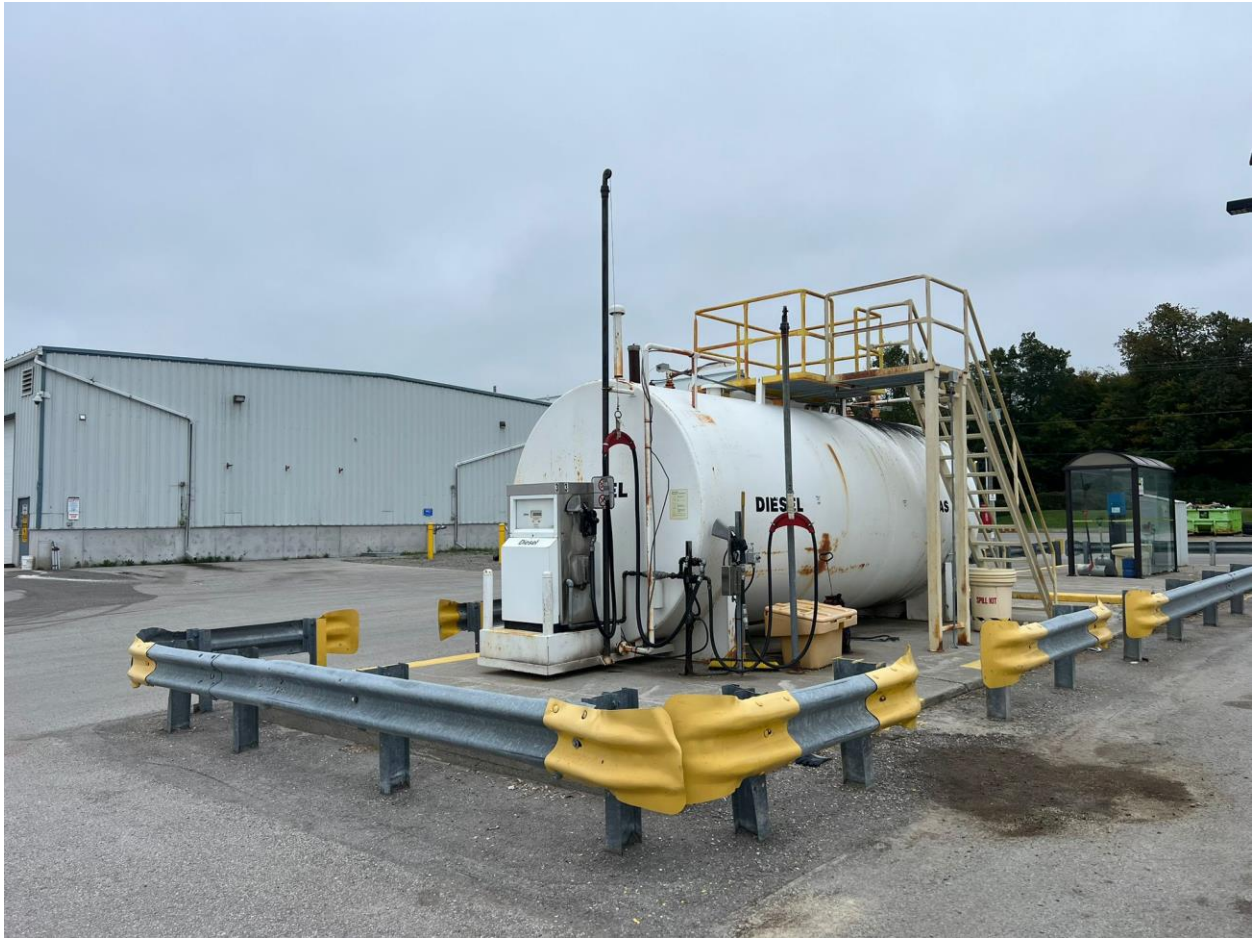
Photo 4. Diesel and Gas Tank

Minor hydrocarbon like staining was observed underneath the diesel above ground storage tanks.

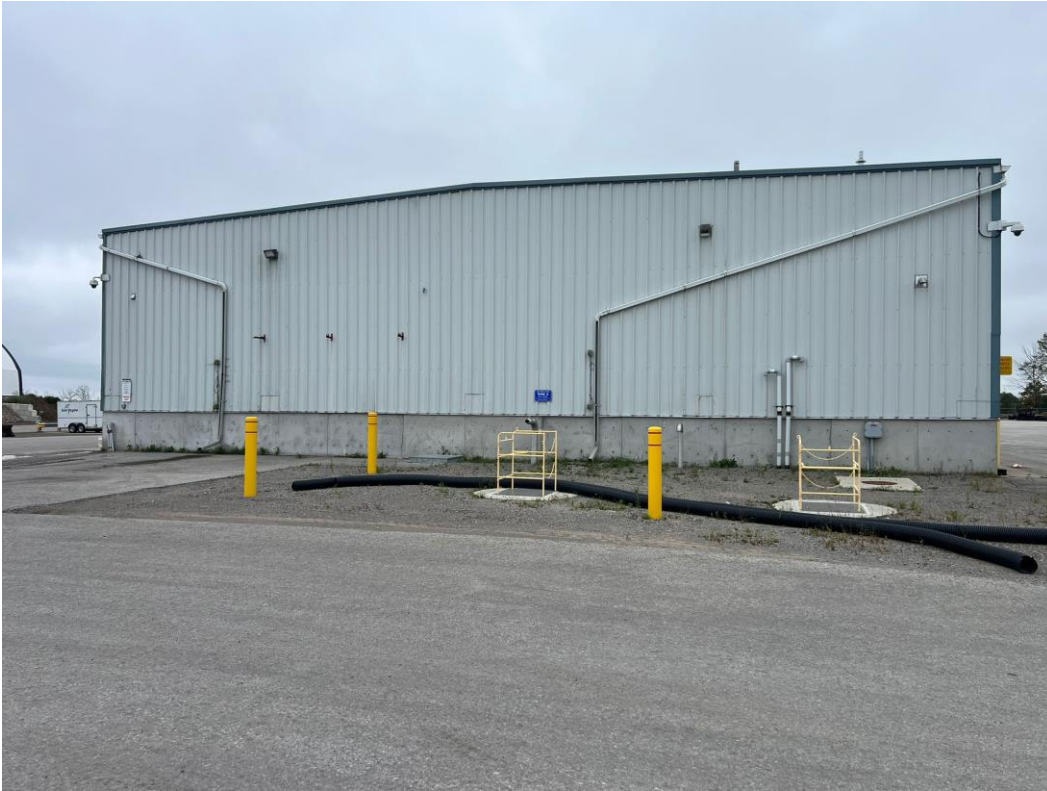
Photo 5. Underground Holding Tanks

One (1) wastewater storage holding tank was noted on Site which was an underground holding tank drained regularly by a licenced waste contractor.
