**Soil Characterization Report: Stockpile Sampling and Delineation Samples for York Region North Road Operations Centre at 3525 Baseline Rd, Georgina, ON.**

**GEC Architecture on behalf of The Regional Municipality of York**

**ET25-1438B**

**April 04, 2025**

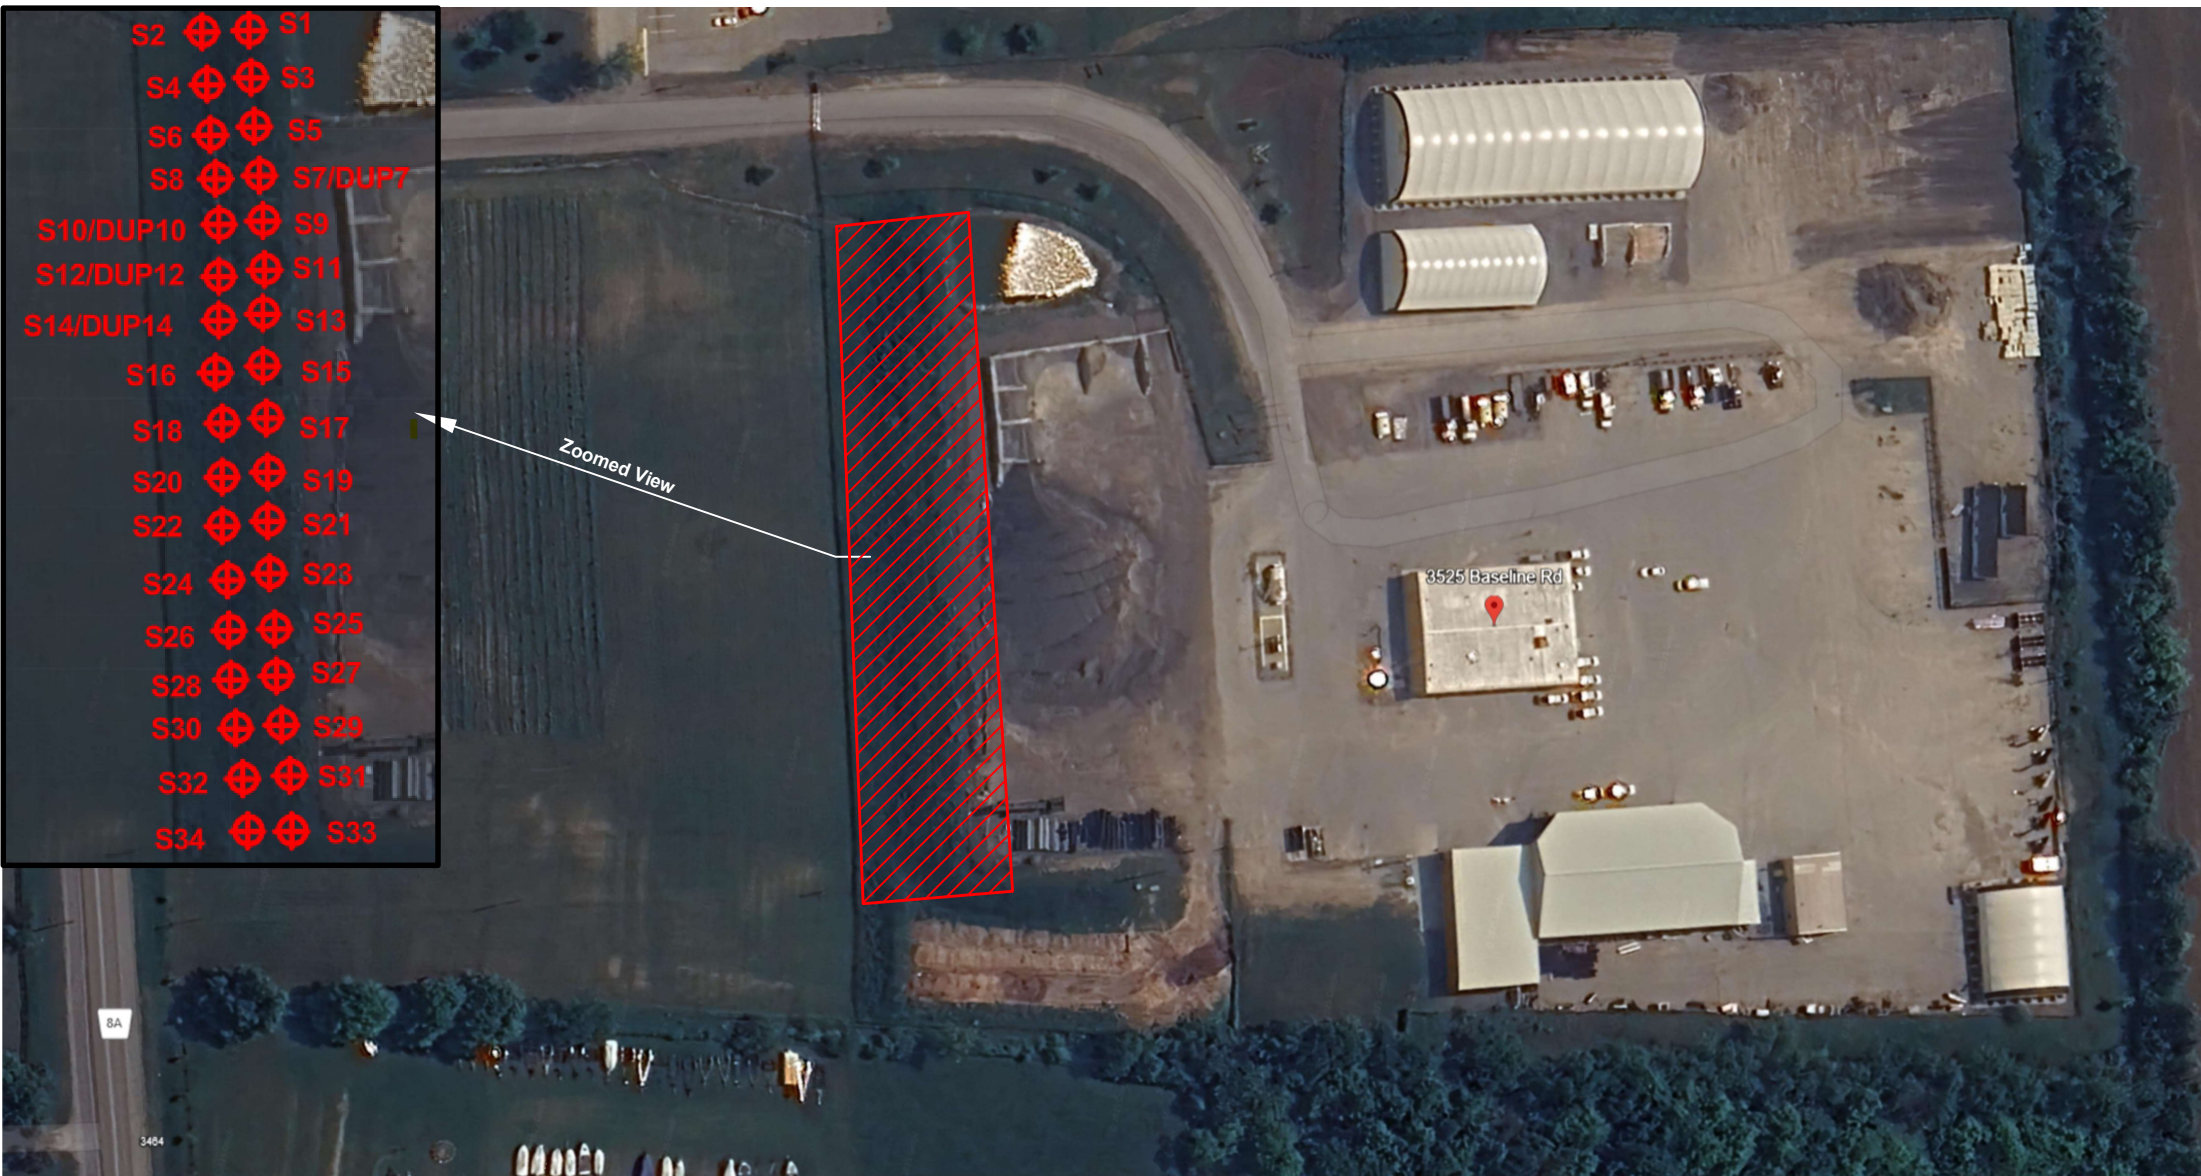
Drawing 1                      Borehole Location

Soil conditions at the Project Area were investigated through the advancement of thirty-five (35) boreholes equally distributed along the Site. On March 10 and March 11, 2025, the boreholes were advanced under the direction of Engtec's Qualified Personnel (QP). The boreholes were advanced to a maximum depth of 2.0 mbgs.

<b>Test Pits</b>	<p><b>Project Name:</b> Soil Characterization Report , 3525 Baseline,Georgina, Ontario</p> <p><b>Project location:</b> 3525 Baseline, Georgina, ON</p> <p><b>Drawing Title:</b> Proposed Boreholes and Test Pits</p> <p><b>Drawing No:</b> 01</p> <p><b>Date:</b> March 24, 2025</p> <p><b>Project Number:</b> ETP25-1034A</p> <p><b>Drawn by:</b> Manpreet Kaur</p> <p><b>Checked by:</b> Hammad Din</p>	<p><b>Engtec Consulting Inc.</b></p> <p>2447 Anson Drive , Mississauga, ON, L5S 1G1 Tel: (905)-856-2988</p>
