QL-A REPORT: SUBSURFACE UTILITY ENGINEERING (SUE)

2960 Teston Road

The Regional Municipality of York
2960 Teston Road

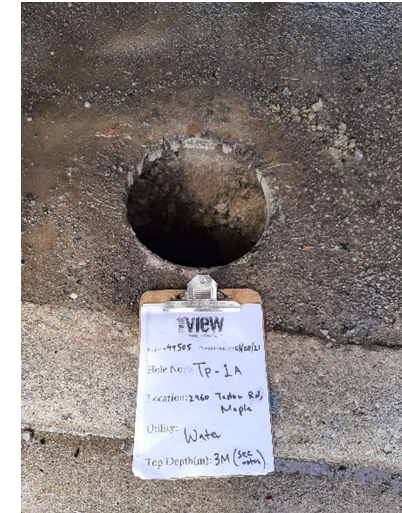
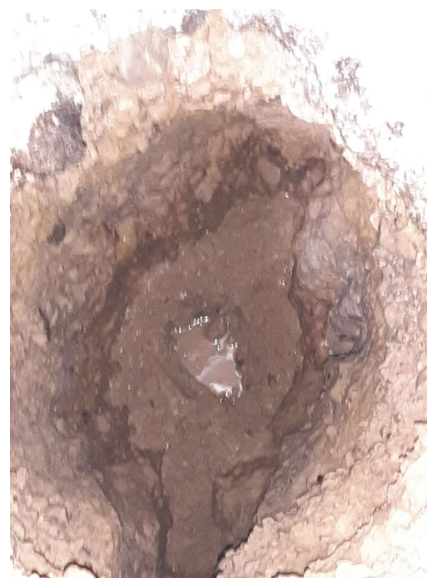
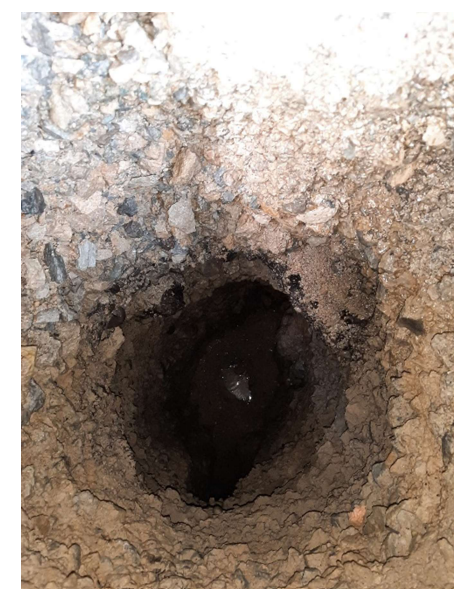
Date: August 03, 2021
Hole No. : TP-1A
Location: 2960 Teston Rd, Maple
Utility: Water
Top Depth (m): N/A
Bottom Depth (m): Unable to find water. Went down up to 3M. Trenched North and South.

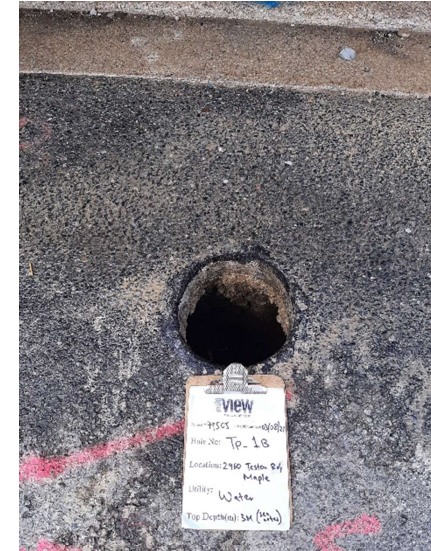
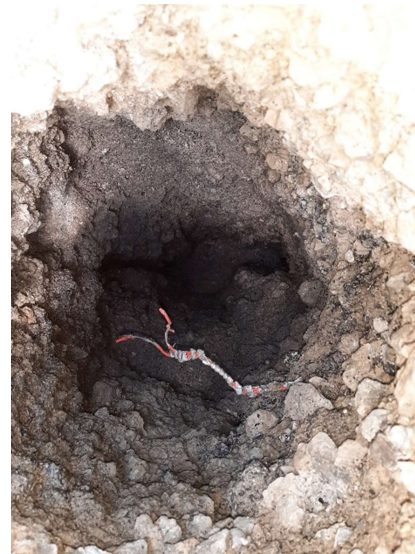
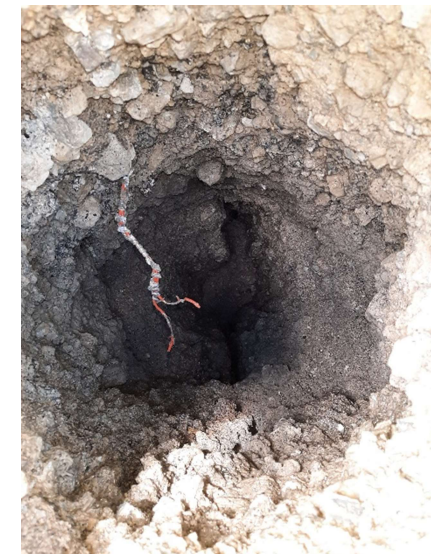
Date: August 03, 2021
Hole No. : TP-1B
Location: 2960 Teston Road, Maple
Utility: Water
Top Depth (m): N/A
Bottom Depth (m): N/A
Observation: Did not find water. Went down up to 3M. Also trenched North and South.

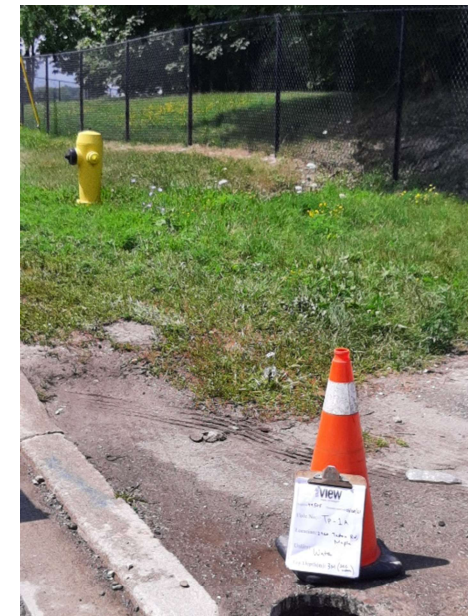
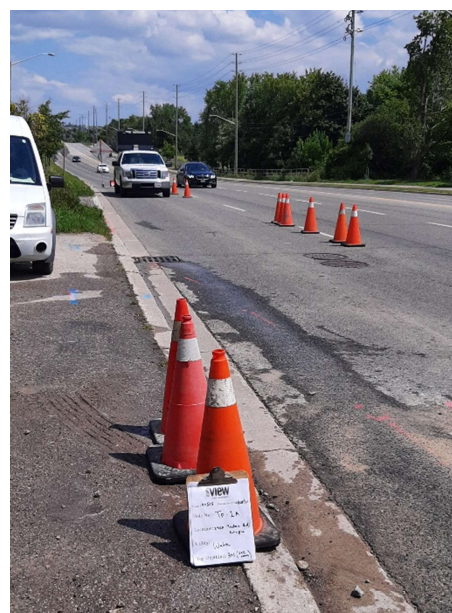
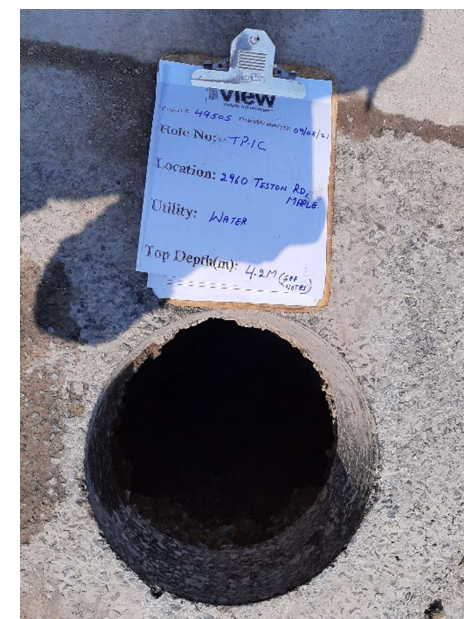
Date: September 09, 2021
Hole No. : TP-1C
Location: 2960 Teston Road, Maple
Utility: Water
Top Depth (m): N/A
Observation: Did not find water went down up to 4.2m. Also trenched North and South

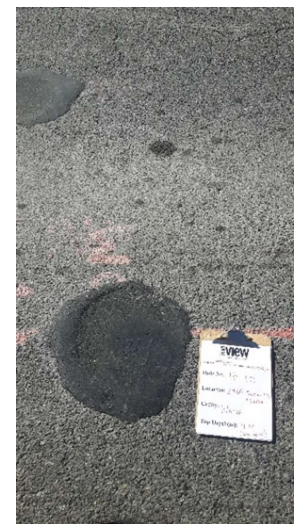
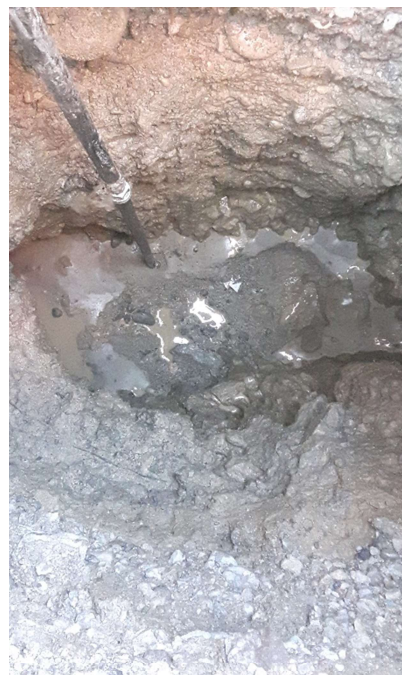
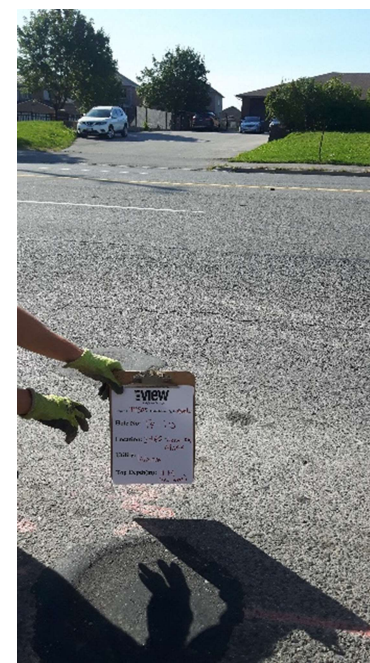
Date: August 09, 2021
Hole No. : TP-1D
Location: 2960 Teston Road, Maple
Utility: Water
Top Depth (m): N/A
Observation: Did not find water. Went down 4m.

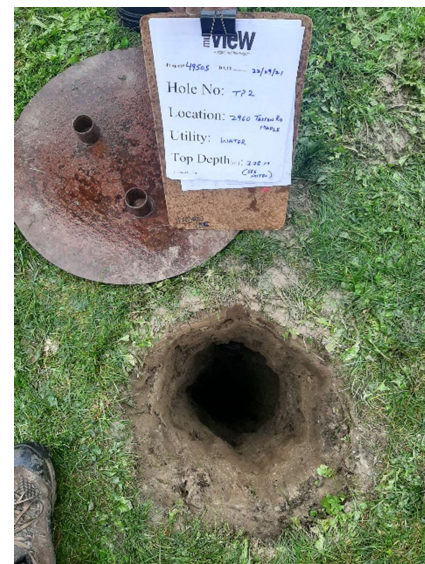
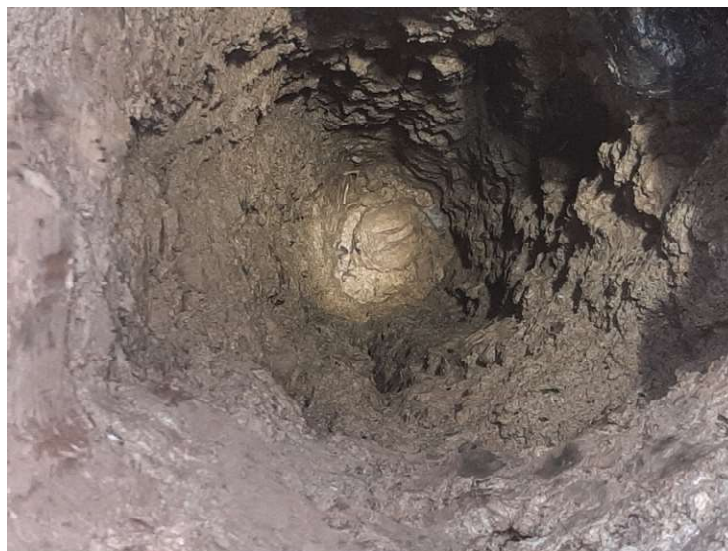
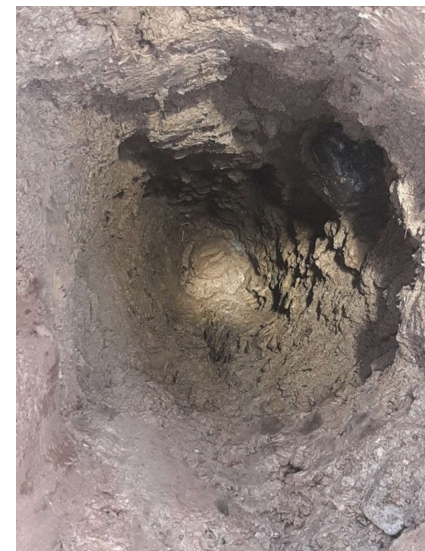
Date: September 22, 2021
Hole No. : TP-2
Location: 2960 Teston Road, Maple
Utility: Water
Top Depth (m): N/A
Observation: Rocks

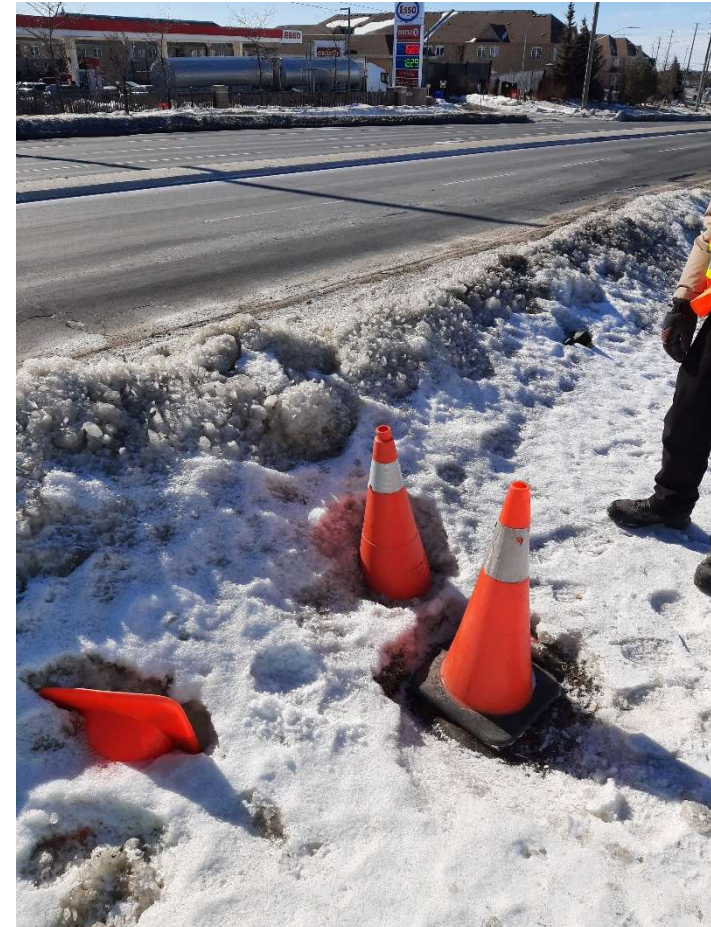
Date: November 04, 2021
Hole No. : TP-3
Location: 2960 Teston Road Maple
Utility: Water
Top Depth (m): N/A
Observation: Went down 3 meters. Couldn't find utility

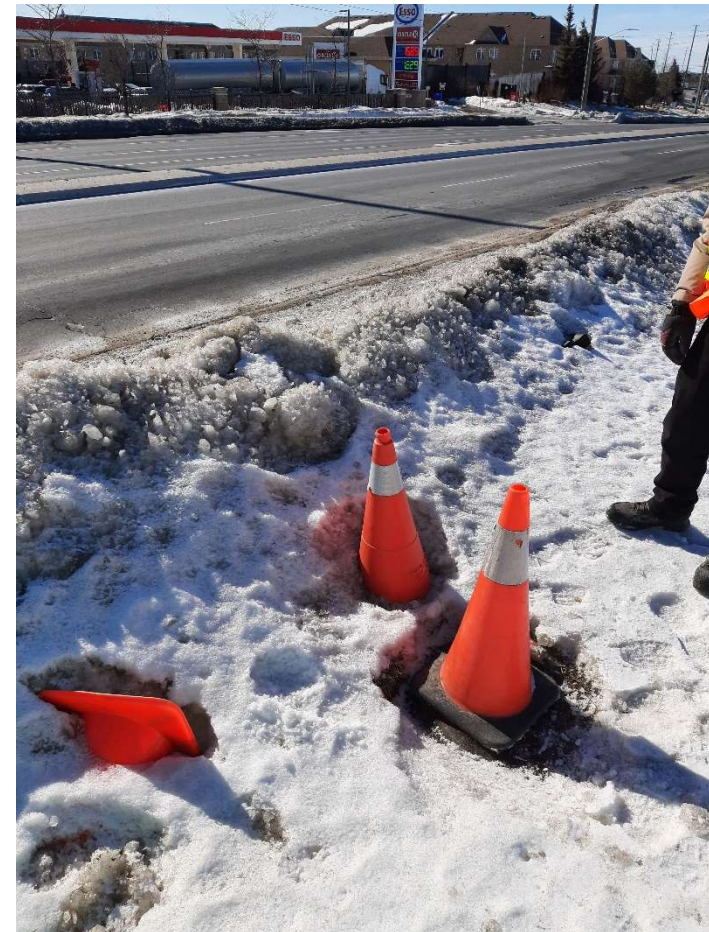
Date: November 03, 2021
Hole No. : TP-4
Location: 2960 Teston Road, Maple
Utility: Water
Top Depth (m): N/A
Observation: Went down 4 meters couldn't find utility.
