Concrete Scanning & Private Utility Locating

Company Name: _____ Resolve tech _____ Company Contact: _____ Ben _____
Job Location: Credit Valley Hospital

Reason for Survey: To identif embedded and sub surface services

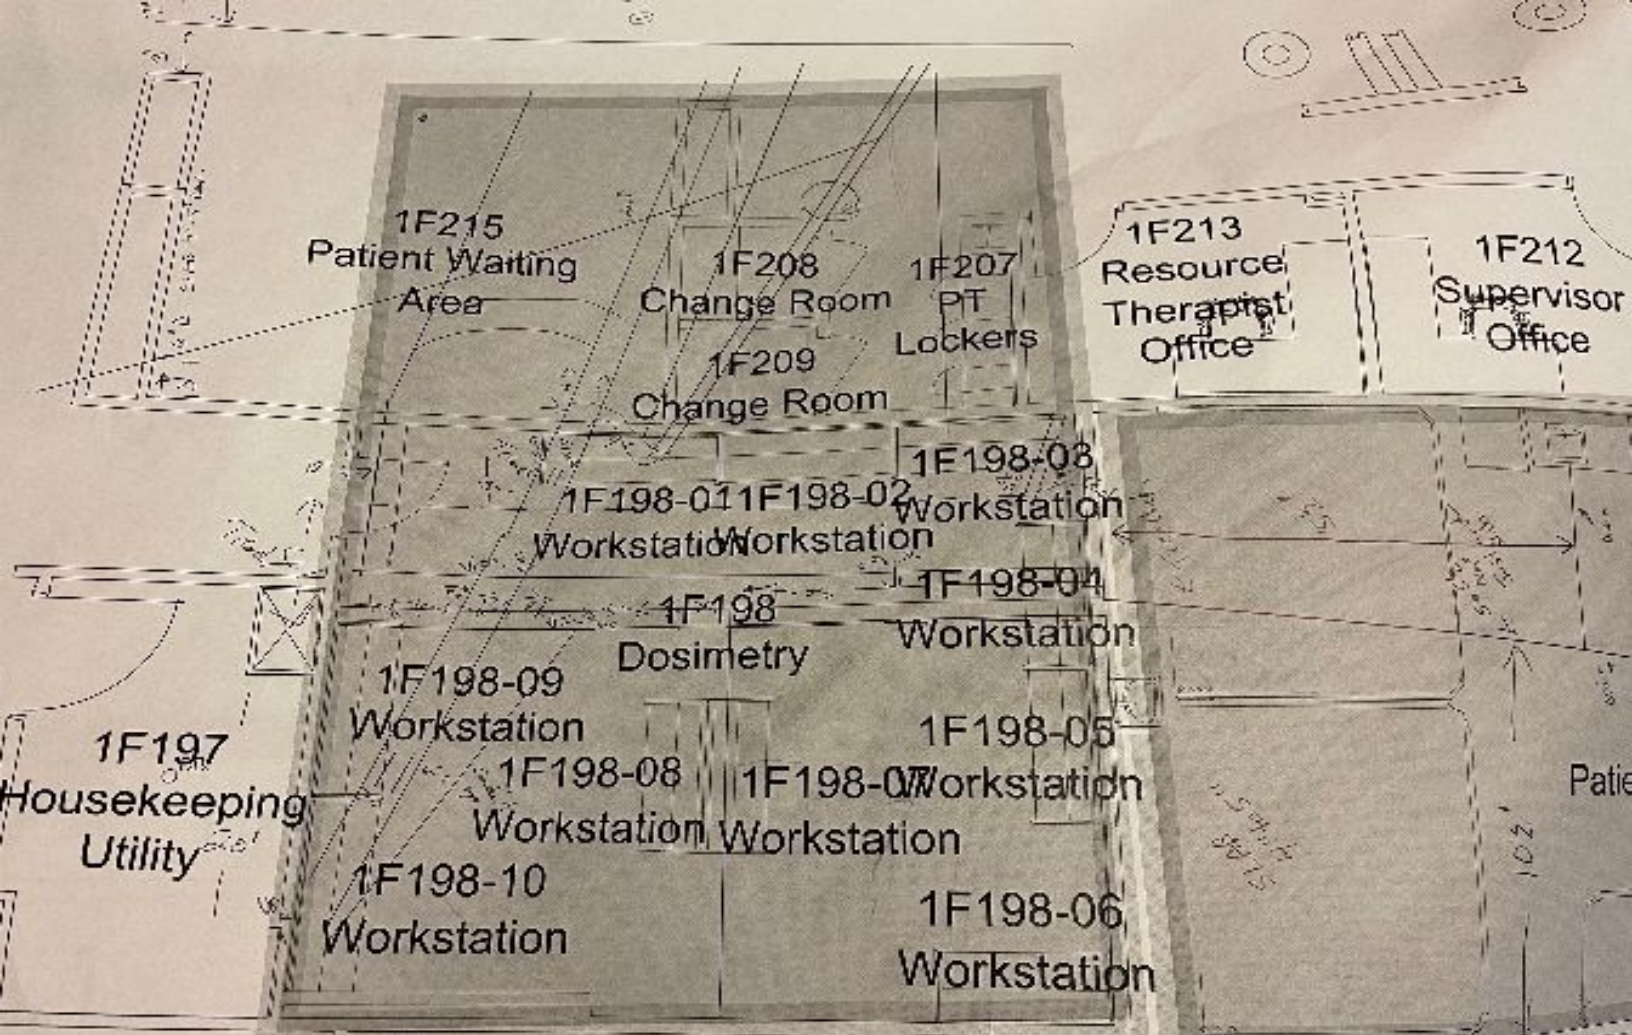
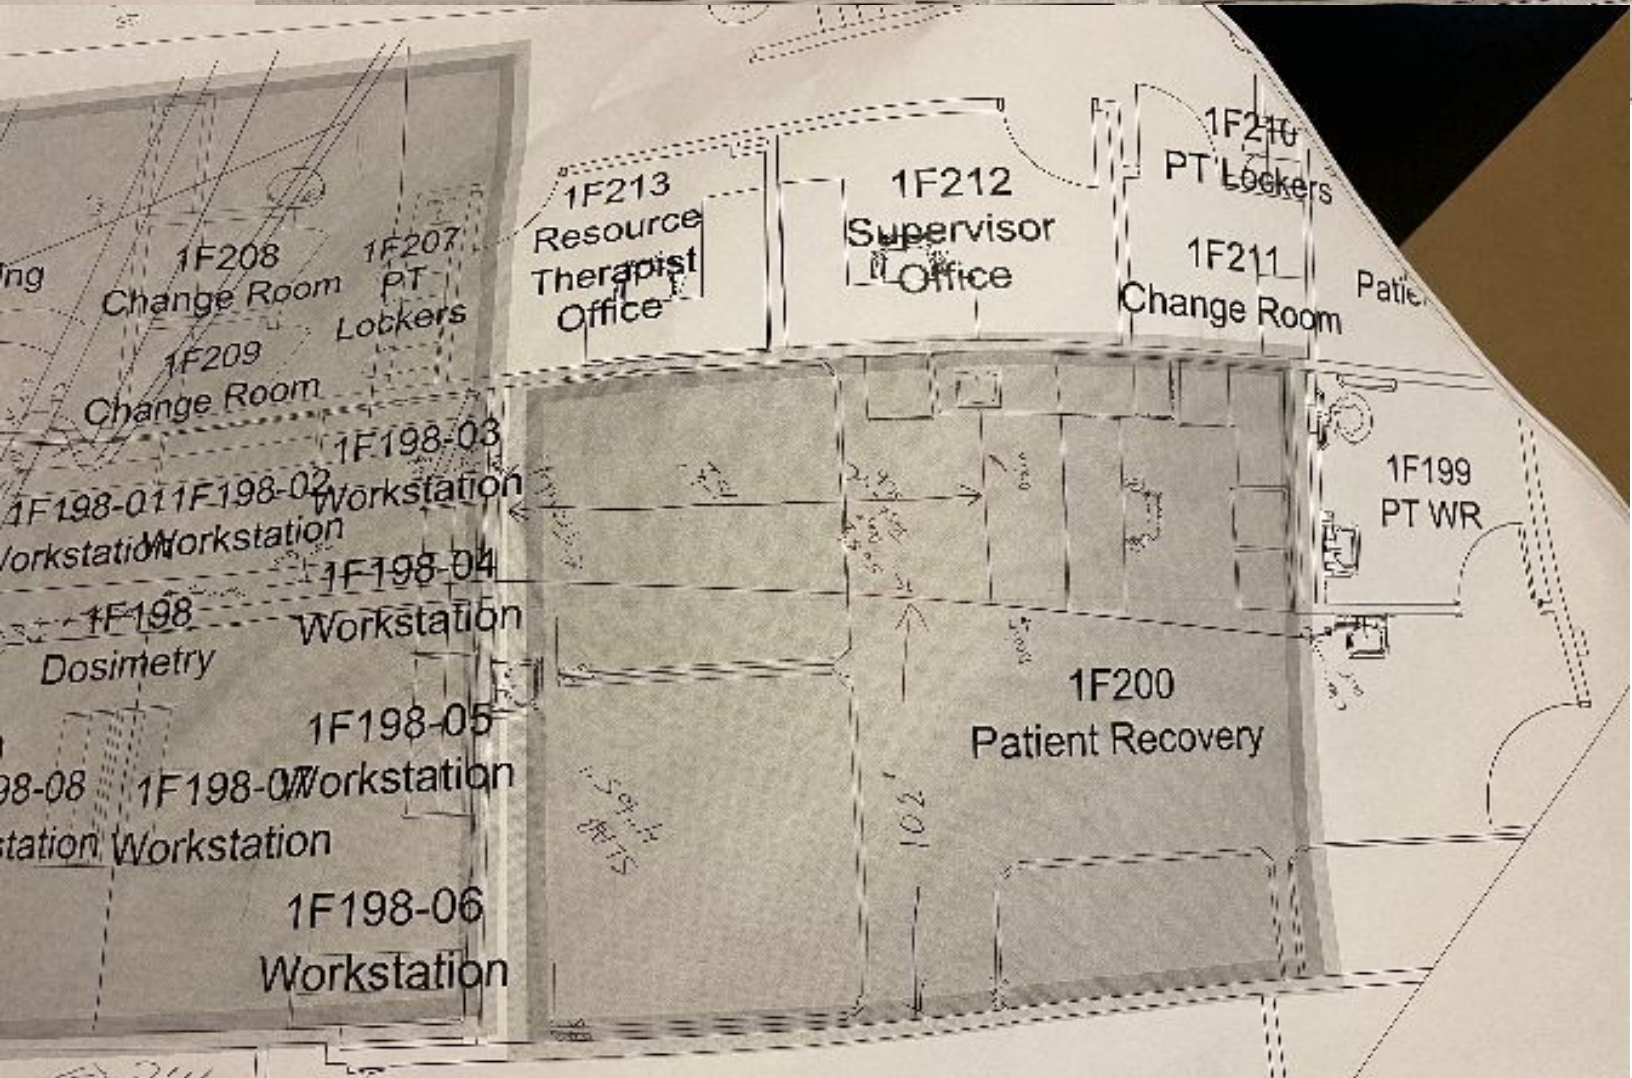
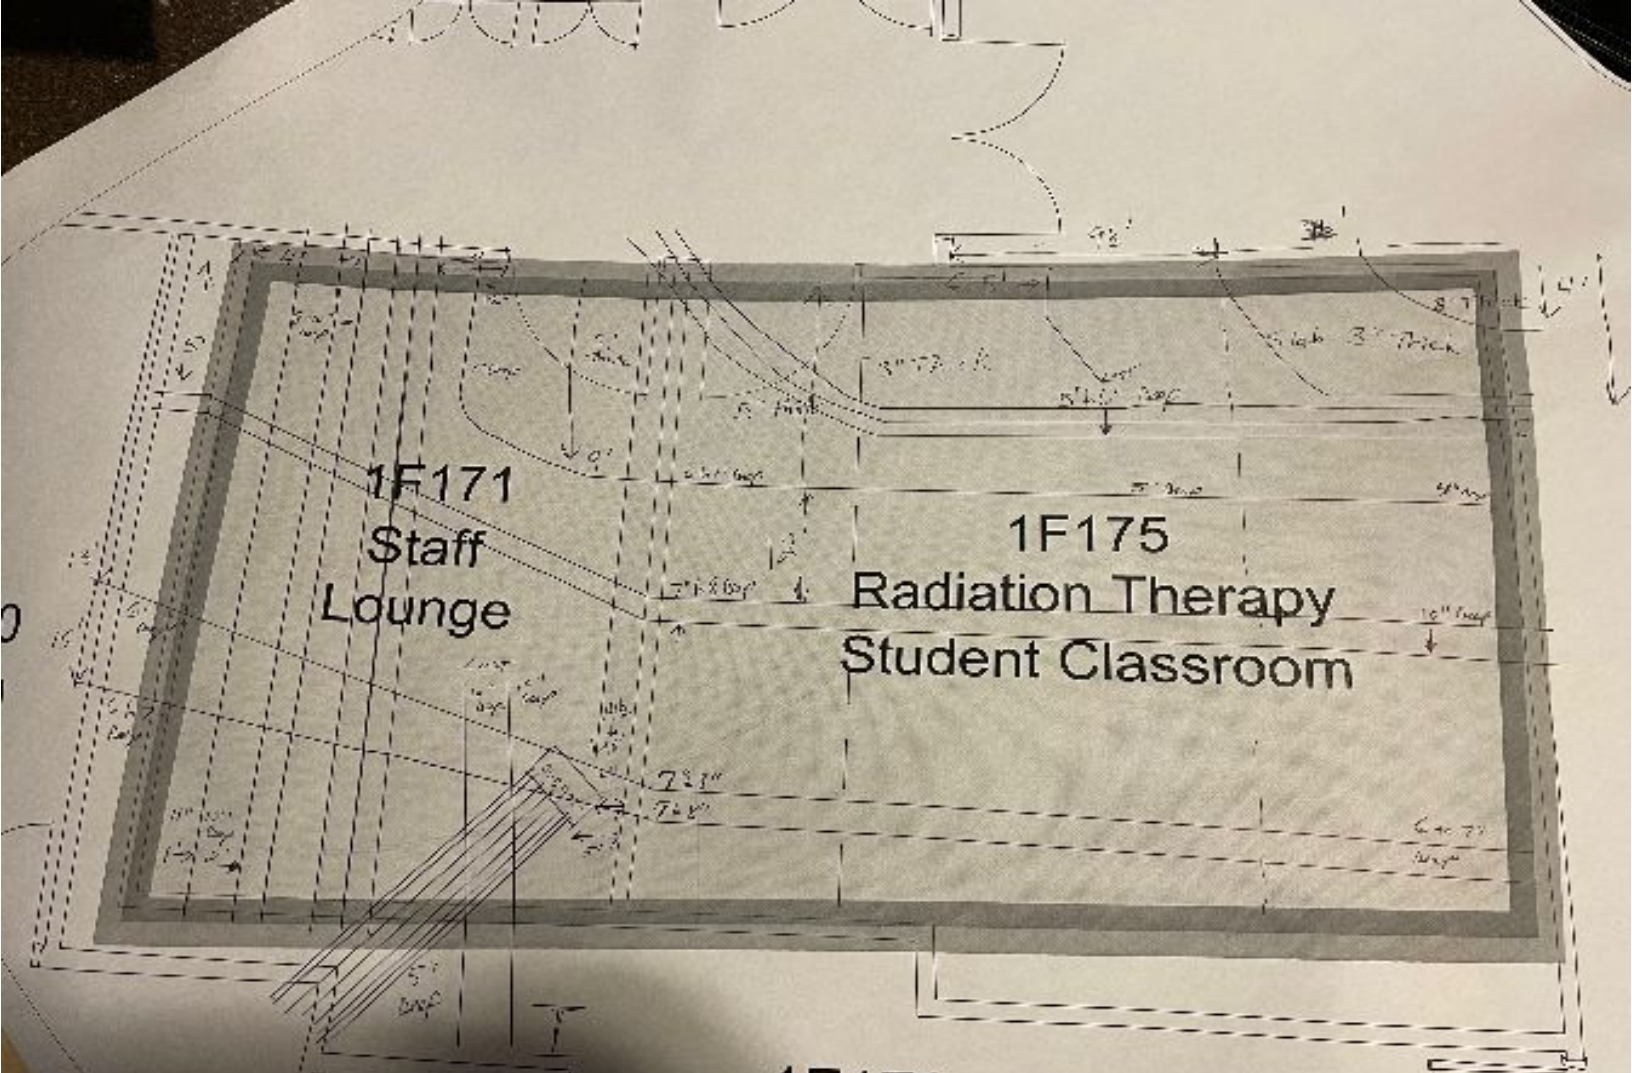
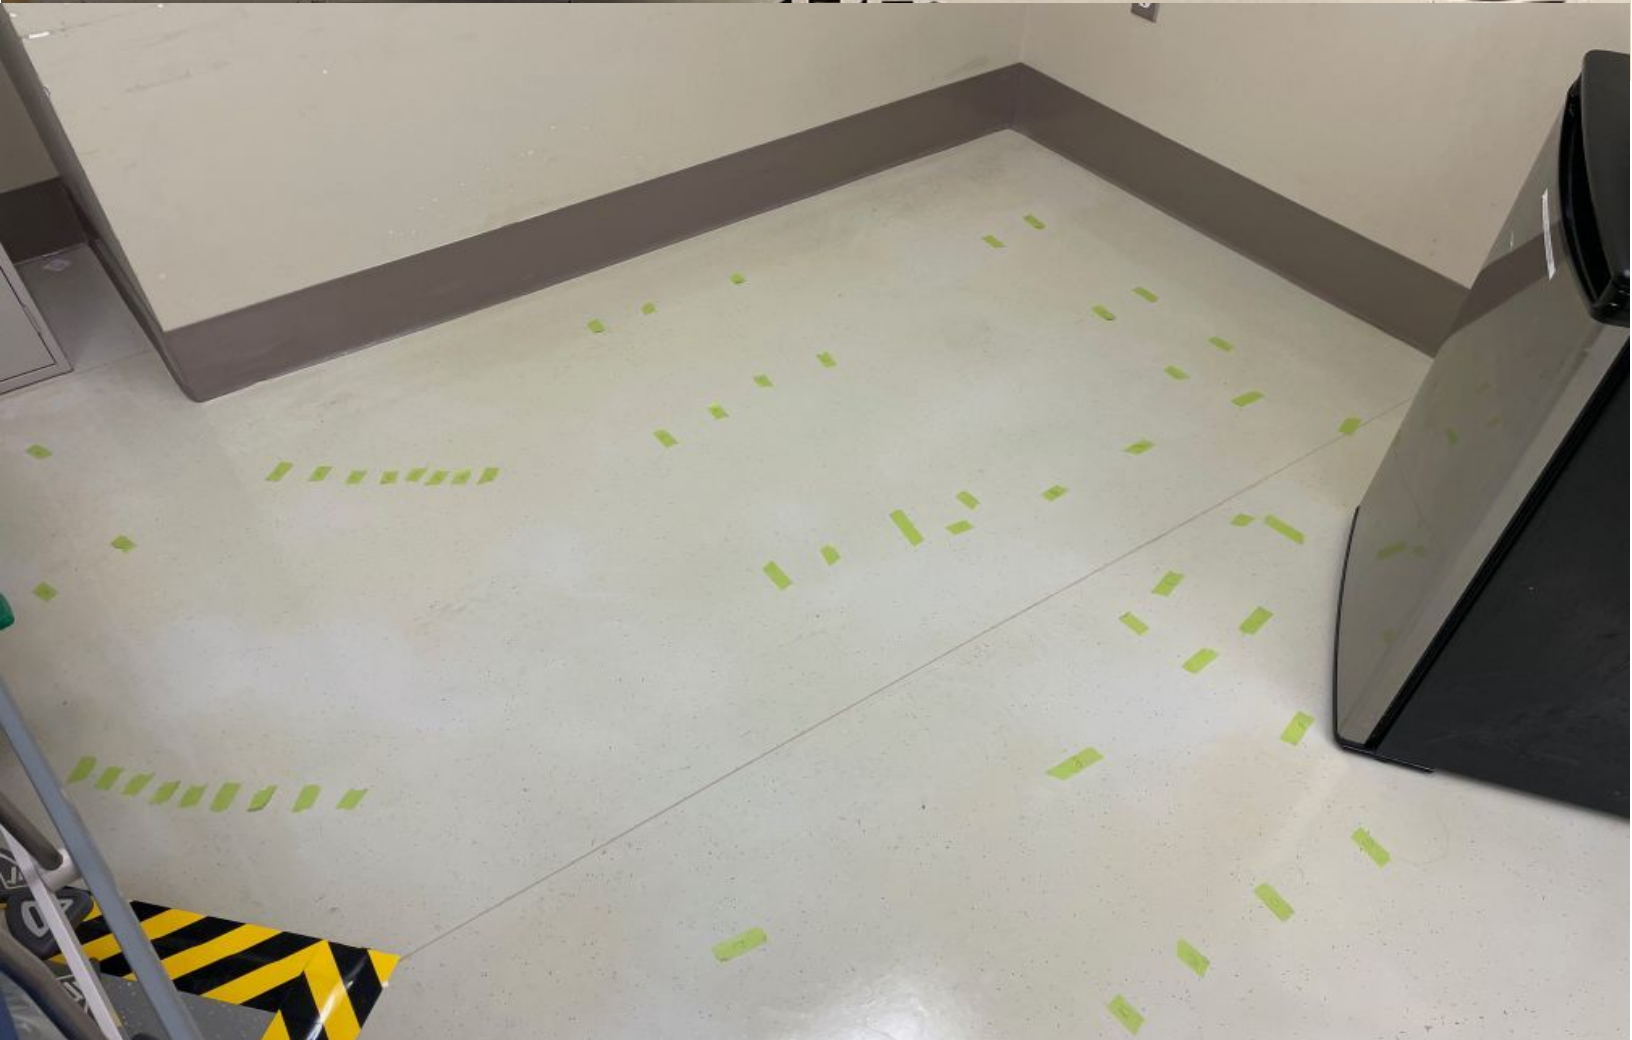
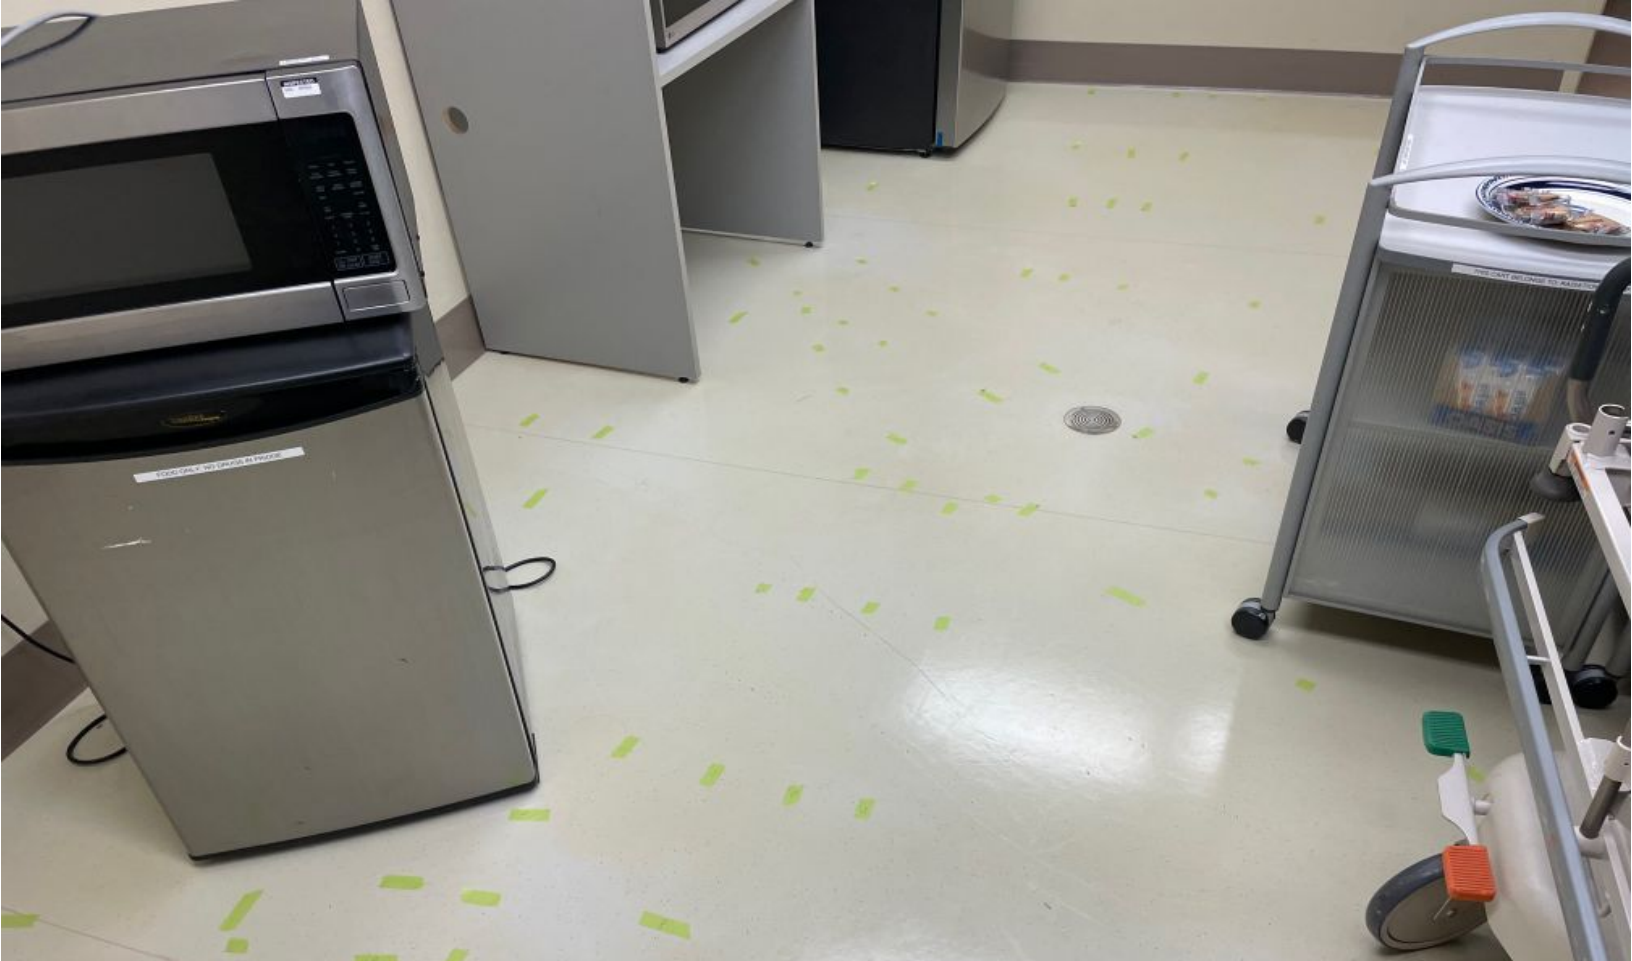
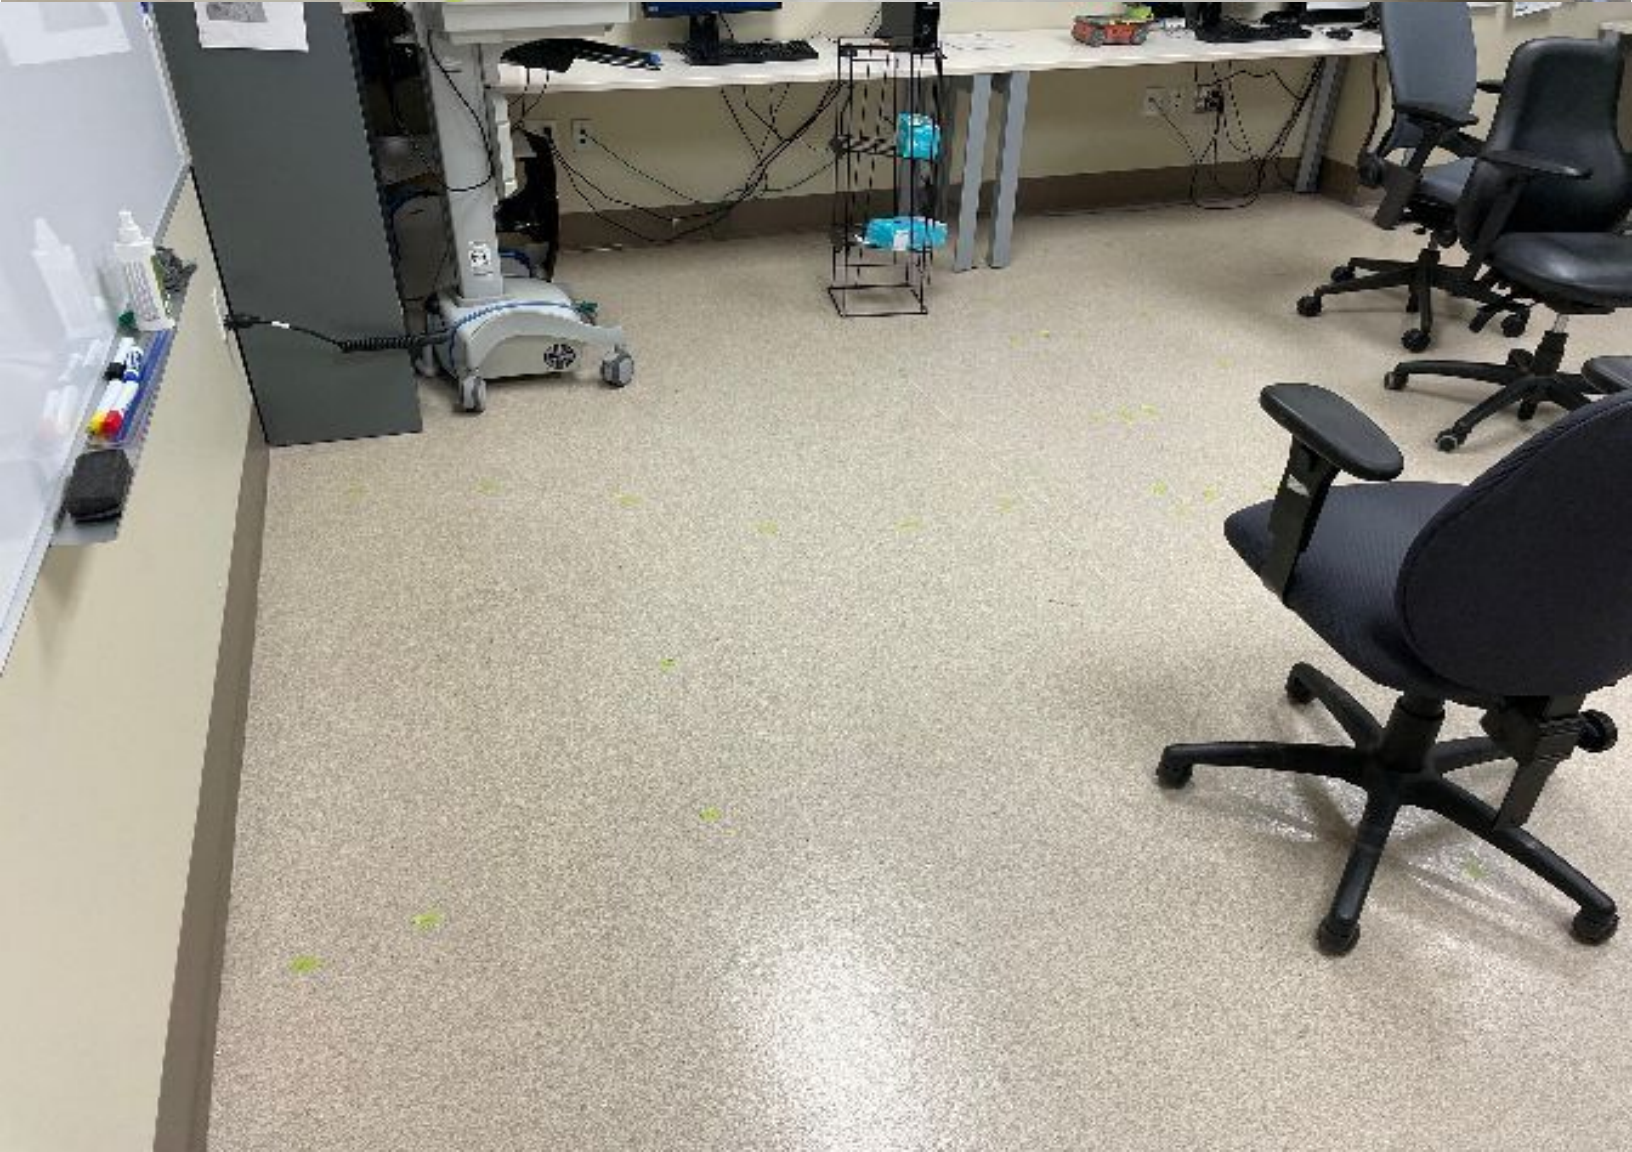
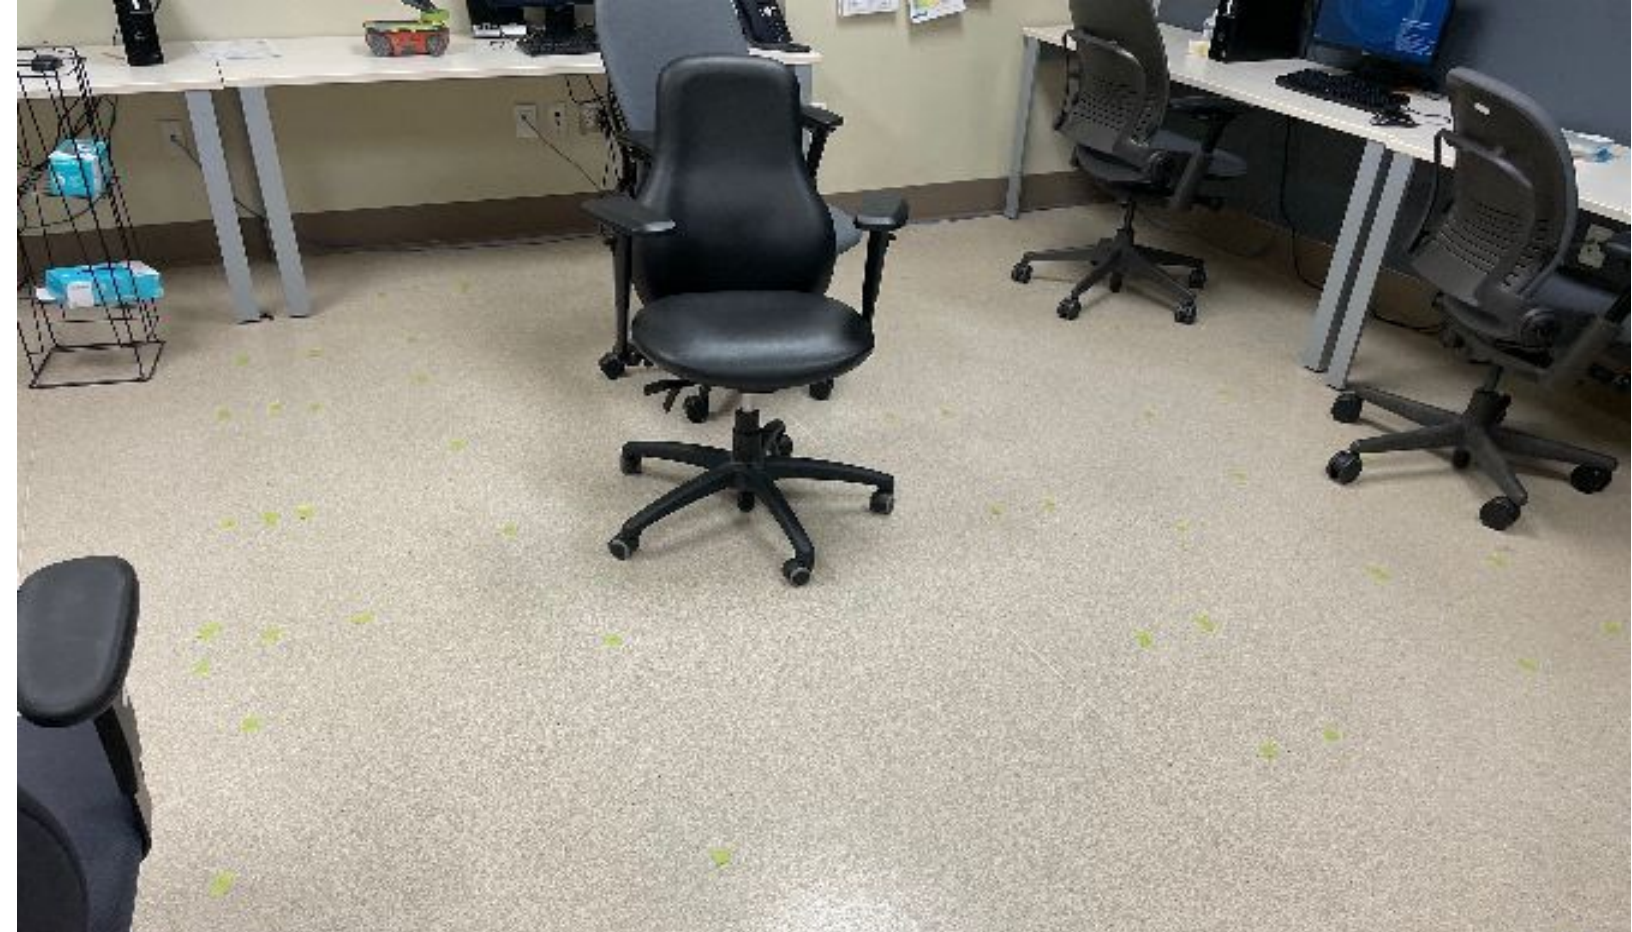
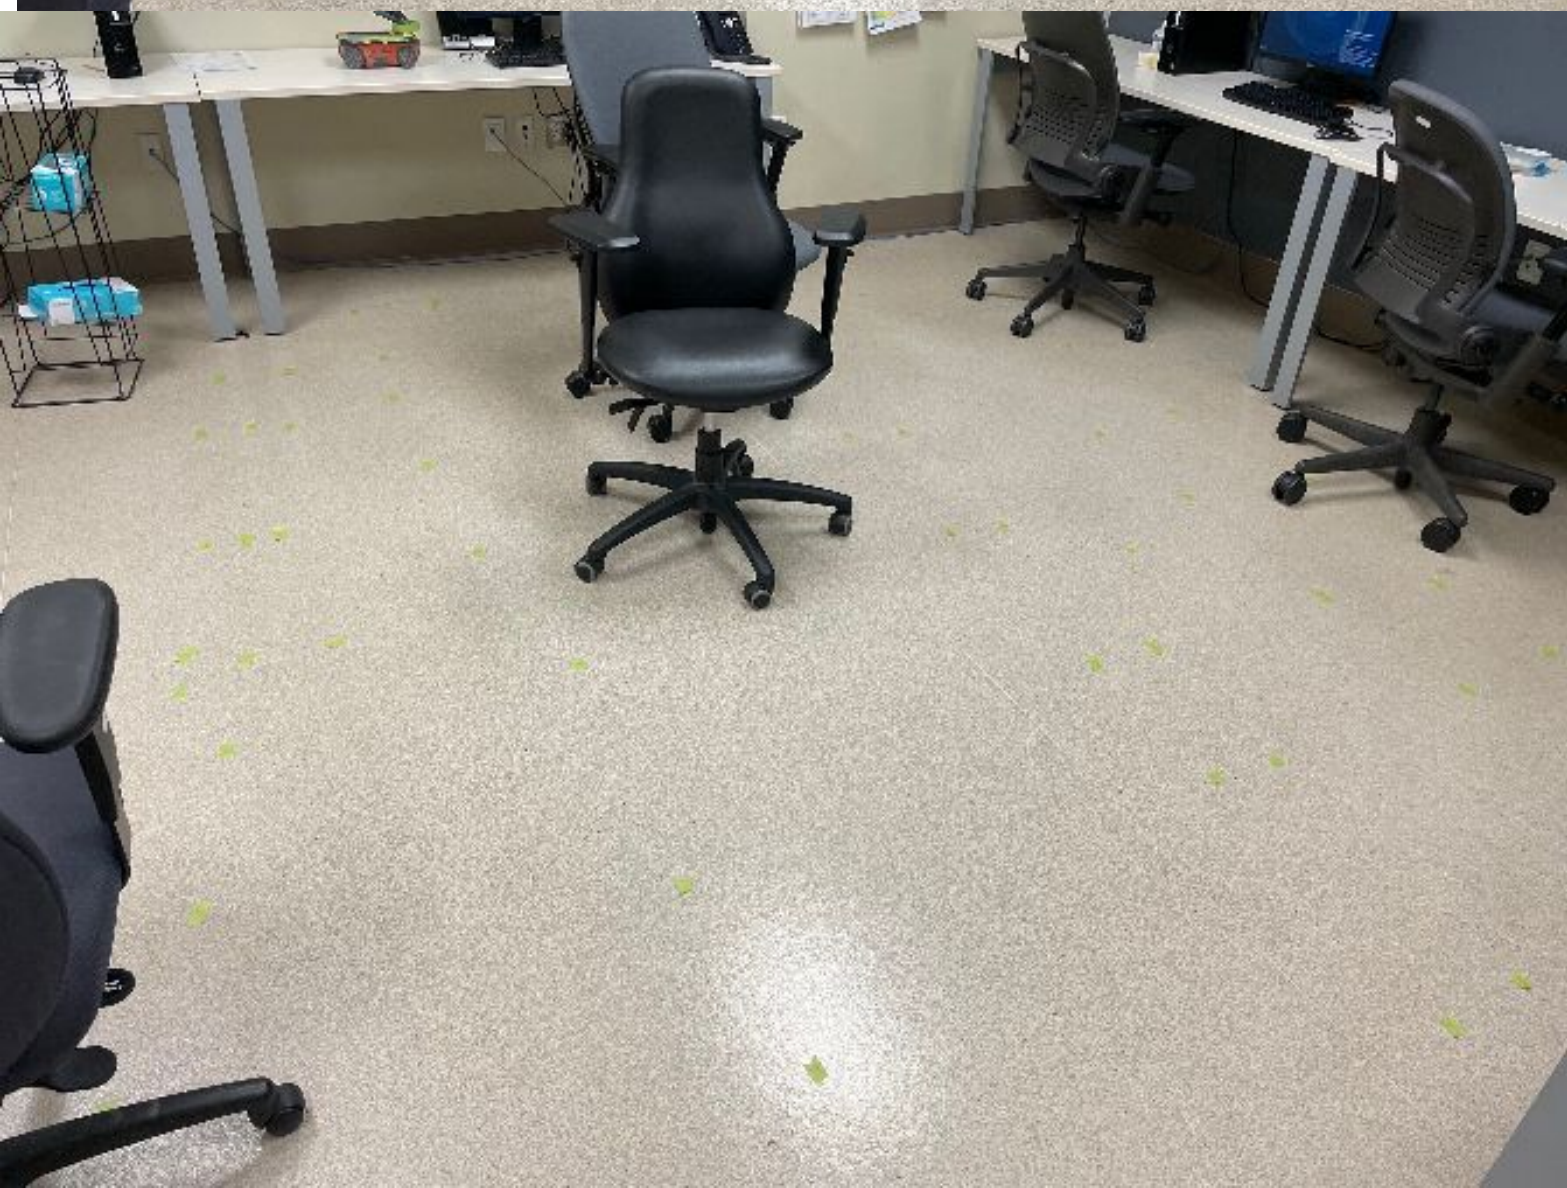
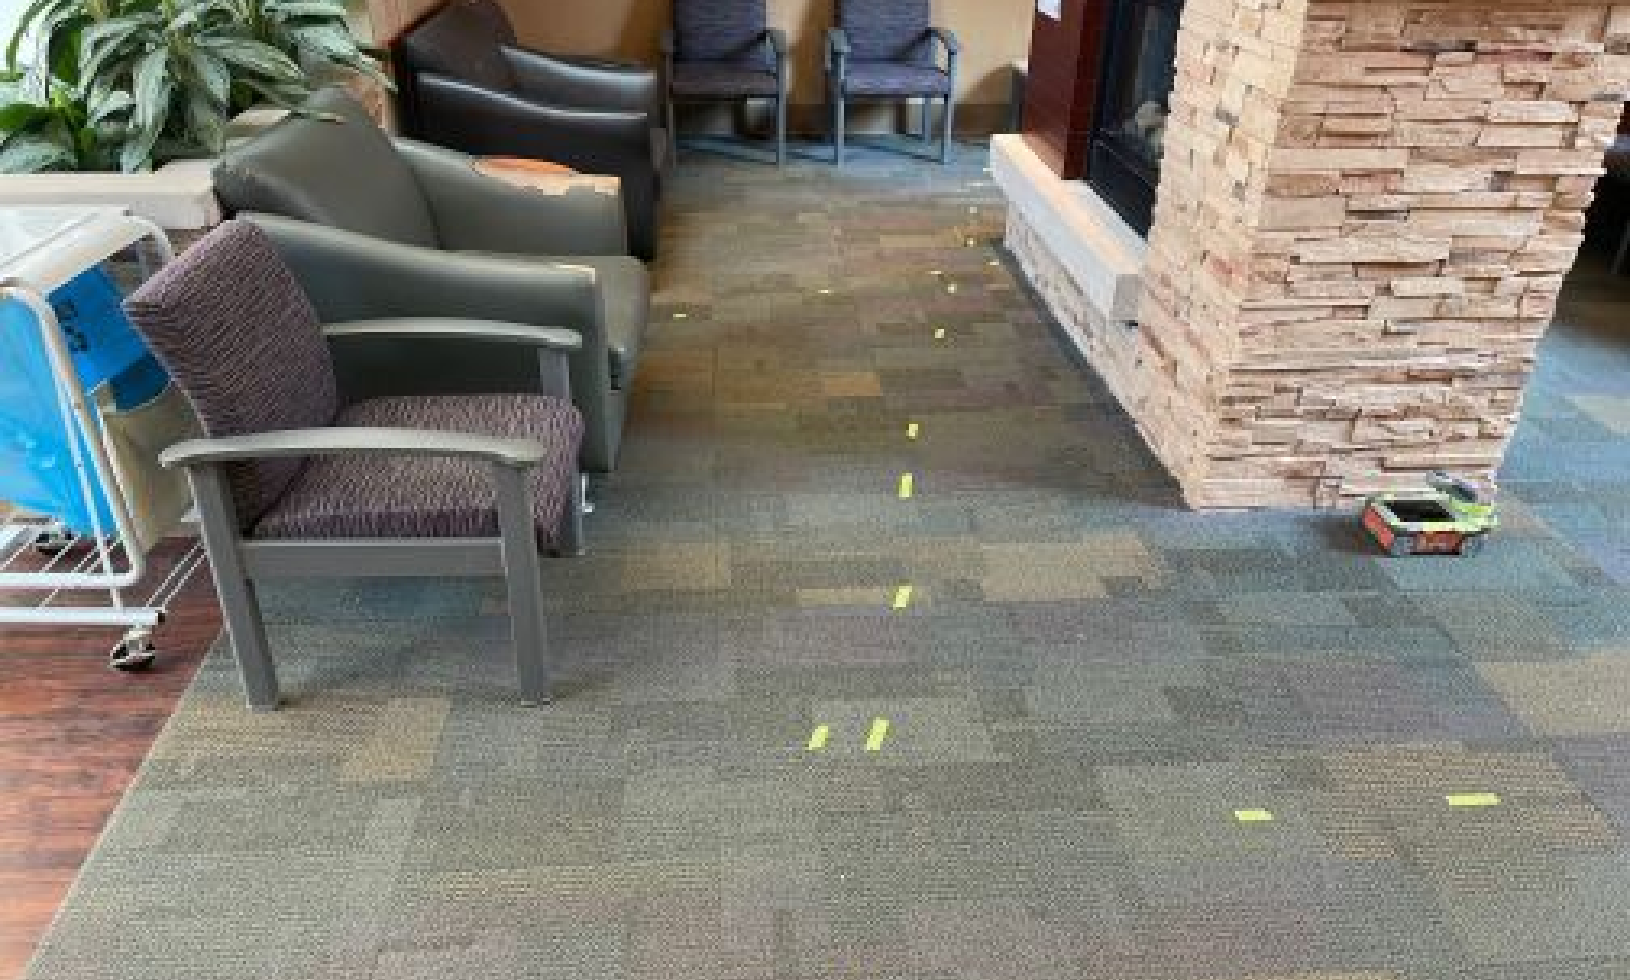
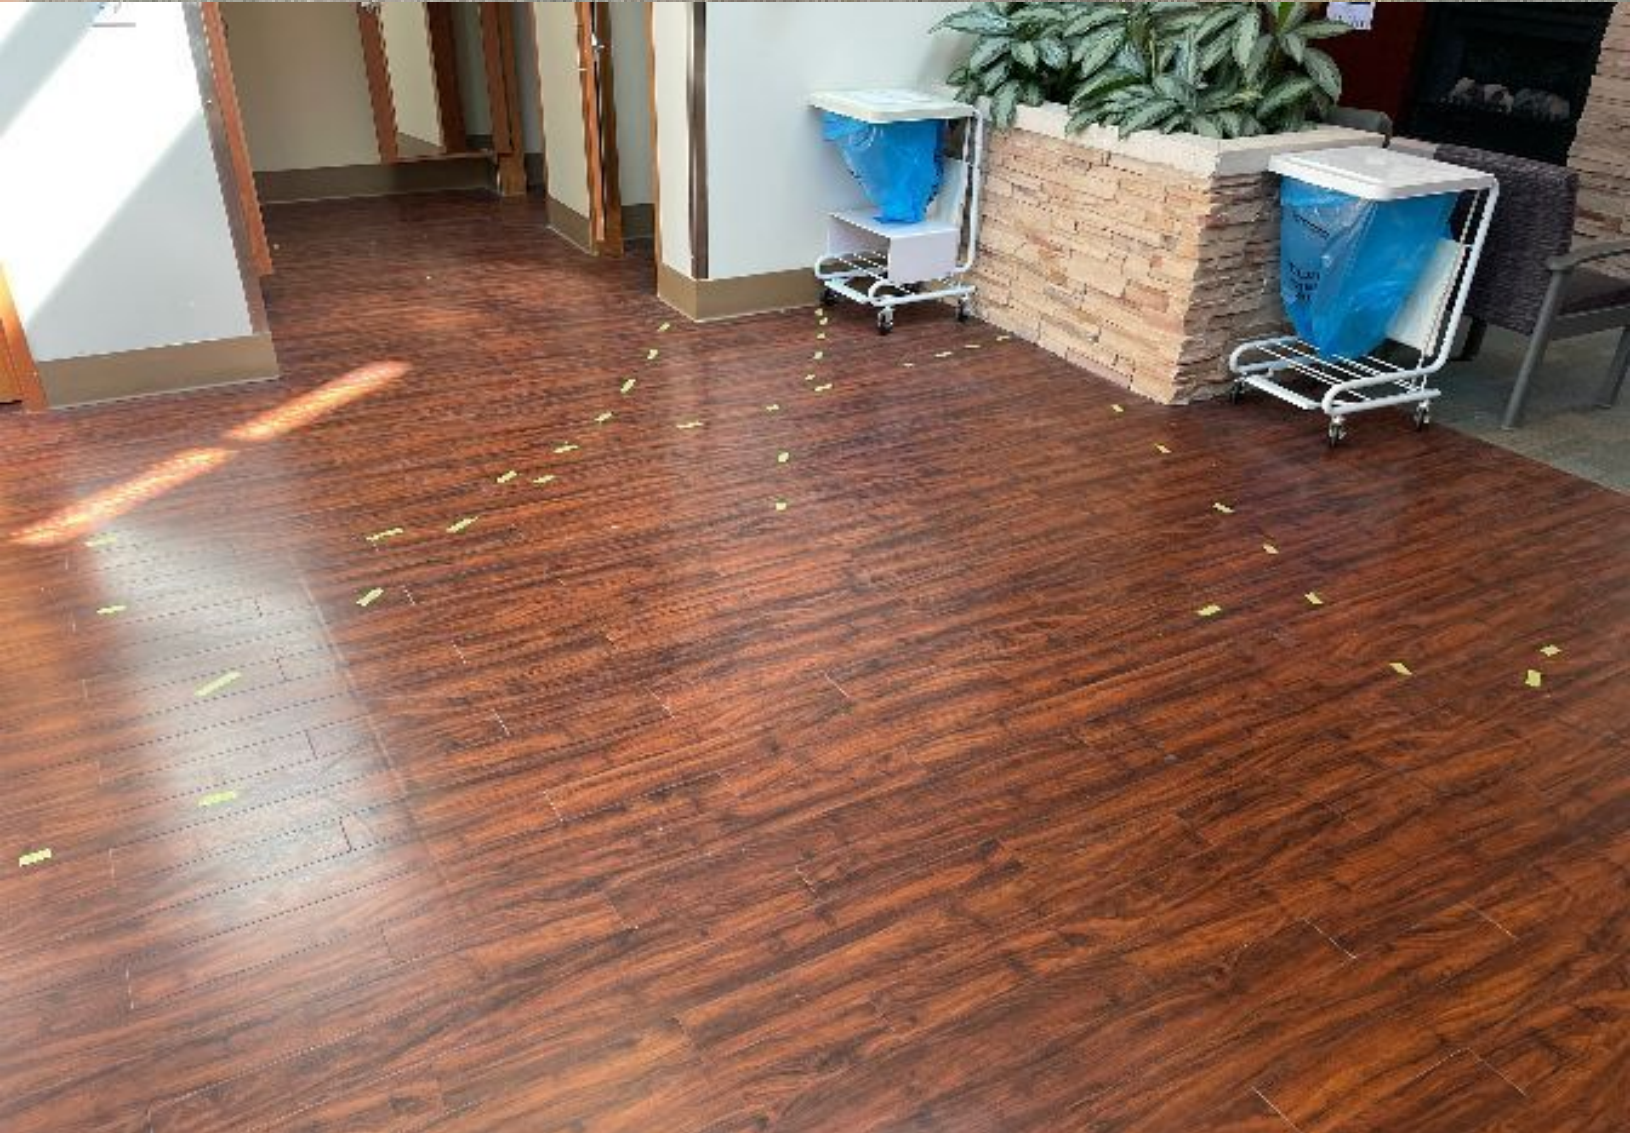
Targets were observed embedded in slab and under slab in grade and were marked with green tape with depths noted on tape due to work taking place in active hospital with finished flooring.

Photos attached to report to summarize locations.
