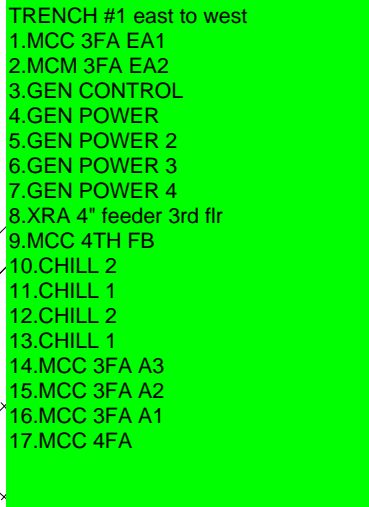
Toned services indicated in blue overlay.

Blue painter tape was used to mark location of each service. Depths were observed to range from 5"-12". Tape was labelled with conduit sources.

There were still embedded objects that were visible in GPR data, that were not located using induction clamping.

Area in storage room was not GPR scanned due to shelving in place full of materials. There were red markings from a previous locate on area in storage room. Previously trenched area marked on drawing, one pass of GPR data was collected at end of shelves and two objects were visible in GPR data.

Given congestion of services, and soil composition below slab, GPR data into grade is adversely affected.
