Concrete Scanning & Private Utility Locating

Company Name: Resolve Tech Company Contact: Ben
Job Location: Credit valley hospital

Reason for Survey: to identify embedded and subsurface services

Description of Work Area: ground floor Photographs Taken: ☒

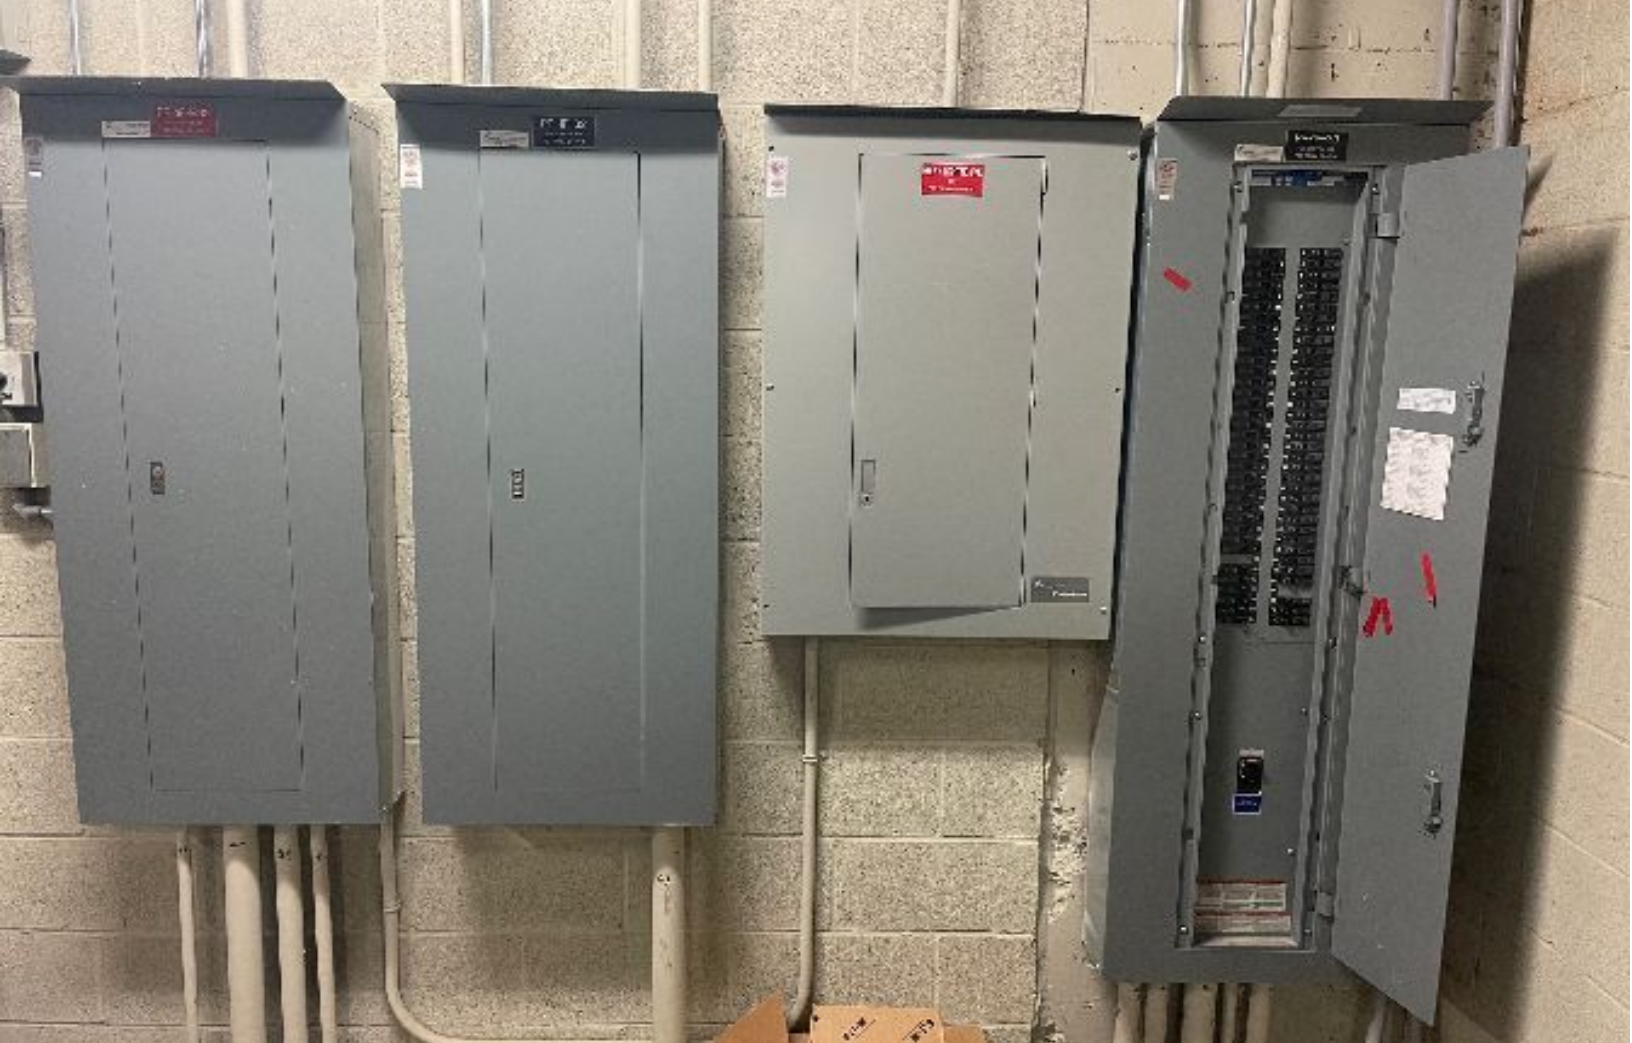
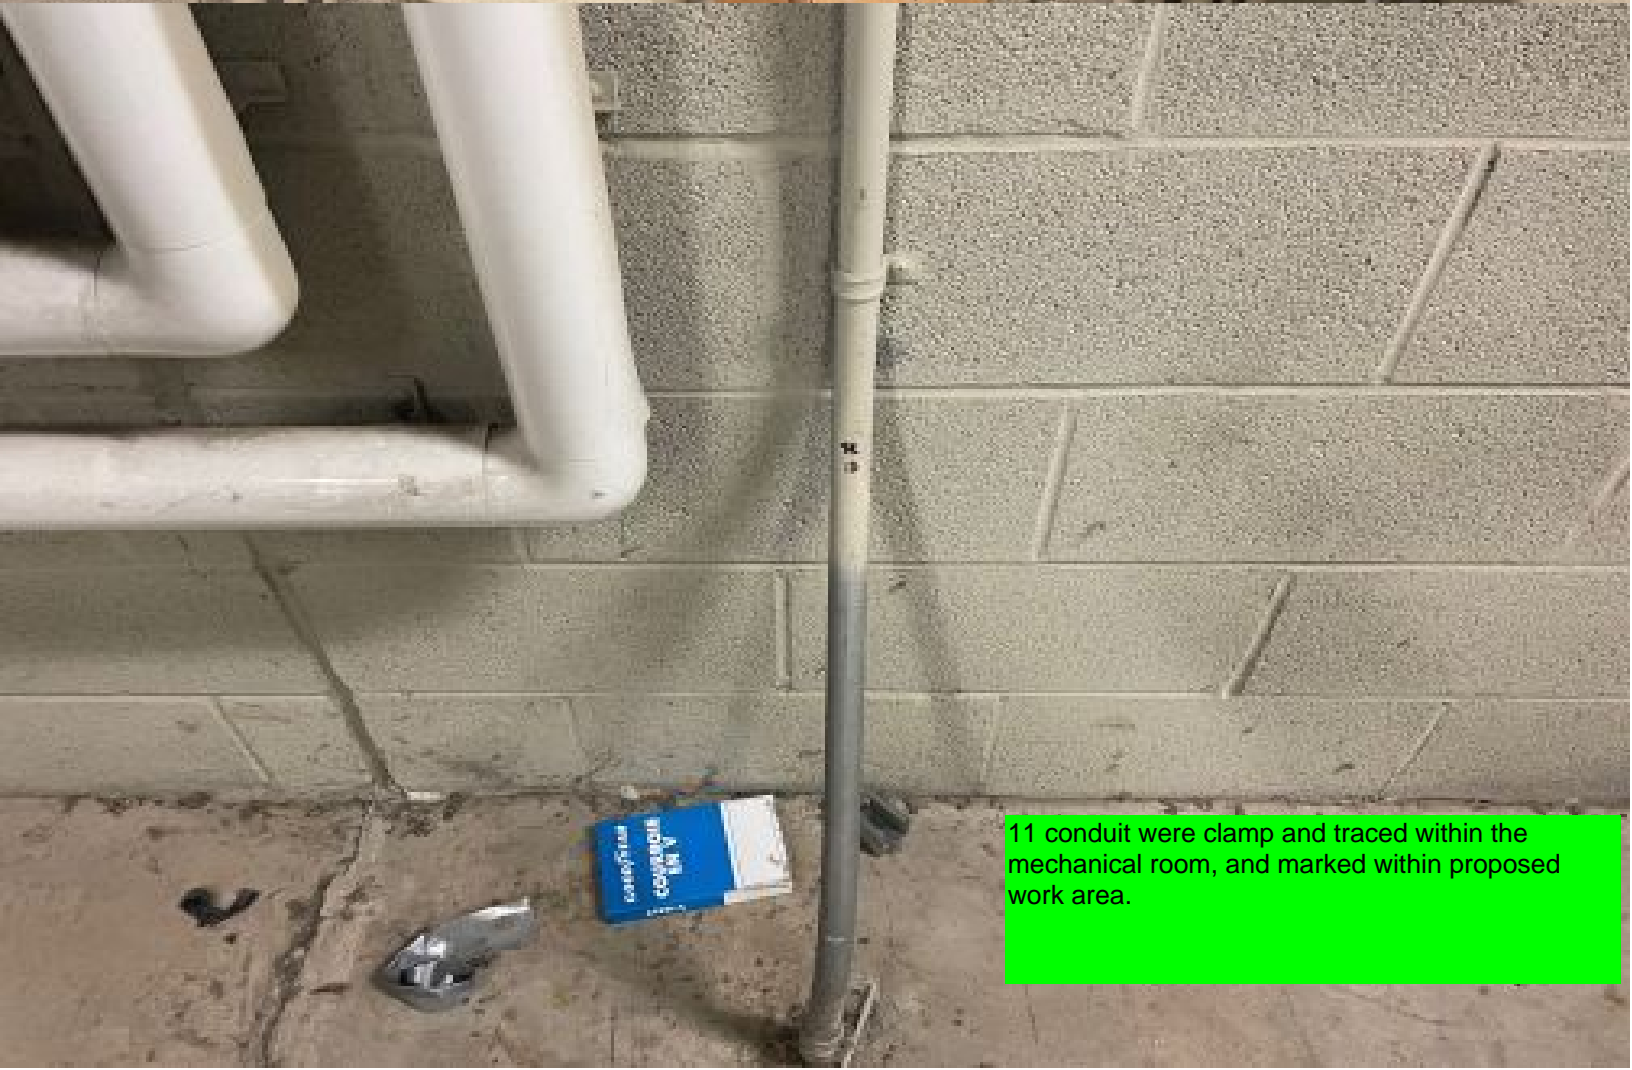
11 conduit were clamp and traced within the mechanical room, and marked within proposed work area.

Highly recommend shutting power to services when work is conducted, especially 600V feeder cables if feasible.
