# **Project Specific Designated Substances Survey – Champlain College Academic – 1770 West Bank Drive, Peterborough**

Prepared for:  
Trent University

Cambium Reference: 02511928.000

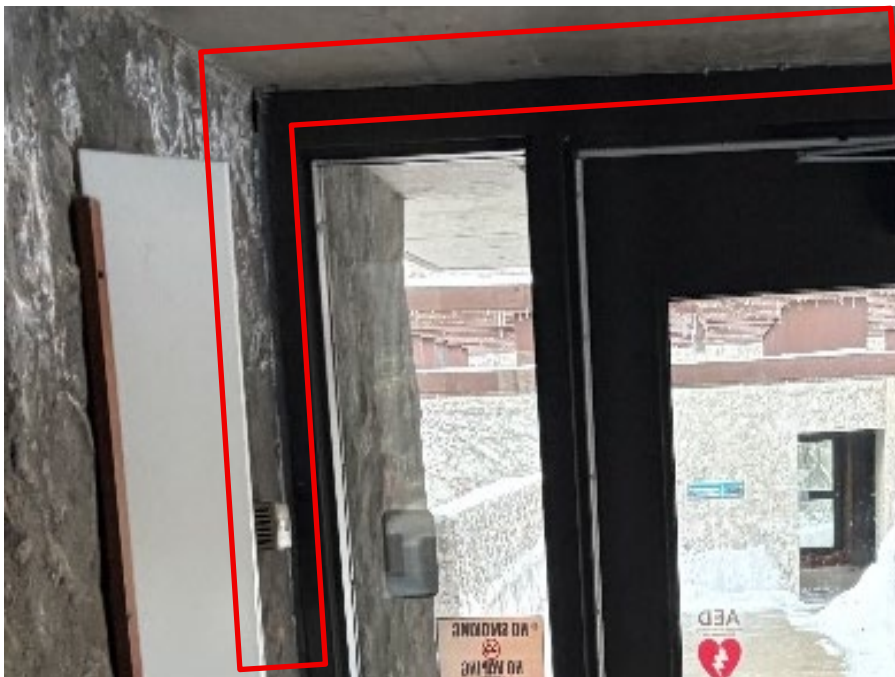
| Colour | Location/Quantity* | Sample ID | Asbestos Content |
|---|---|---|---|
| Grey | Door seal around northern doorways, first floor | ASB-104.1 to ASB-104.3 | None Detected |

All visually similar grey caulking throughout the assessed area, is considered to be non-asbestos.

**Photo 1: Non-asbestos grey caulking present around the northern doorways of the first-floor.**

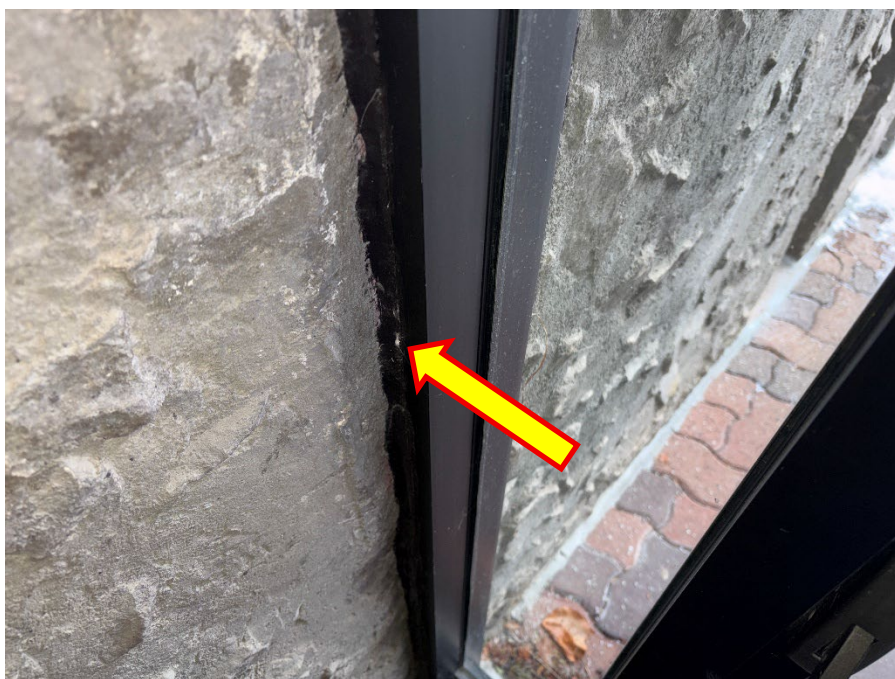
| Colour | Location/Quantity* | Sample ID | Asbestos Content |
|---|---|---|---|
| Black | Door seal around central doorways, second floor / 35 linear feet | ASB-103.1 | 0.5% Chrysotile |

All visually similar white and black caulking applied to the door seal throughout the assessed area, where present in the assessed area, is considered to be asbestos-containing. All white and black caulking was identified in good condition

**Photo 2: Asbestos-containing black caulking.**

- If affected by renovation activities, remove asbestos-containing caulking using Type 1 procedures as outlined in O. Reg. 278/05.

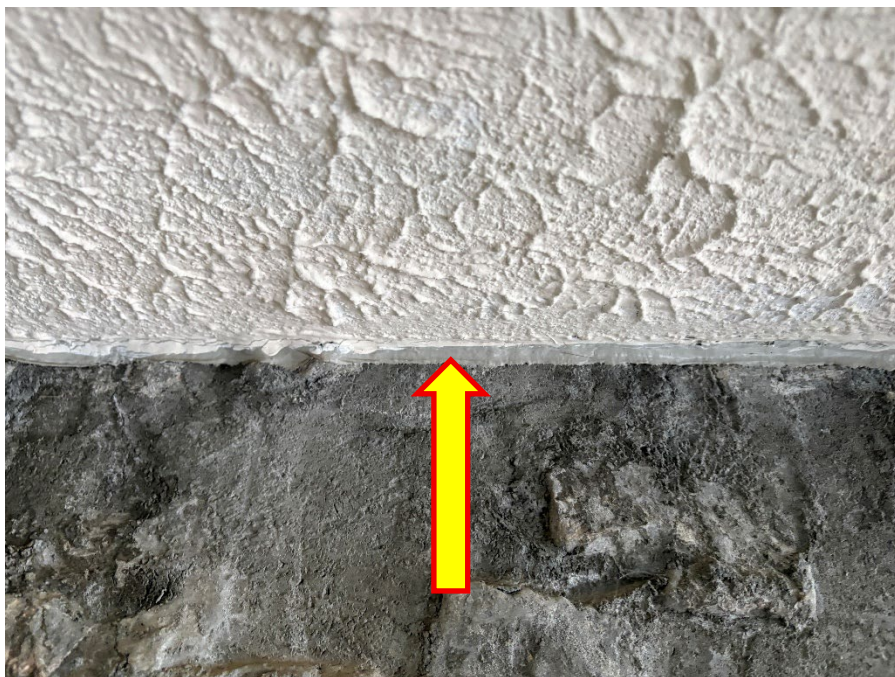
| Colour | Location/Quantity* | Sample ID | Asbestos Content |
|---|---|---|---|
| White | Ceiling corner seam around central doorways second floor / 20 linear feet | ASB-102.1 | 5% Chrysotile |

**Photo 3: Asbestos-containing white caulking.**

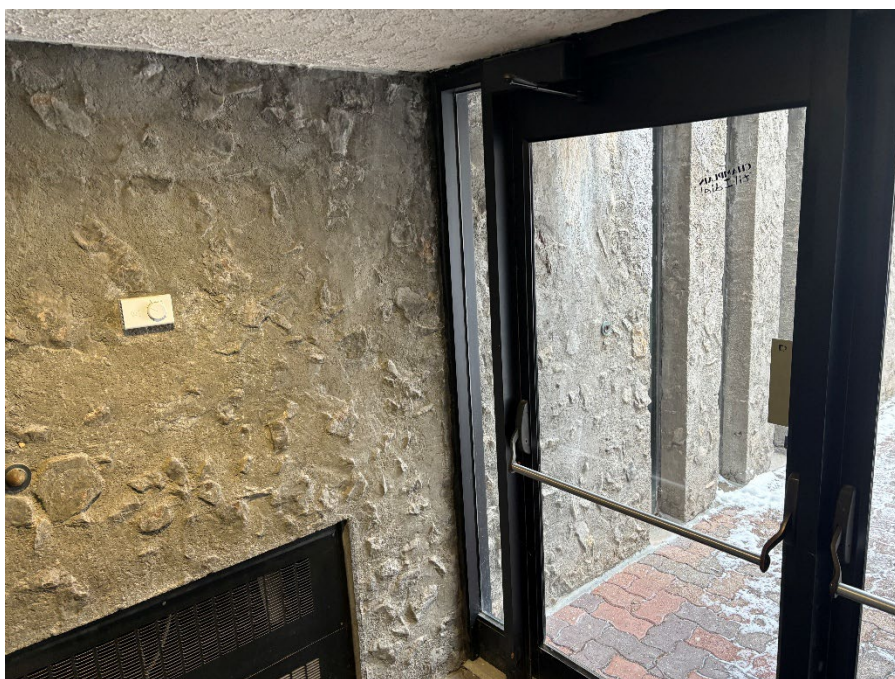
Non-asbestos texture finish is present on the ceiling around the doorways of the central east facing vestibule on the second floor in the assessed area (samples ASB-101.1 to ASB-101.3).

**Photo 4: General view of second floor vestibule.**
