DESIGNATED SUBSTANCES AND HAZARDOUS MATERIALS SURVEY

Mulock Estate
16780 Yonge Street
Newmarket, Ontario (1878)

ECOH Project No.: 26372-06
April 16, 2021

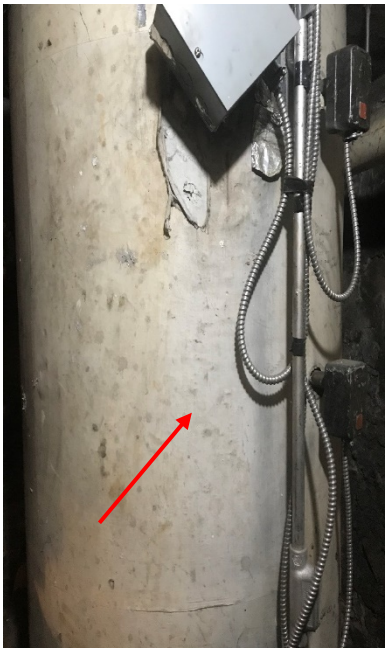
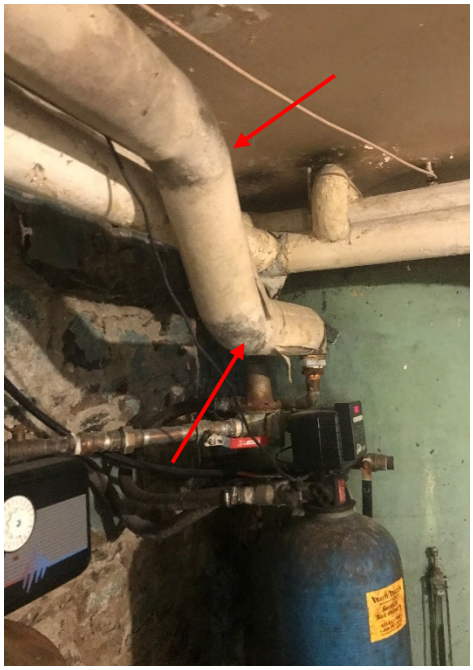
Parging Cement on fittings and Boiler Tank.

This material was confirmed to be **asbestos-containing** by laboratory analysis **(60% Chrysotile)**
