Asbestos Reassessment Report

Carl A Pollock Hall (Building No. 29)
200 University Avenue West, Waterloo, Ontario

February 8, 2021

Pinchin File: 221052.000

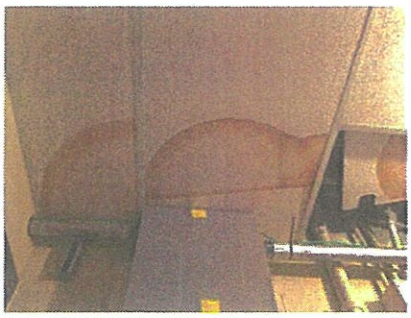
ABATEMENT ITEM #01 2021- 01

Location #:	Room 1330 Electrical Room		
Inspection Date:	01/19/21		
Material	2'x4" acoustic ceiling tiles		
Condition	Poor		
Accessibility	B		
Action Level:	3		
Type of ACM Operation:	Type 1 Removal		
Recommended Operation:		**Action**	**Quantity**
	X	Removal	8 SF ✓
		Repair	
		Encapsulation	
		Debris Clean-up	
Notes:	Observed 3 asbestos-containing acoustic ceiling tiles with visible water damage.

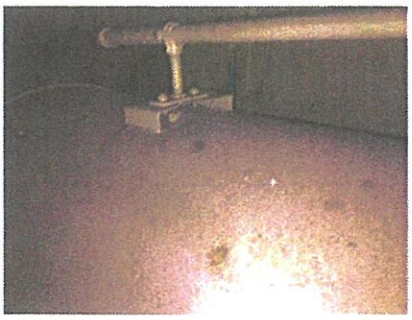
ABATEMENT ITEM #02 2021- 01

Location #:	Room 3983 Mechanical Room		
Inspection Date:	01/19/21		
Material	Sprayed fireproofing debris		
Condition	Poor		
Accessibility	B		
Action Level:	3		
Type of ACM Operation:	Type 2 Debris Clean up. Type 2 precautions required to enter room until debris clean-up completed.		
Recommended Operation:		**Action**	**Quantity**
		Removal	
		Repair	
		Encapsulation	
	X	Debris Clean-up	2 SF ✓
Notes:	Sprayed fireproofing debris present on top of mechanical equipment

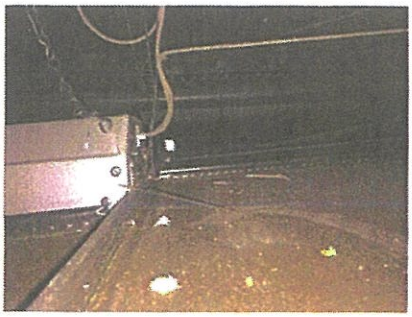
ABATEMENT ITEM #03 2021- 01

Location #:	Throughout the Building		
Inspection Date:	01/19/21		
Material	Sprayed fireproofing debris		
Condition	Poor		
Accessibility	C (Visible)		
Action Level:	3		
Type of ACM Operation:	Type 2 Precautions to enter or work in ceiling space		
Recommended Operation:		**Action**	**Quantity**
		Removal	
		Repair	
		Encapsulation	
		Debris Clean-up	
Notes:	Sprayed fireproofing overspray and debris was observed on piping, conduit, on top of lay-in ceiling tiles, etc. in the ceiling spaces throughout majority of the building (refer to the database for all locations). Sprayed fireproofing debris was observed on top of ceiling tiles is various locations and is presumed to be present on-top of acoustic ceiling tiles throughout the building where sprayed fireproofing is present. O. Reg. 278/05 Type 2 procedures are required to enter or work within these ceiling spaces.

Reason: Work to be T&M due to unknown quantities
