September 9th, 2024

Our File: T245720

RE: Ground Penetrating Radar investigation at Toronto Western Hospital, 339 Bathurst St. in Toronto, Ontario

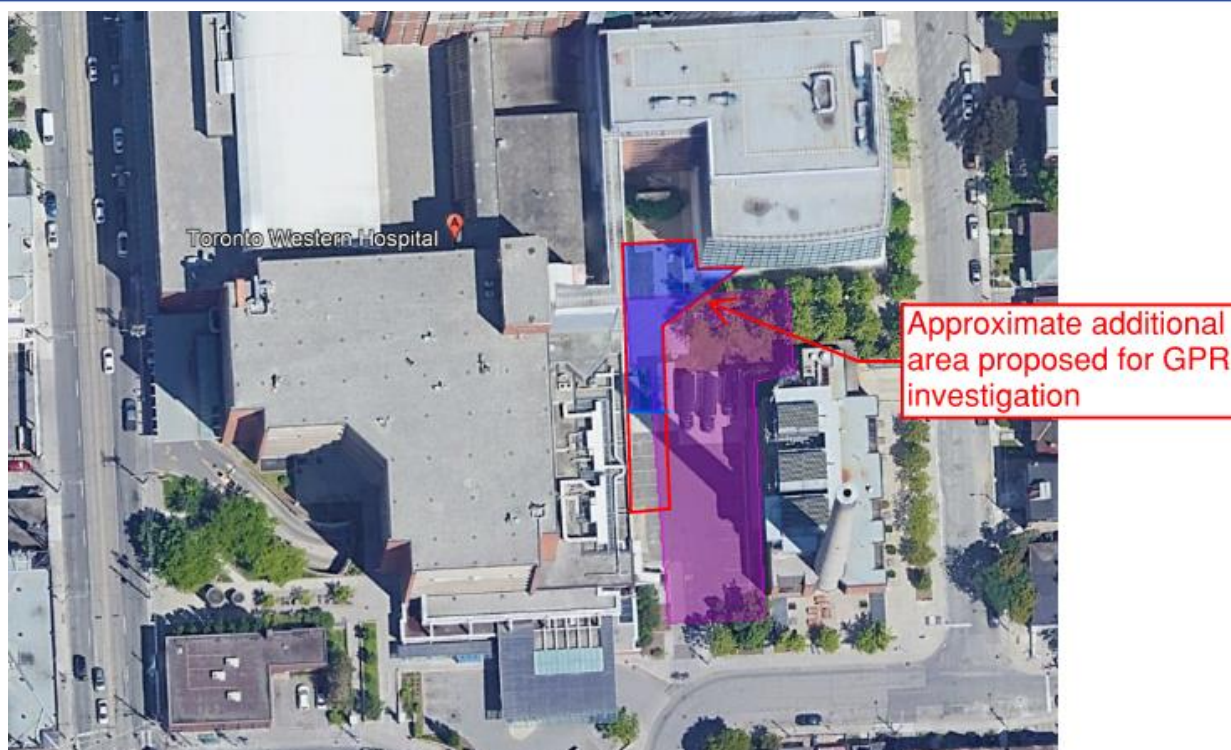
Figure 1: Proposed survey location outlined in red. Previous survey shaded in pink. Extent of area actually surveyed due to construction on-site shaded in blue.

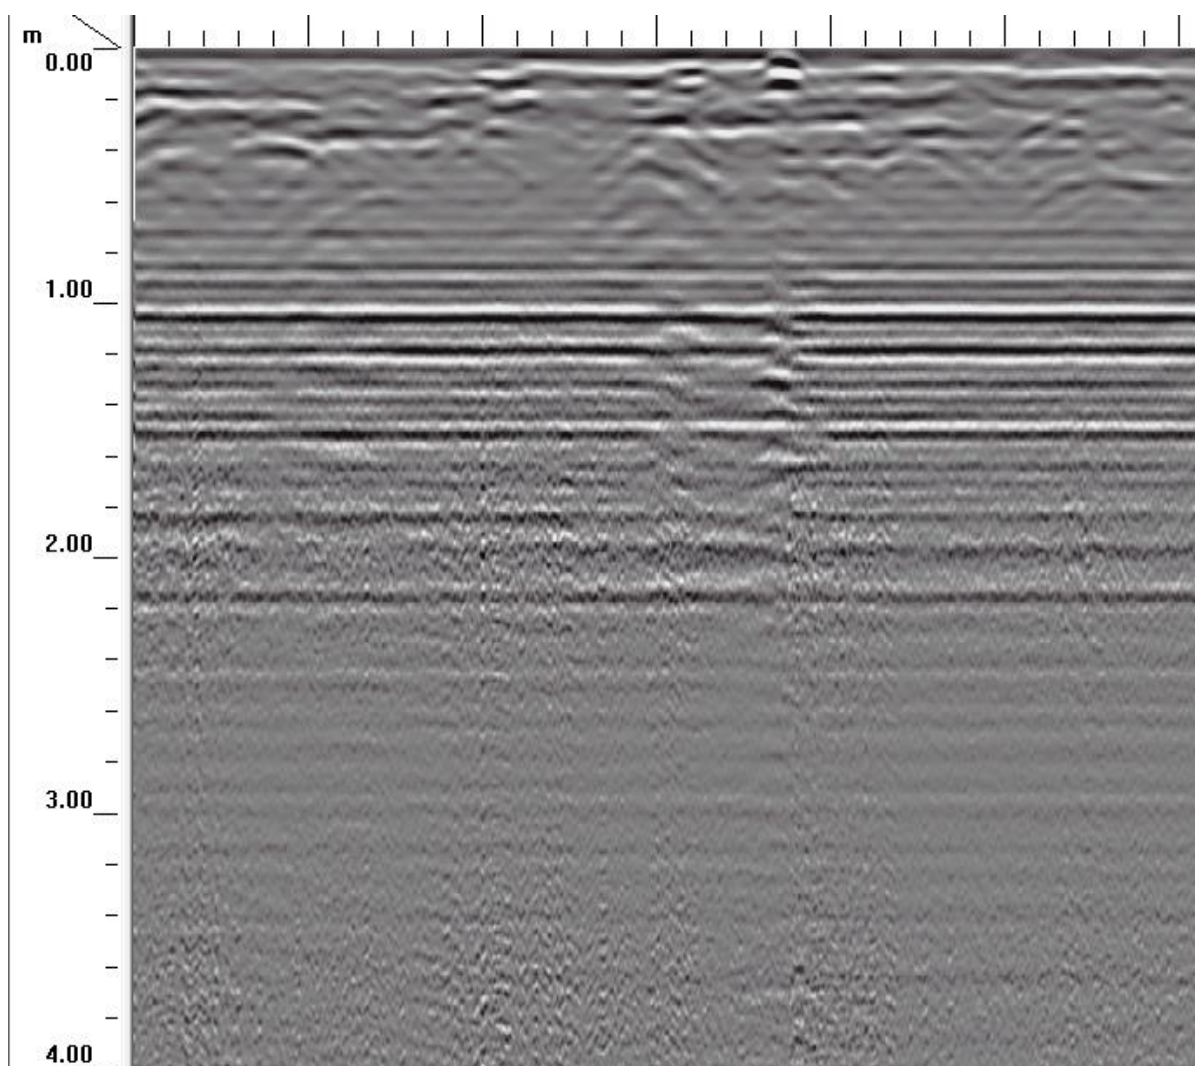
A radar image depicting typical, unobstructed soils is provided in Figure 3 for comparison with the following results.

Figure 3: Example of typical data without anomalies. Horizontal lines are soil layers/stratification and weakly reflective hyperbolas are rocks and soil features

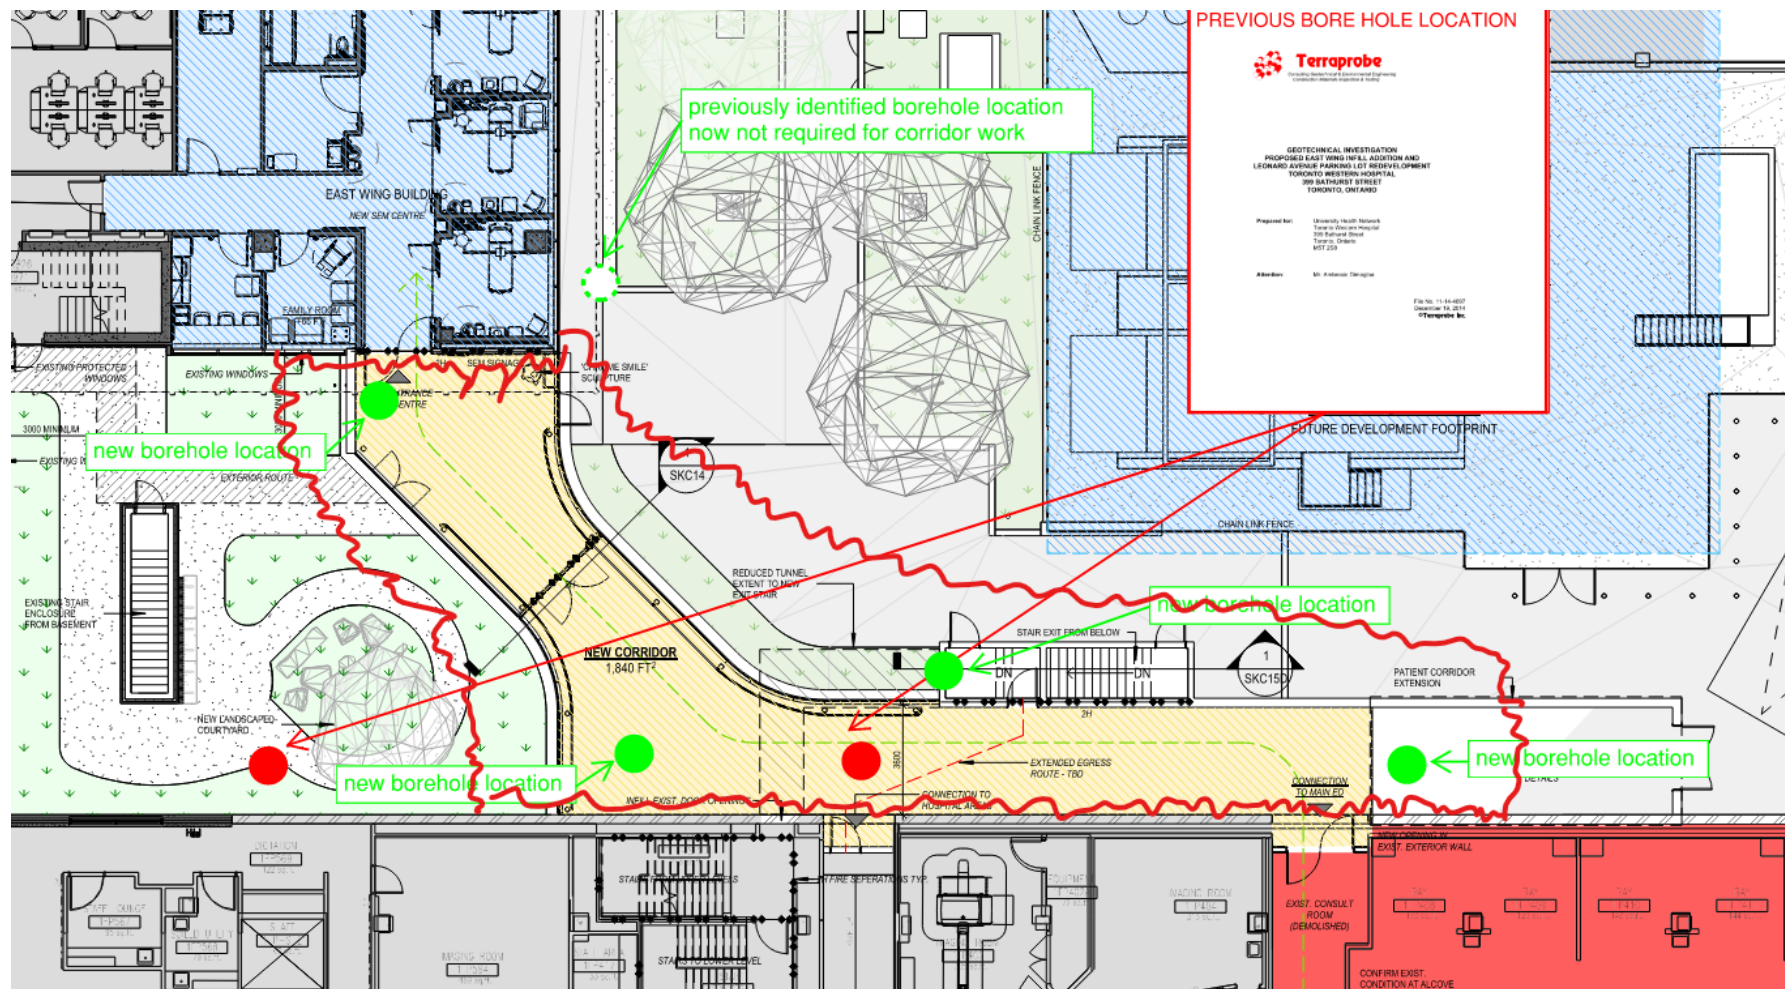
The area contained eight (8) regions of interest (ROIs). Each one is numbered and displayed within the attached drawing as shown in Figure 2. Based upon the image provided by the client (Figure 11), it does not appear that the anomalies overlap with the proposed borehole locations.

Figure 11: Client-provided borehole plan
