**399 BATHURST STREET
TORONTO, ON**

FCAP-TW ROOF CONDITION ASSESSMENT

FINAL REPORT

October 20, 2017

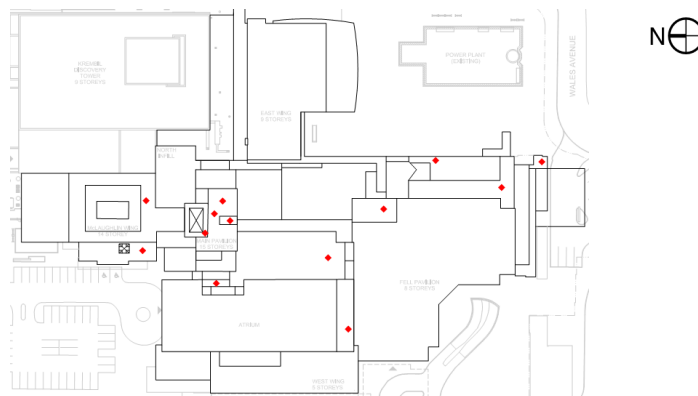
Figure 5: Exploratory opening locations (shown in red).

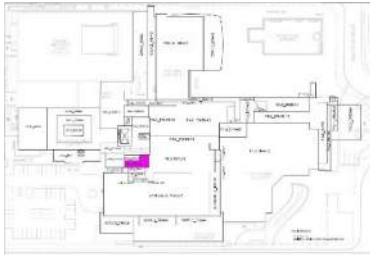
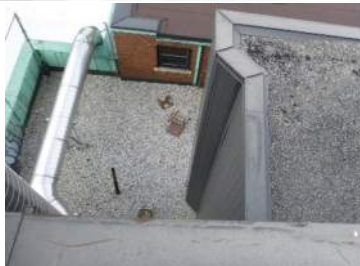
A.41 Main Pavilion Roof 5.3 (Tremco Ref: 14)

- Main Field: ▪ Debris noted throughout roof.
- Perimeter Finishing: ▪ Serviceable condition.
- Projection Details: ▪ Serviceable condition.
- Ponding/Drainage: ▪ Serviceable condition.
- Adjacent Walls: ▪ Presumed serviceable condition.

- Replacement Roof ▪ None
- Considerations:

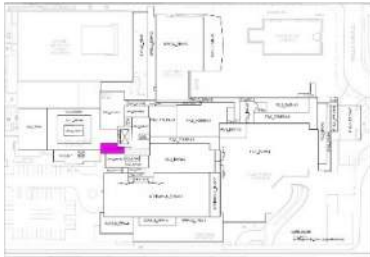
A.44 Main Pavilion Roof 8.0 (Tremco Ref: 45)

- Main Field: ▪ Debris noted.
- Perimeter Finishing: ▪ Serviceable condition.
- Projection Details: ▪ Metal flashing exhibit some surface corrosion.
 ▪ Sealant and/or pitch pockets exhibit some deterioration.
- Ponding/Drainage: ▪ Serviceable condition.
- Adjacent Walls: ▪ Serviceable condition.

- Replacement Roof ▪ Difficult access
- Considerations:

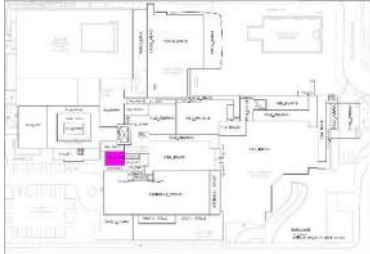
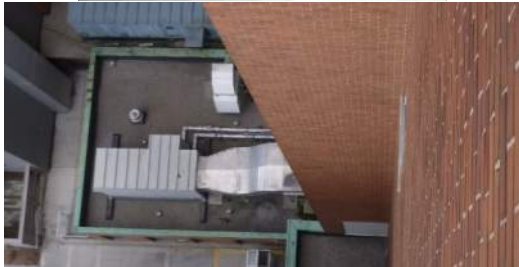
A.45 Main Pavilion Roof 8.1 (Tremco Ref: 46)

- Main Field: ▪ Debris noted.
- Perimeter Finishing: ▪ Serviceable condition.
- Projection Details: ▪ Metal flashing exhibit some surface corrosion.
- Sealant and/or pitch pockets exhibit some deterioration.
- Ponding/Drainage: ▪ Serviceable condition.
- Adjacent Walls: ▪ Serviceable condition.

- Replacement Roof ▪ Difficult access
- Considerations: ▪ Significant detail work around penetrations

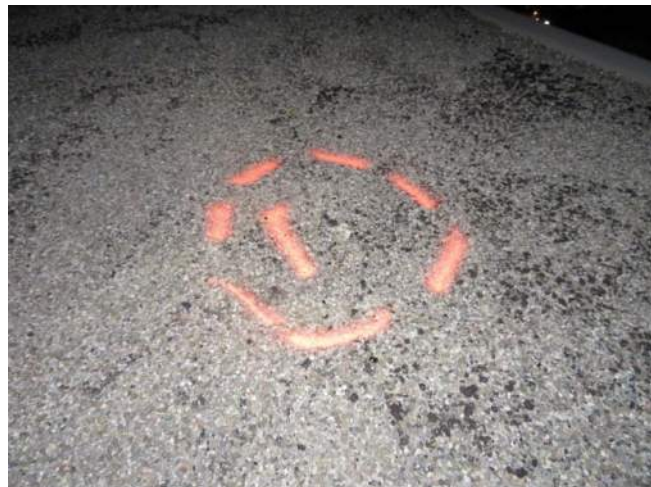
Notes: The elevated surface temperature may indicate presence of water under the BUR. Possibility of false positive due to thicker ballasting.

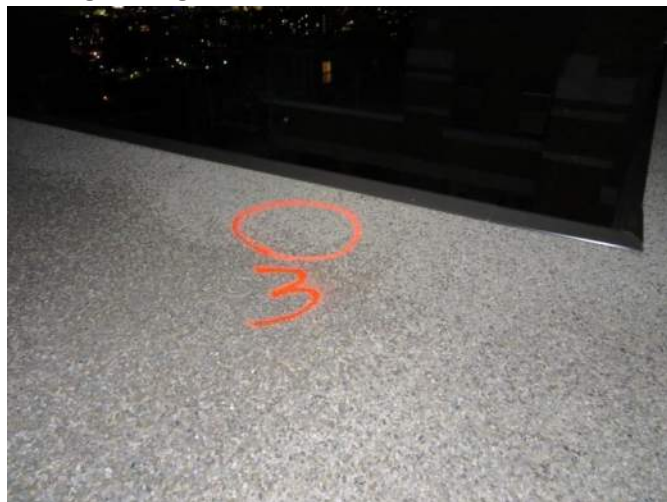
Notes: The elevated surface temperature may indicate presence of water under the BUR.

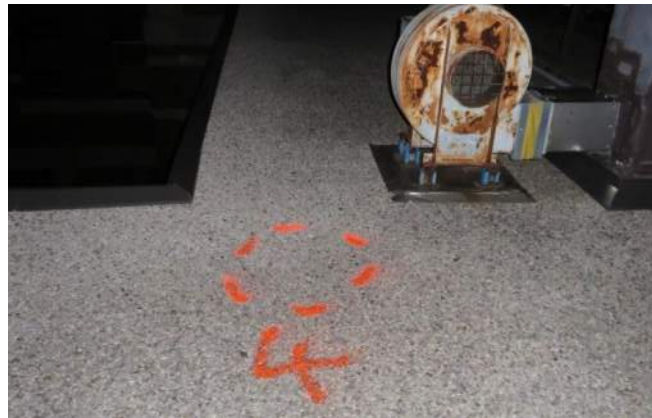
Location 4: M1.2.0, Dimensions: 2'x2' = 4ft²

Notes: The elevated surface temperature may indicate presence of water under the BUR.

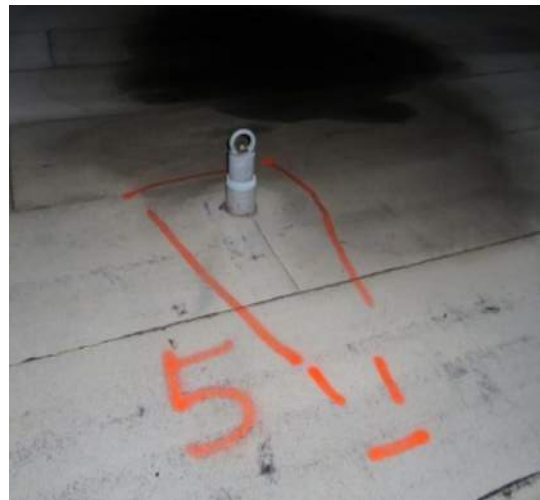
Location 5: EW1.1, Dimensions: 1.5'x6' = 9ft²

Notes: The elevated surface temperature may indicate presence of water under membrane. Signs of picture framing.

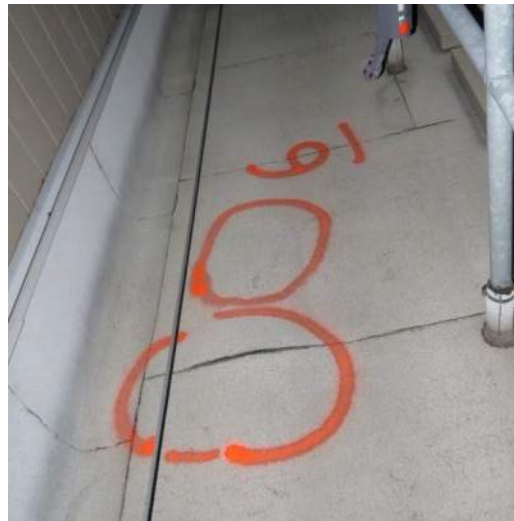
Locations 6 – EW1.2, Dimensions: 2'x3' = 6ft²

Notes: The elevated surface temperature may indicate presence of water under air blister/delamination bubbles.

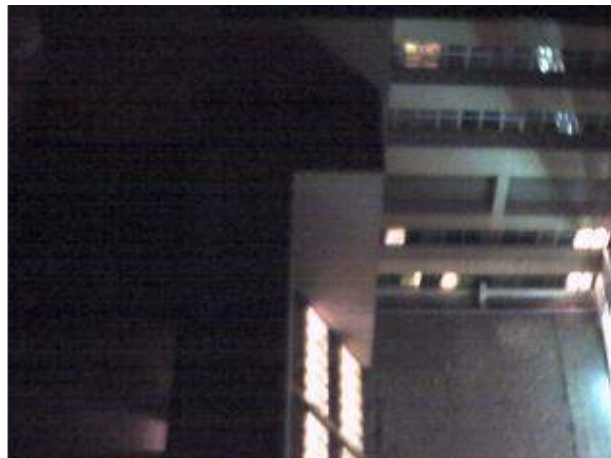
Notes: The elevated surface temperature may indicate presence of water under the membrane in a radial pattern centered on the vent/drain. We were unable to access this roof and suggest further testing.

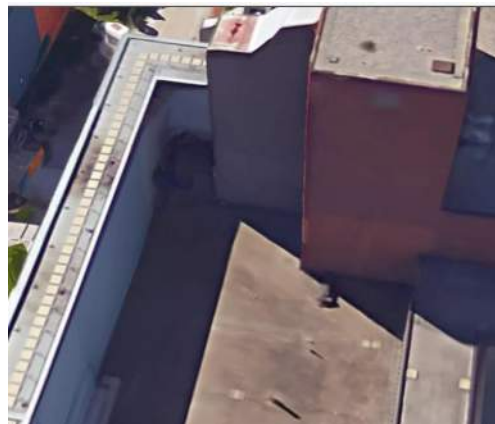
Location 11: F5.0, Dimensions: 12'x12' = 144ft²

Notes: We were unable to access this roof and suggest further testing. The elevated surface temperature may indicate presence of water under the membrane. This roof may not have experienced enough solar gain to radiate as much, but worth further investigation.

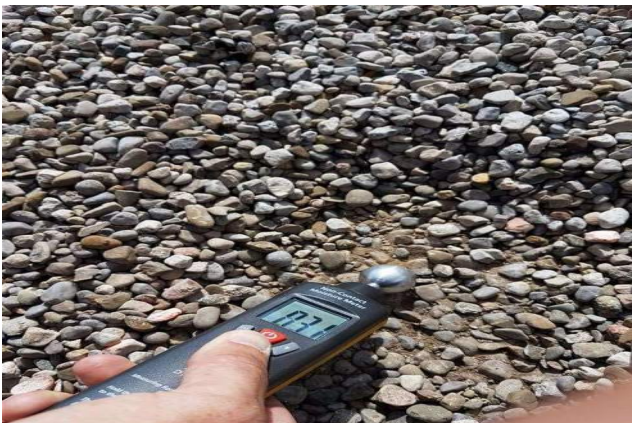
Baseline number on a non destructive probe on roof #11 - this roof contains suspected wet areas 2-4. It reads 30

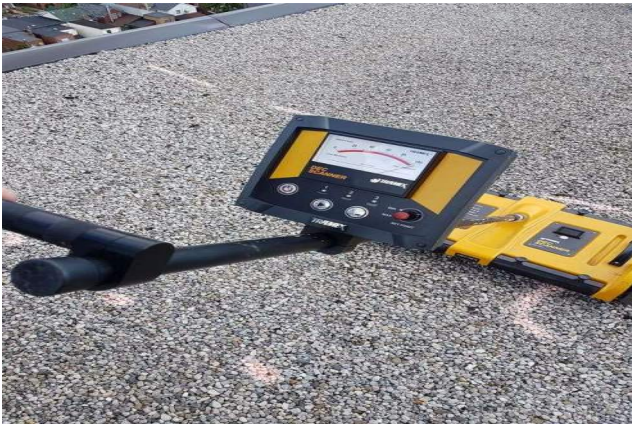
Suspected Wet Area #2 - Trammex reading on suspected area is 100. The original scan on this area is accurate. It has around 72 Sq. Ft. of wet.

Suspected wet area #2 is wet as per the original scan and should be cut out and replaced.

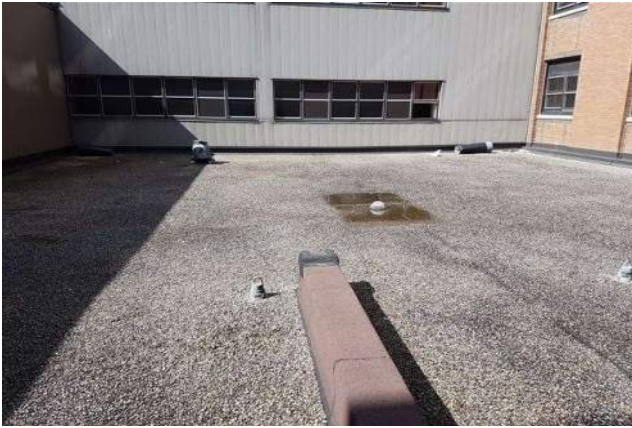
Areas of suspected wet were identified in a preliminary scan from BlueGreen Consulting (anomaly #11 in the report), but due to extensive surface moisture, we could not verify these results aside from a non destructive probe on the area divider which identified it as an area of suspected wet.

A general view - we were not able to verify the Thermography from BlueGreen Consulting Group as the roof was too wet and not conducive to scanning.

Although the warranty on this roof is void on account of the non-approved alterations, we will return when the roof is dry to verify the scan results to prevent the spread of any potential wet insulation. We also recommend replacing the modified bitumen flashing membrane on the area dividers as they contain moisture and are no longer watertight.

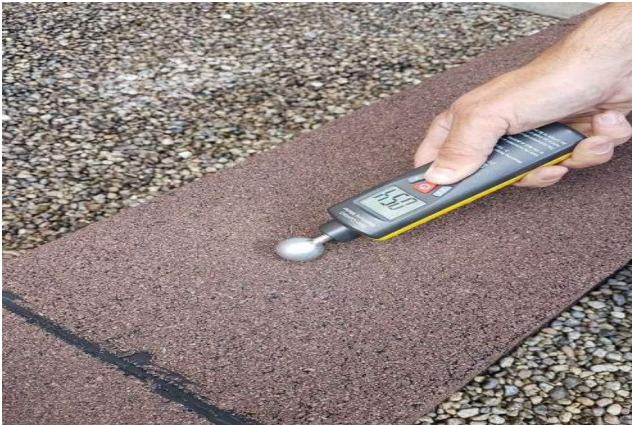
The area dividers on this roof were also covered in a modified bitumen membrane that was not part of the original Tremco roof. As these were not a Tremco approved alteration the warranty on this roof was voided. The moisture probe also identified moisture within these areas of modified bitumen membrane.

A reading of 54 on the area divider indicating that there is sub surface moisture. It also felt wet to the touch. This membrane was not part of the original Tremco roof and was altered after the fact, voiding the warranty.

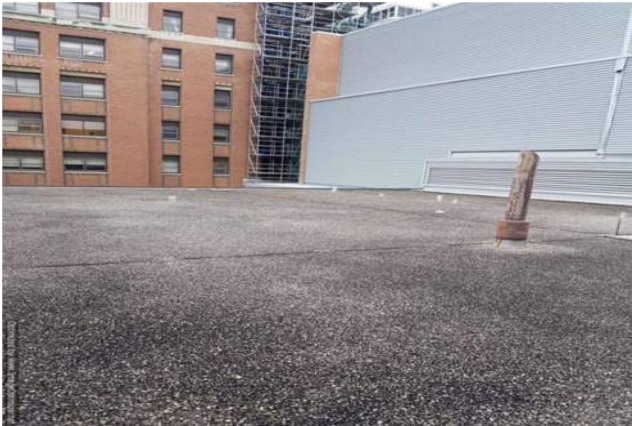
A general view - this roof was not accessed during the original scan, so the thermograms were taken from an adjacent roof.

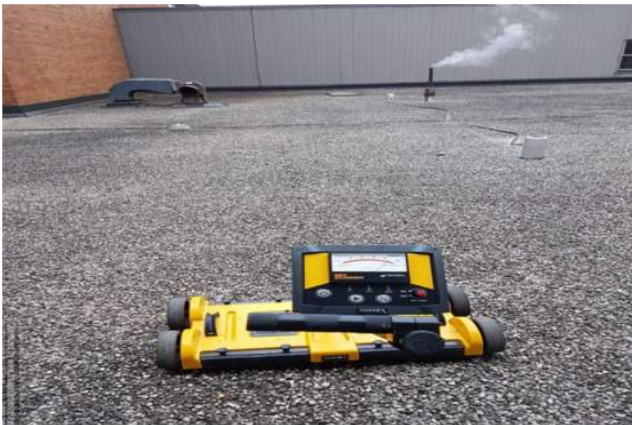
Scanned in summer 2017 - 3' x 12' area of wet insulation was identified

Anomaly #12 - The Tramex Dec scanner verifying that anomaly #12 in the BlueGreen report is accurate and this area of roof (approx. 36 sq. ft) is wet.

Investigate the adjacent upper roof/wall connection to eliminate that as the source of the moisture entry into this roof area.

Remove the area of wet roofing and replace to match existing.
