**LIMITED DESIGNATED SUBSTANCE SURVEY  
REPORT  
(RENOVATION AREAS)**

**Sunnybrook Health Sciences Center K Wing 3<sup>rd</sup>  
Floor Center and East Pod  
2075 Bayview Avenue  
Toronto, Ontario**

**August 4, 2020**

**Maple Project No. 18903**

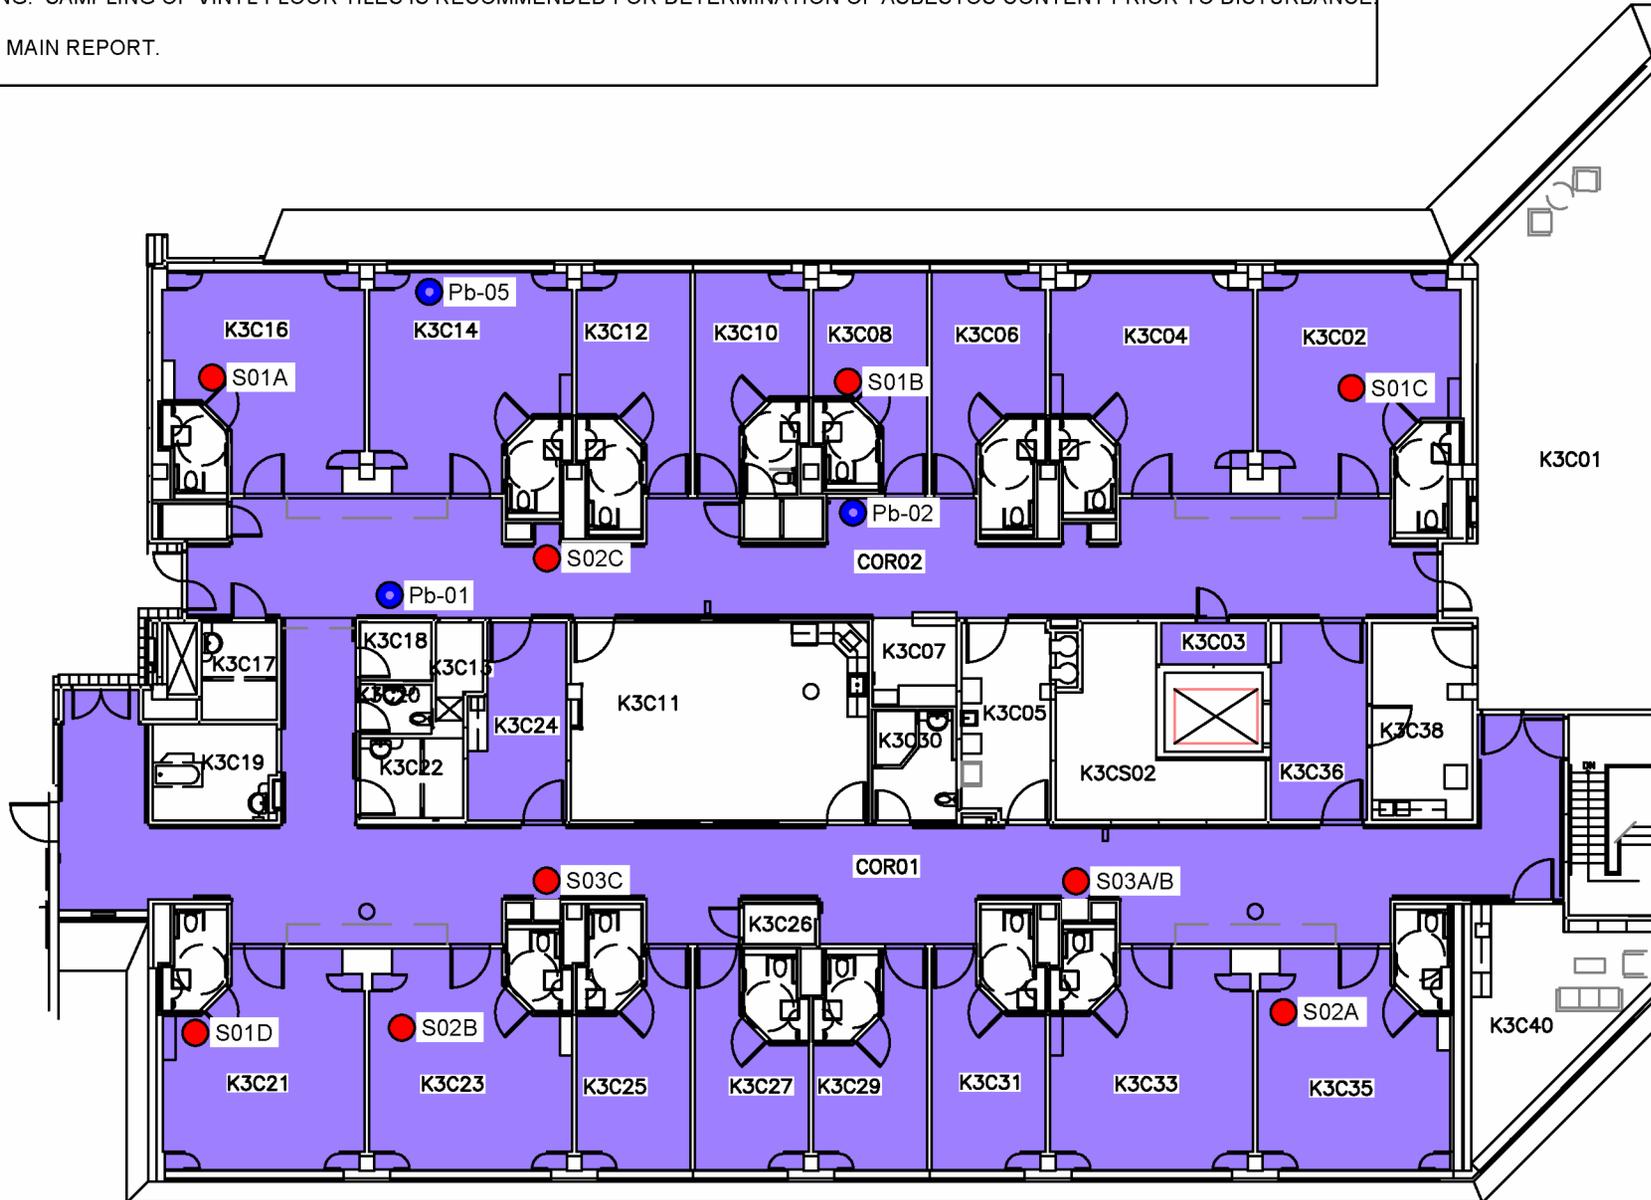
1) ASBESTOS CONTAINING VINYL FLOOR TILES ARE PRESENT WITHIN THE BUILDING. ALL VINYL FLOOR TILES ARE CONSIDERED ASBESTOS CONTAINING. SAMPLING OF VINYL FLOOR TILES IS RECOMMENDED FOR DETERMINATION OF ASBESTOS CONTENT PRIOR TO DISTURBANCE

REFER TO MAIN REPORT.

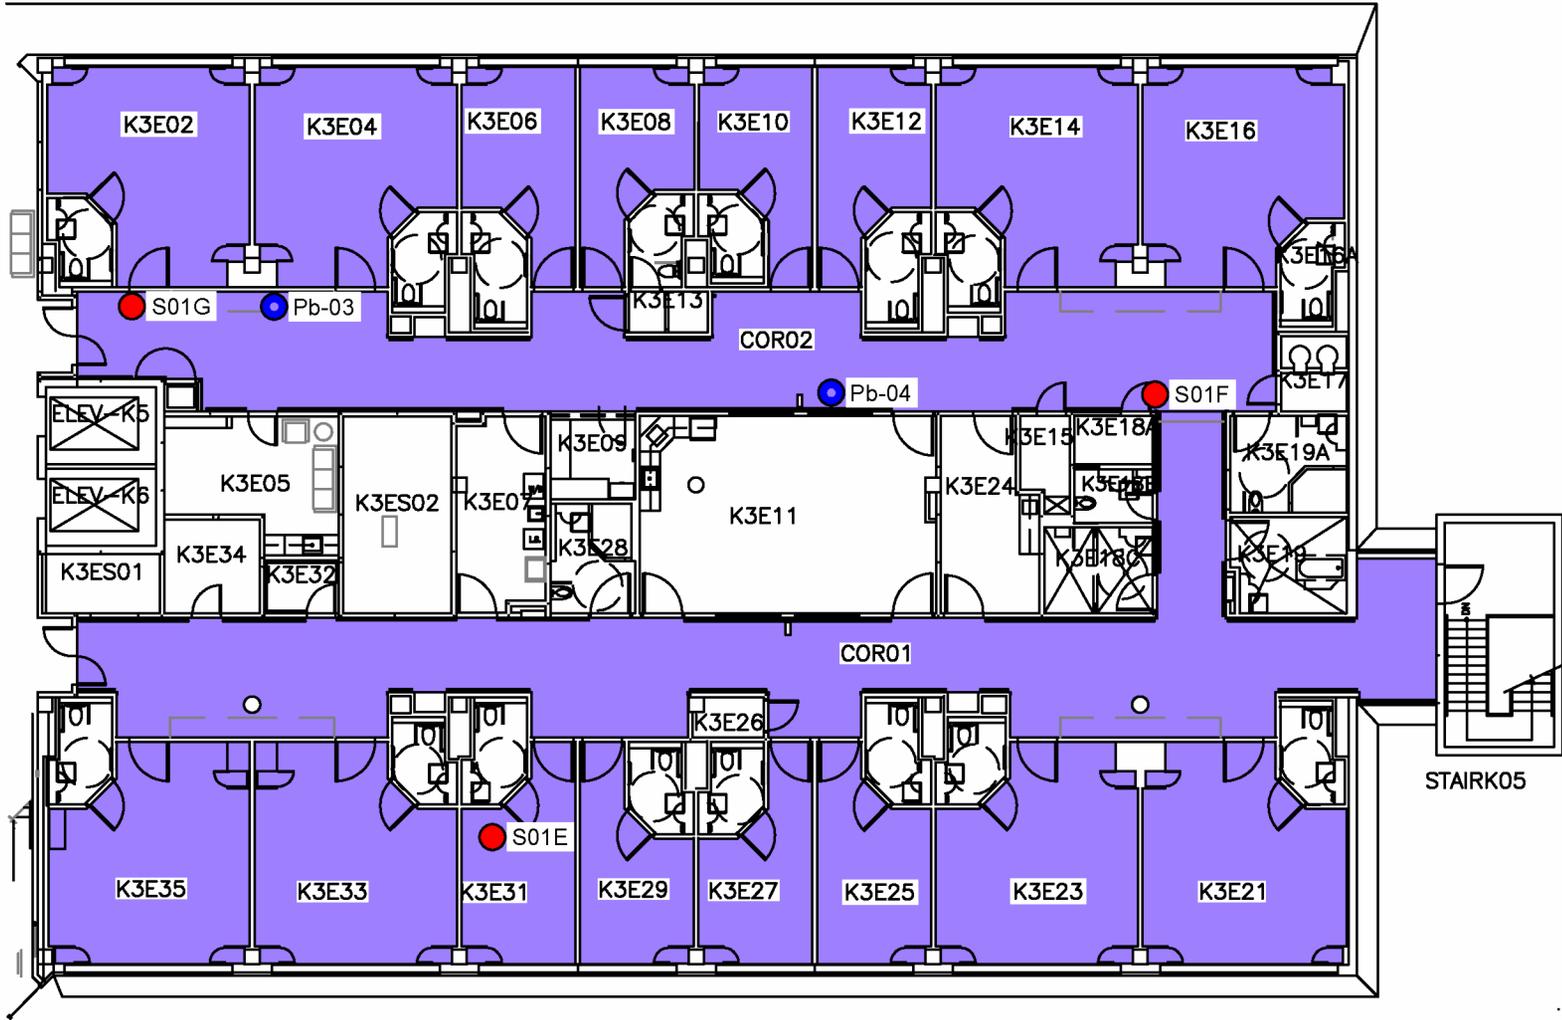
1) ASBESTOS CONTAINING VINYL FLOOR TILES ARE PRESENT WITHIN THE BUILDING. ALL VINYL FLOOR TILES ARE CONSIDERED ASBESTOS CONTAINING. SAMPLING OF VINYL FLOOR TILES IS RECOMMENDED FOR DETERMINATION OF ASBESTOS CONTENT PRIOR TO DISTURBANCE.

REFER TO MAIN REPORT.
