Pre-engineered Building
3265 Principal's Road, Mississauga
University of Toronto Mississauga

Version 1.4

Arborist Report

Re: **Arborist Report for the Pre-engineered Building at the University of Toronto
Mississauga**

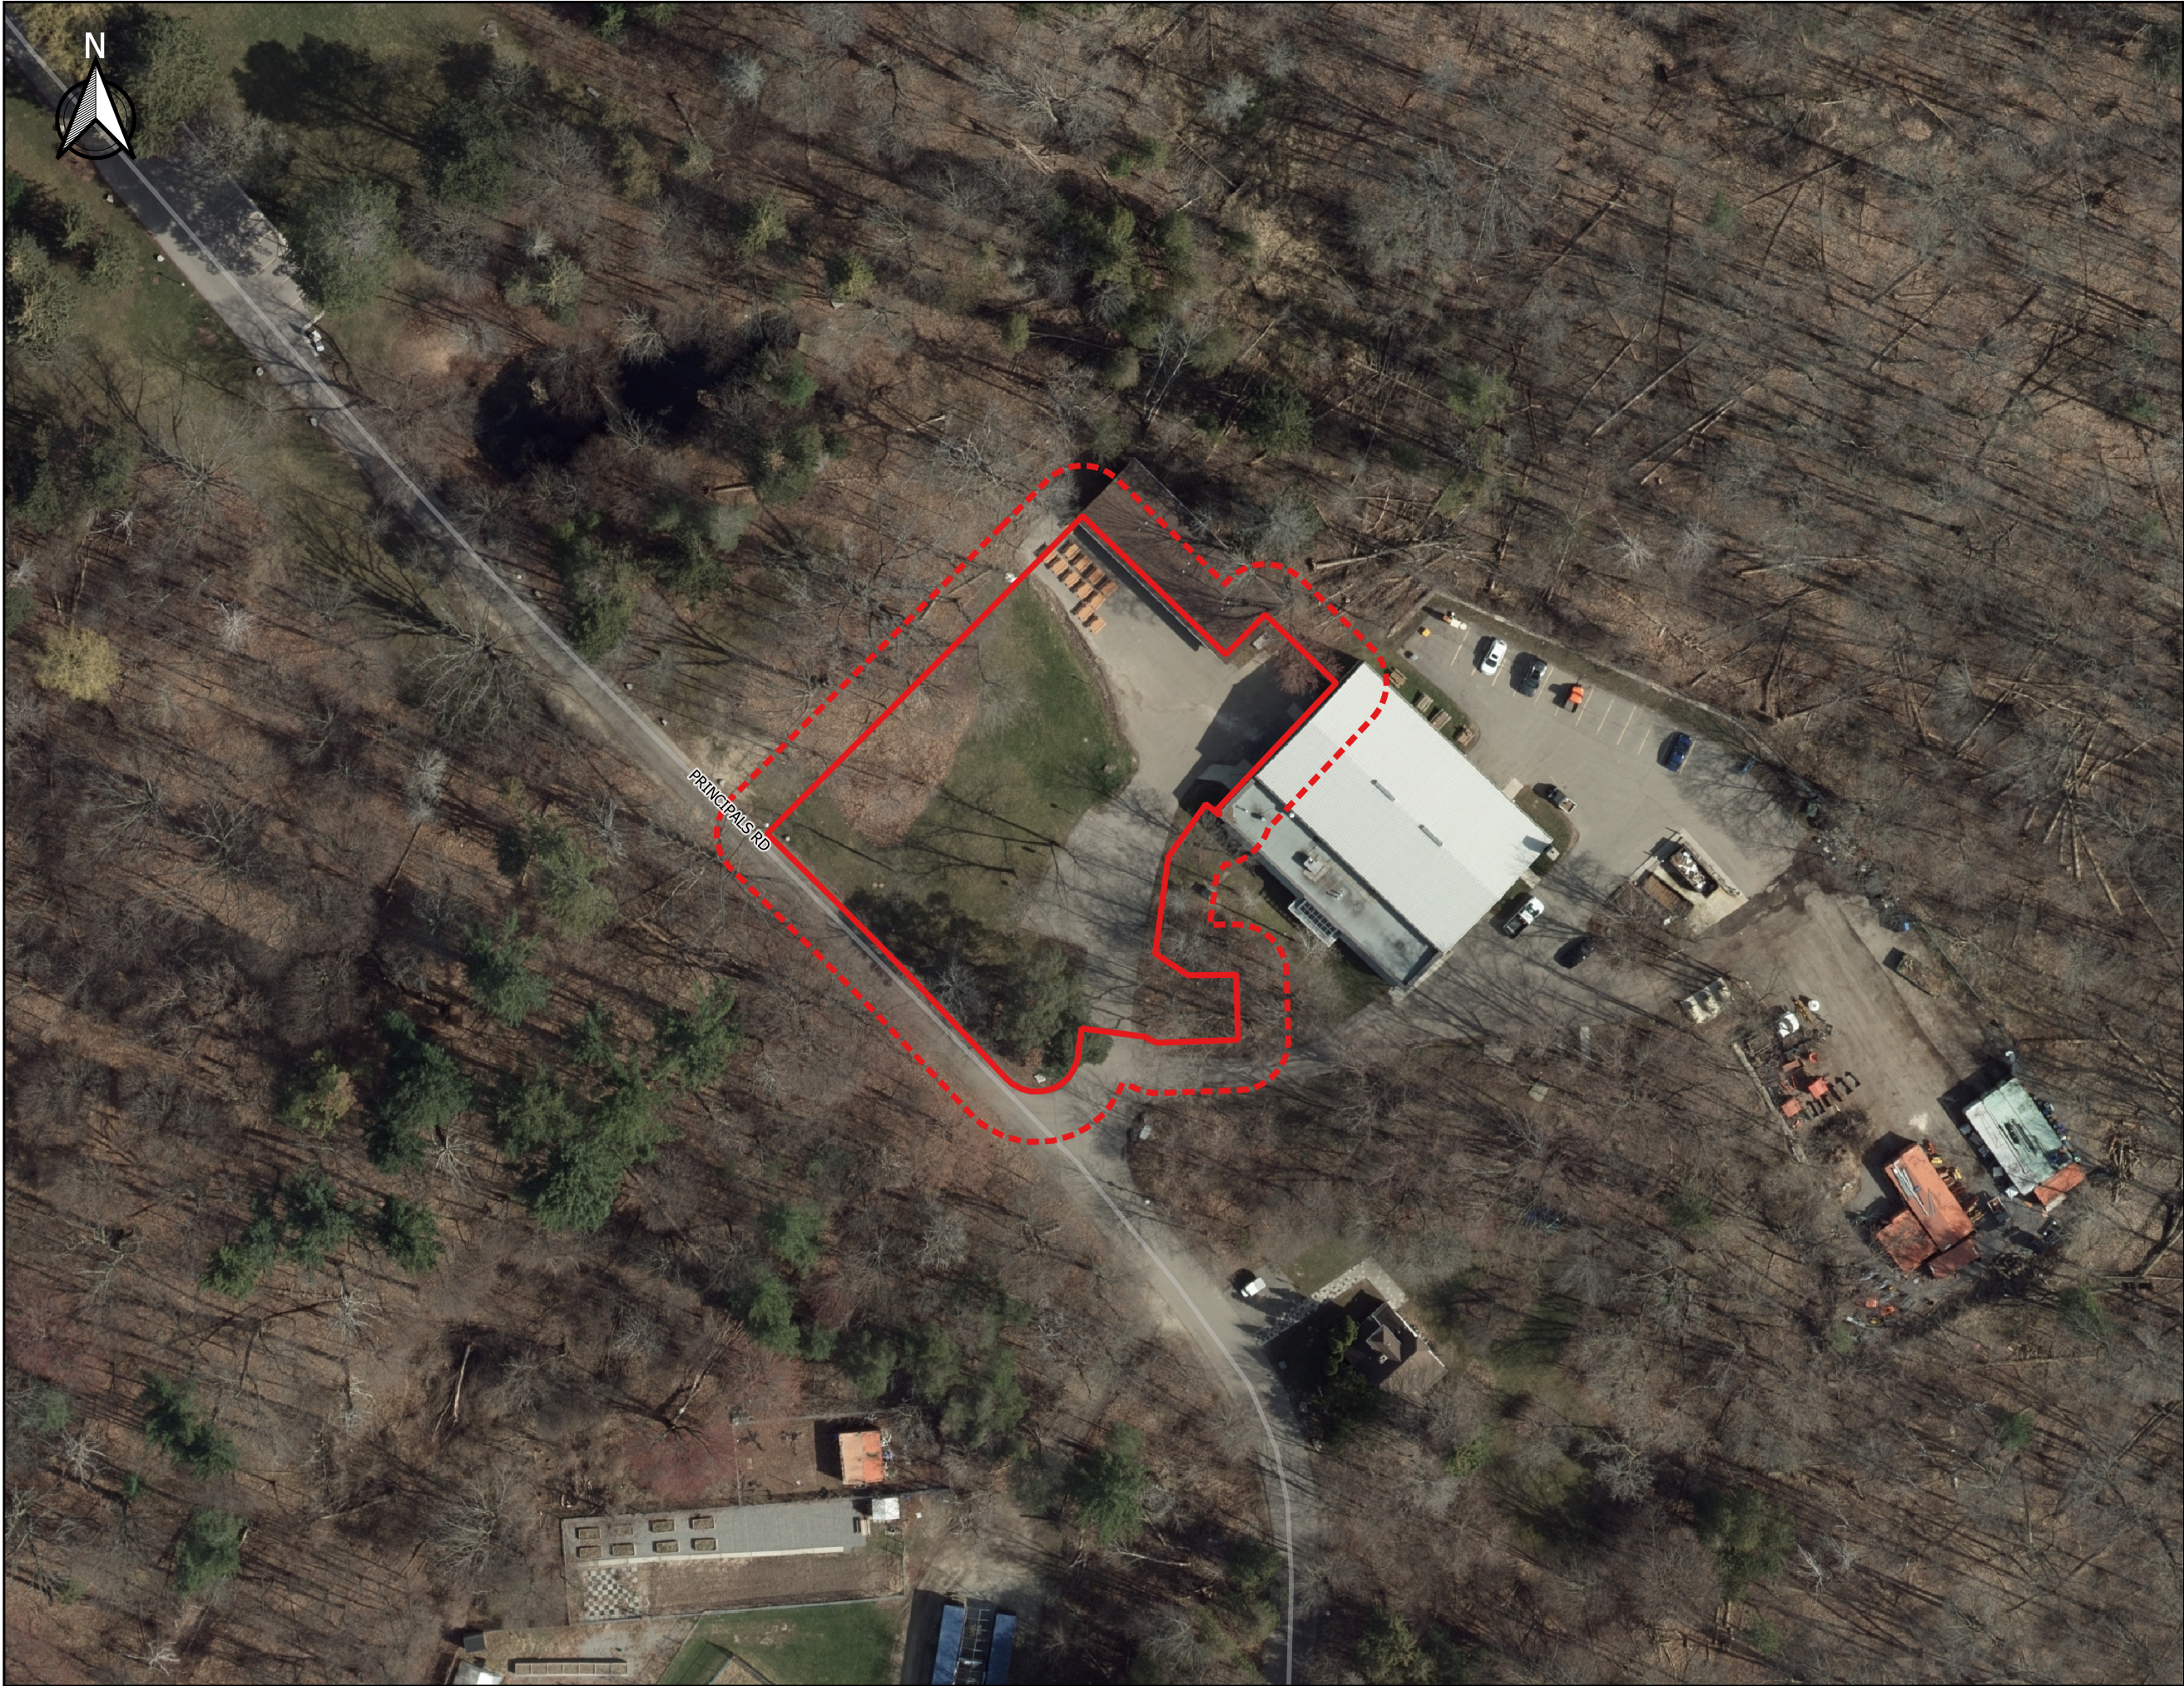
Figure 2: Tree Inventory and Preservation Plan

The tree inventory included 45 trees, comprising both urban landscape and naturally occurring individuals (Figure 2). All of the inventoried trees fall within the property limits of the University of Toronto Mississauga. Of the 18 species of trees inventoried, Norway maple (*Acer platanoides*) was the most common. More than 80% of the inventoried trees exhibited an overall fair to good health condition. More than half of the inventoried trees (~55%) were non-native species. An image gallery has been provided for reference (Appendix A).

Three (3) trees were assessed as hazardous (i.e., Tree ID 48, 216 and 265). All identified hazard trees are recommended for removal, except Tree ID 48, which is to be prune and retained.

To minimize compaction impacts from the weight of construction machinery to the root system of Tree ID 212, 213, 226 and 228, it is recommended that a layer of mulch with a depth of approximately 10-15 cm be applied at the base of said trees and covered in plywood (Figure 2). Mulch should be certified pest-free, dye-free and made of native species. Mulch should be removed immediately following completion of all site works.

Solid tree preservation hoarding is recommended to protect trees selected for preservation. The location of tree preservation hoarding has been depicted (Figure 2). We recommend the location of hoarding be staked by an Ontario Land Surveyor prior to its erection. The tree preservation hoarding should be erected prior to the onset of siteworks and must remain in place for the duration of all construction activity. There should be no disturbance (e.g., digging, trenching, compaction, changes in grade or other soil disturbance) beyond the limits of tree preservation hoarding. Fill should never be placed beyond the limits of the tree preservation hoarding. Tree preservation hoarding should be monitored throughout the undertaking of the proposed works.

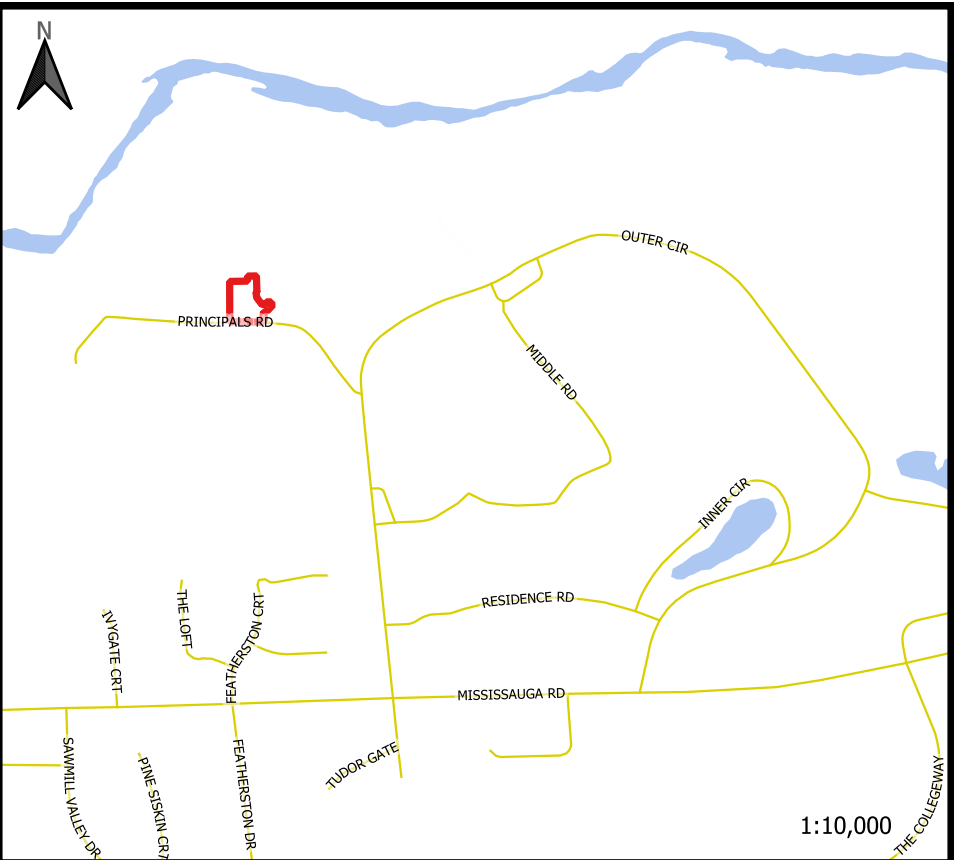
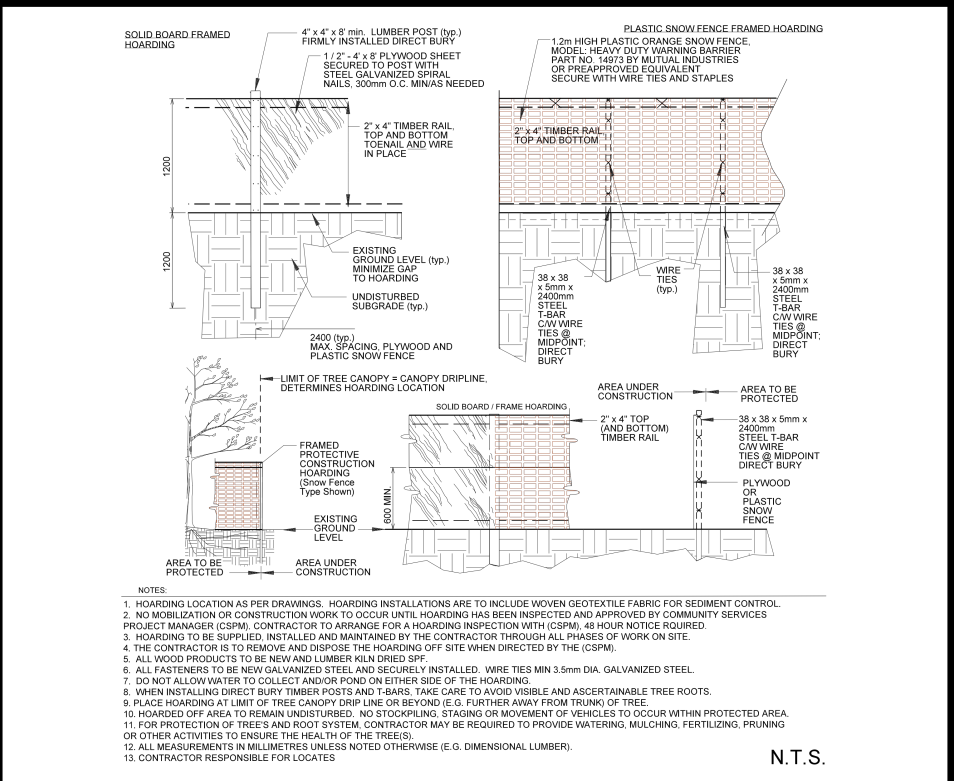
Title:
**Figure 2: Tree Inventory and Preservation Plan
Part 2 of 2**

239	1638	<i>Acer platanoides</i>	Norway Maple	13	1.56	4	Good	-Slight lean		Remove
240	728	<i>Prunus serotina</i>	Black Cherry	19	2.28	3	Fair	-Thin crown		Remove
241	729	<i>Fraxinus americana</i>	White Ash	26		0	Dead	-EAB infected		Preserve
242	750	<i>Scandosorbus intermedia</i>	Swedish Whitebeam	26	3.12	4	Fair	-Large cracks on main stem -Damage at root flare		Injure
245	752	<i>Celtis occidentalis</i>	Common Hackberry	25,26	2.16	6	Good			Preserve
248	749	<i>Juglans x bixbyi</i>	Walnut Hybrid	36	4.32	9	Fair	-Some cankers -Slight lean		Preserve
250	730	<i>Acer platanoides</i>	Norway Maple	14	1.68	5	Good			Preserve
263	731	<i>Acer negundo</i>	Manitoba Maple	38	4.56	7	Fair	-Significant Lean		Remove
264	732	<i>Acer rubrum</i>	Red Maple	39	4.68	6	Fair	-Large hollow at root flare -Included bark		Injure
265	733	<i>Acer saccharinum</i>	Silver Maple	39	4.68	4	Poor	-Large dead limb over road -Dieback -Epicormic shoots	Yes	Remove Hazard Tree

272	739	<i>Acer platanoides</i>	Norway Maple	26	3.12	7	Good	-slight lean		Preserve
274	742	<i>Acer platanoides</i>	Norway Maple	41	4.92	5	Fair	-2 stems diverge at 0.5 m -Included bark		Injure
