DESIGNATED SUBSTANCES SURVEY

Building A-243

17 Hangar Road, Borden, Ontario

March 23, 2022

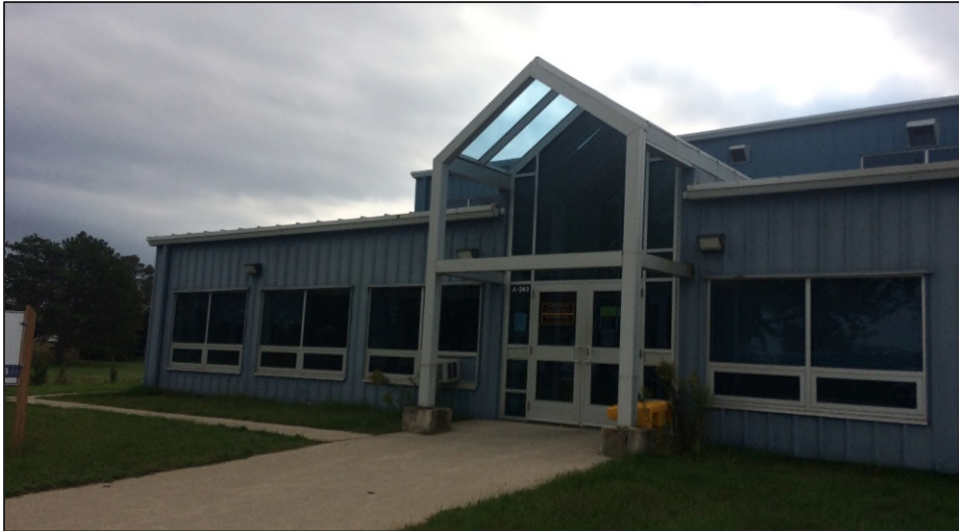
Photo: 1

General East view of Building A – 243.

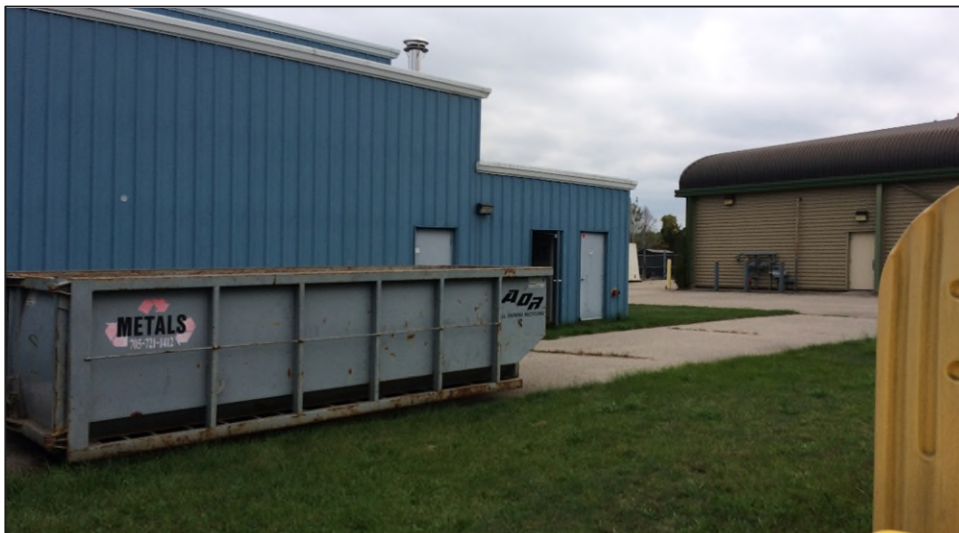
Photo: 2

General North view of Building A – 243.

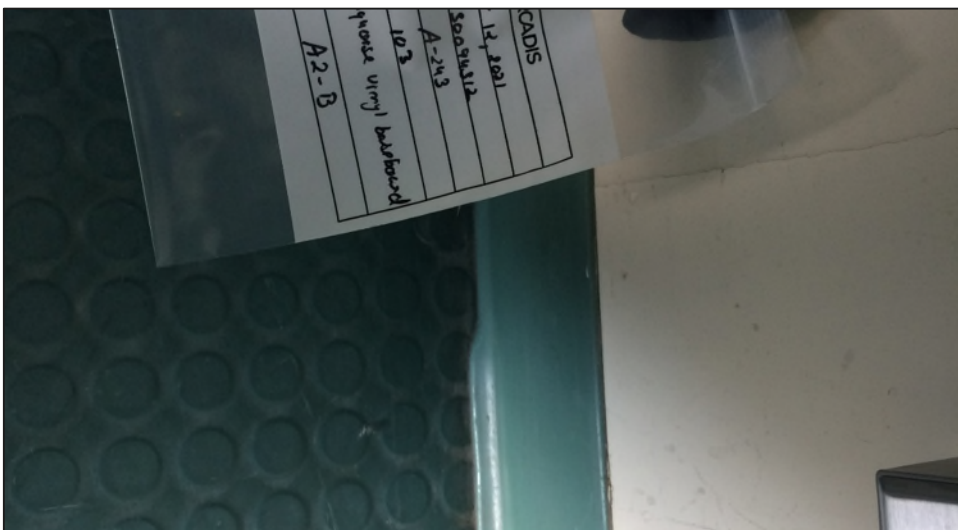
Photo: 6

| Sample No. | Sample Location | Sample Description | Asbestos Content |
|---|---|--|---|
| A2-B (Photo 6) | Room 103 | Vinyl baseboard – turquoise | None Detected |

Room 102/Sample A3-A –
Non-asbestos-containing
mastic behind baseboard –
turquoise.

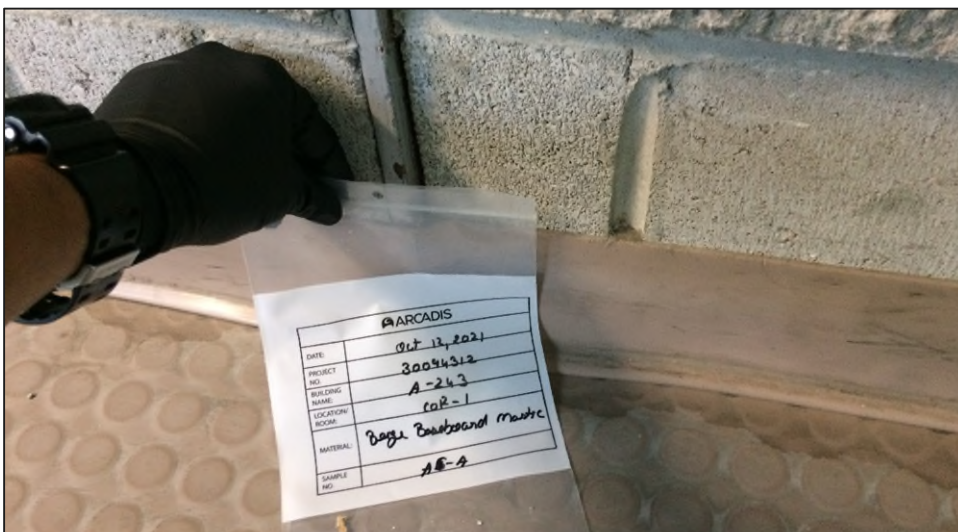
Photo: 9

| Sample No. | Sample Location | Sample Description | Asbestos Content |
|---|---|--|---|
| A6-A (Photo 9) | Corridor 1 | Beige vinyl baseboard mastic | None Detected |

Corridor-1/Sample A5-A –
Non-asbestos-containing
beige vinyl baseboard.

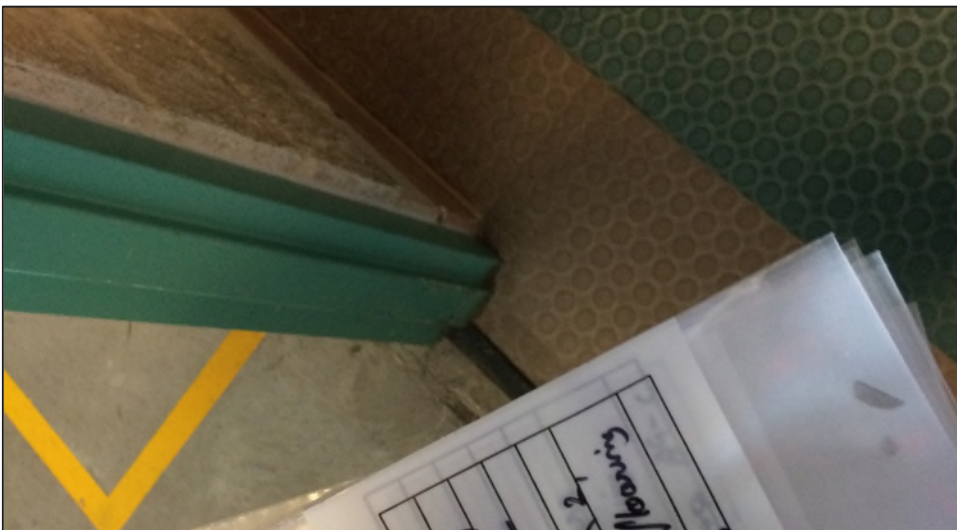
Photo: 12

| Sample No. | Sample Location | Sample Description | Asbestos Content |
|---|---|---|---|
| A9-B (Photo 12) | Corridor 2 | Vinyl sheet flooring – beige | None Detected |

Room 105/Sample A8-A –
Non-asbestos-containing
turquoise vinyl sheet flooring.

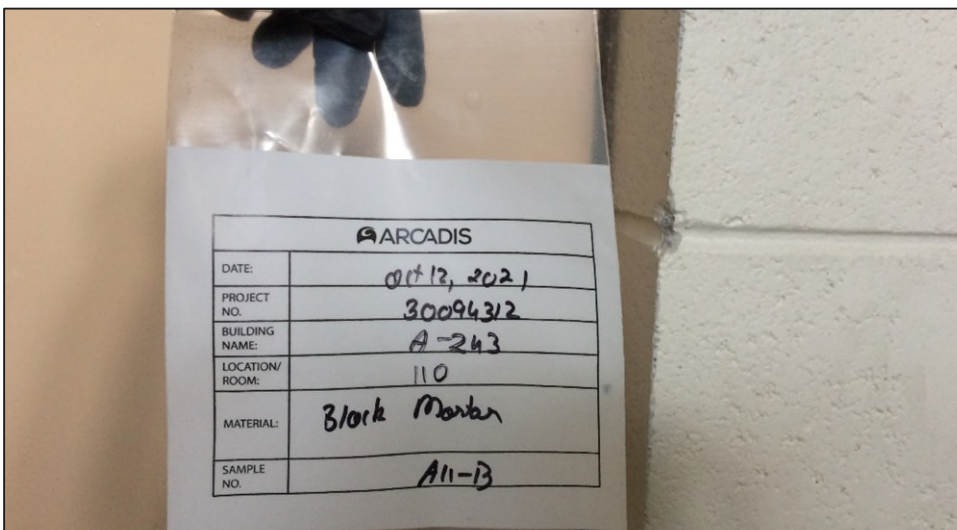
Photo: 15

| Sample No. | Sample Location | Sample Description | Asbestos Content |
|---|---|---|---|
| A11-B (Photo 15) | Room 110 | Concrete block mortar | None Detected |

Room 109/Sample P-1 –
White paint on block wall. No
parameters exceeded.

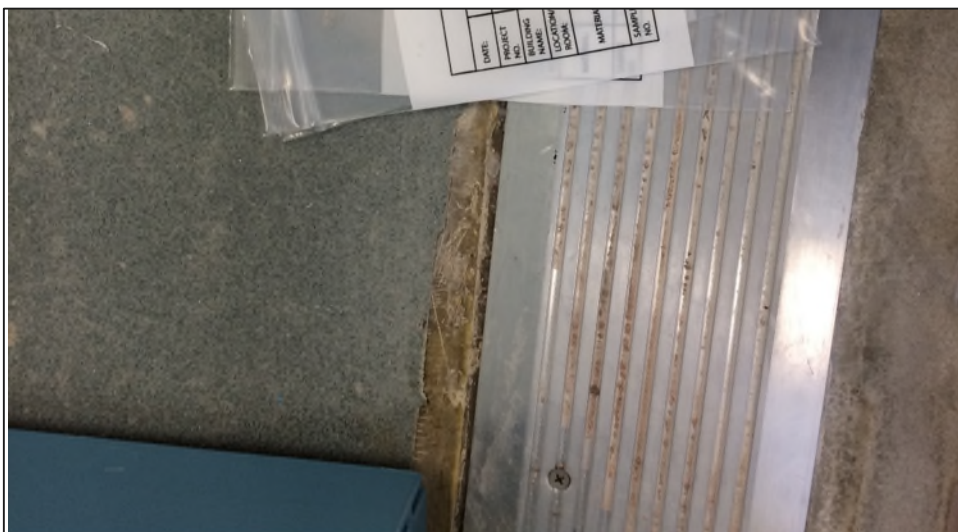
Photo: 18

| Sample No. | Sample Location | Sample Description | Asbestos Content |
|---|---|---|---|
| A13-A (Photo 18) | Room 123 | Vinyl sheet flooring – black | None Detected |

Room 123/Sample A14-A –
Non-asbestos-containing
mastic behind black vinyl
sheet flooring.

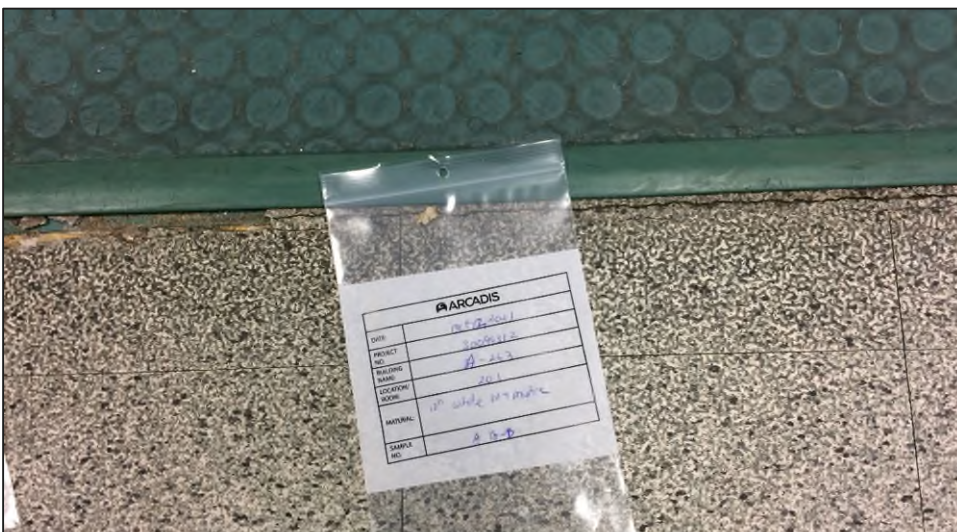
Photo: 24

| Sample No. | Sample Location | Sample Description | Asbestos Content |
|---|---|---|---|
| A18-A (Photo 24) | Room 205 | 12" white vinyl floor tile (white with black flecks) – mastic | None Detected |

Room 205/Sample A17-A – Non-asbestos containing 12" vinyl floor tile with black flecks.

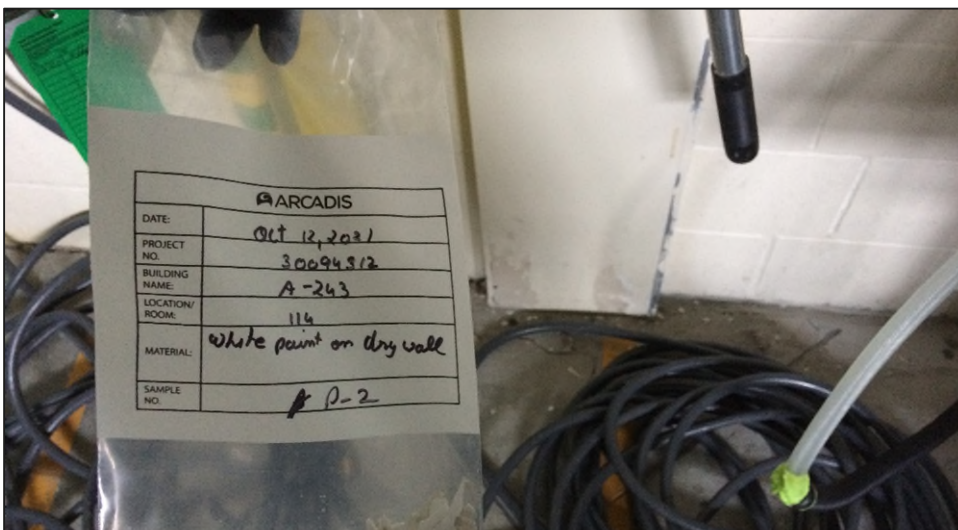
Photo: 27

| Sample ID | Sample Location | Substrate Material | Sample Description | Condition | Analytical Results (µg/g) | | | | |
|---|---|---|---|---|---|---|---|---|---|
| P-2 (Photo 27) | Room 114 | Drywall | White wall paint | Good | <1.0 | 19.9 | 7.6 | <0.050 | <2.6 |

Boiler Room/Boiler – May contain asbestos-containing material.
