## Plumbing & HVAC Assessment Waterloo City Centre

265 Lexington Court  
Waterloo, ON  
N2J 4A8

PREPARED BY:

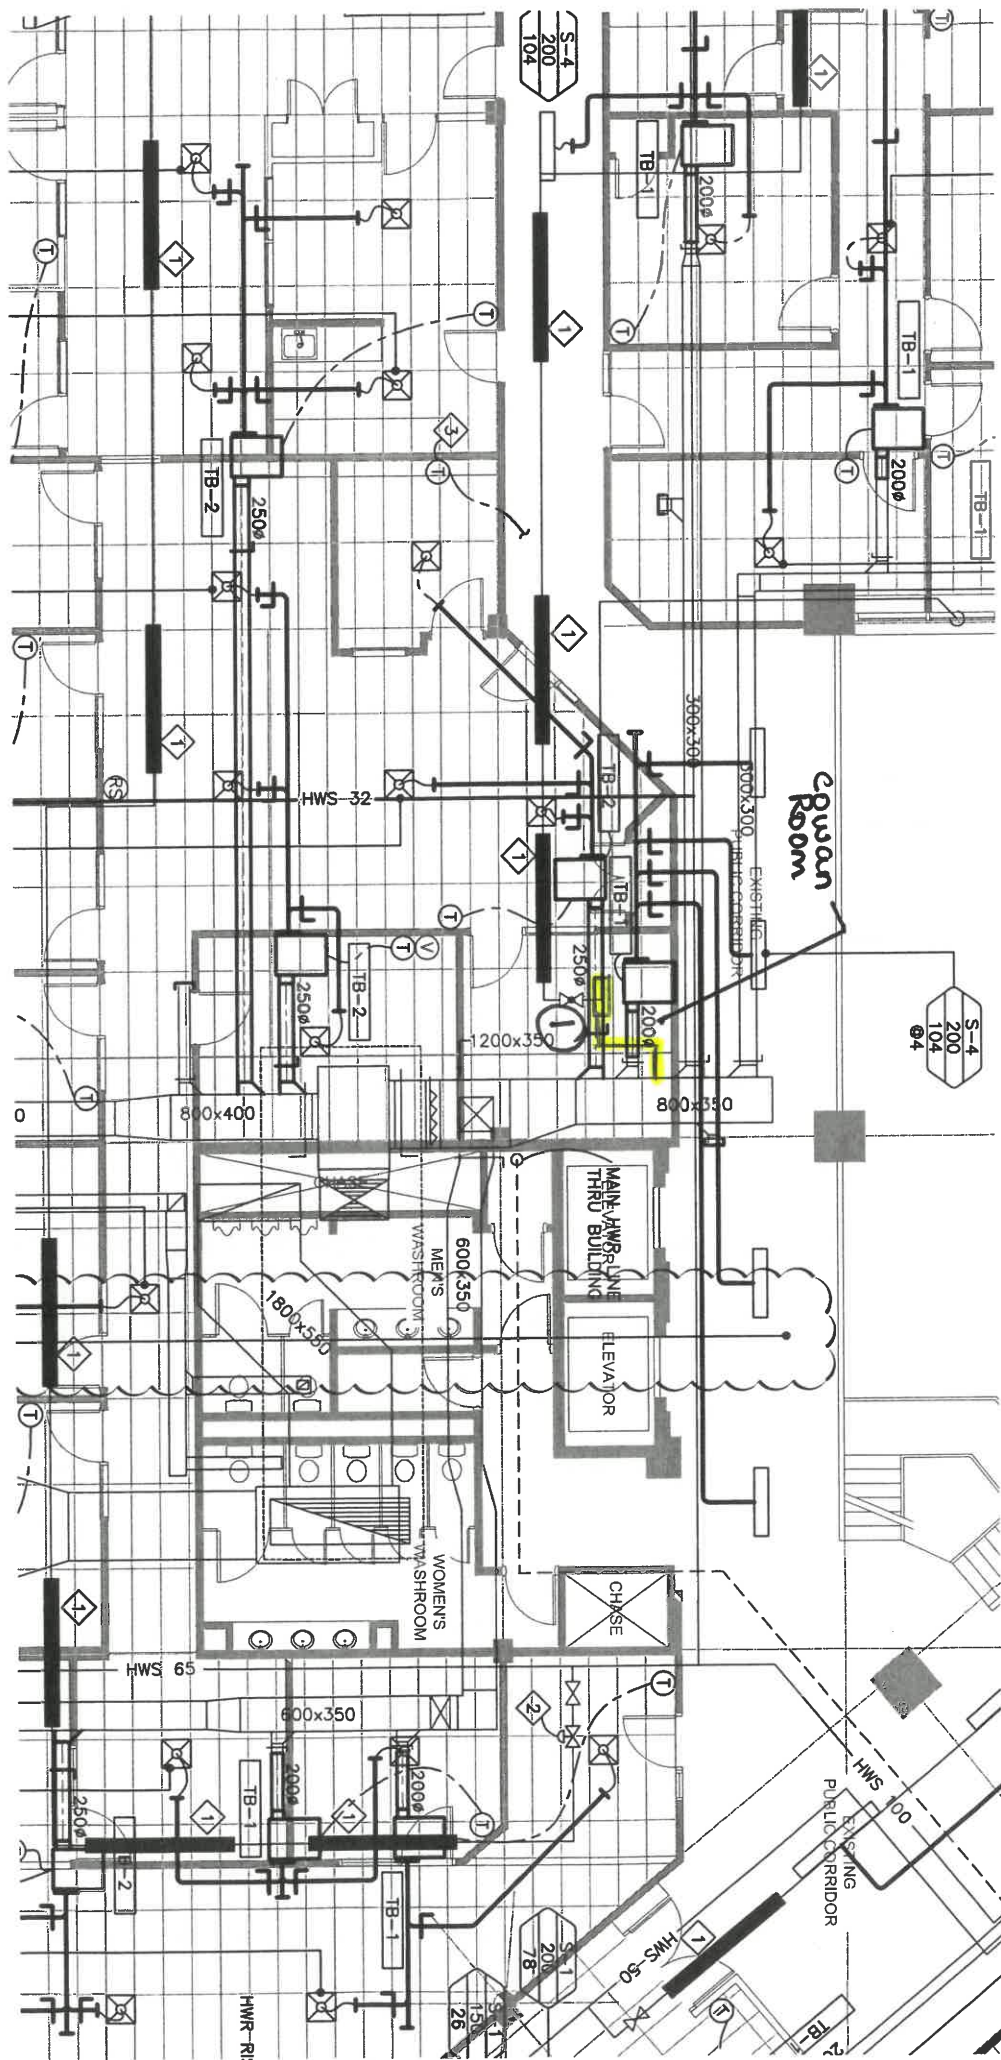
# WATERLOO CITY HALL EX. PART RTU-3 - THIRD FLOOR - HVAC LAYOUT

- VVT-1,2,3,30 ARE NOT VAV'S. THEY HAVE A HOT WIRE THAT READS VELOCITY AND IS CONVERTED TO CFM.
- MAX : 100% DAMPER POSITION / MIN : 15% DAMPER POSITION.
- VVT 30 : VVT SERVES ANOTHER AREA OTHER THAN CONNIE LOUNGE.
