## **DESIGNATED SUBSTANCES AND HAZARDOUS MATERIALS SURVEY**

**North District Patrol Yard (Building Code G013-B1)  
3525 Baseline Road  
Georgina, Ontario**

**ECO Project No.: 25991-05  
November 2, 2020**

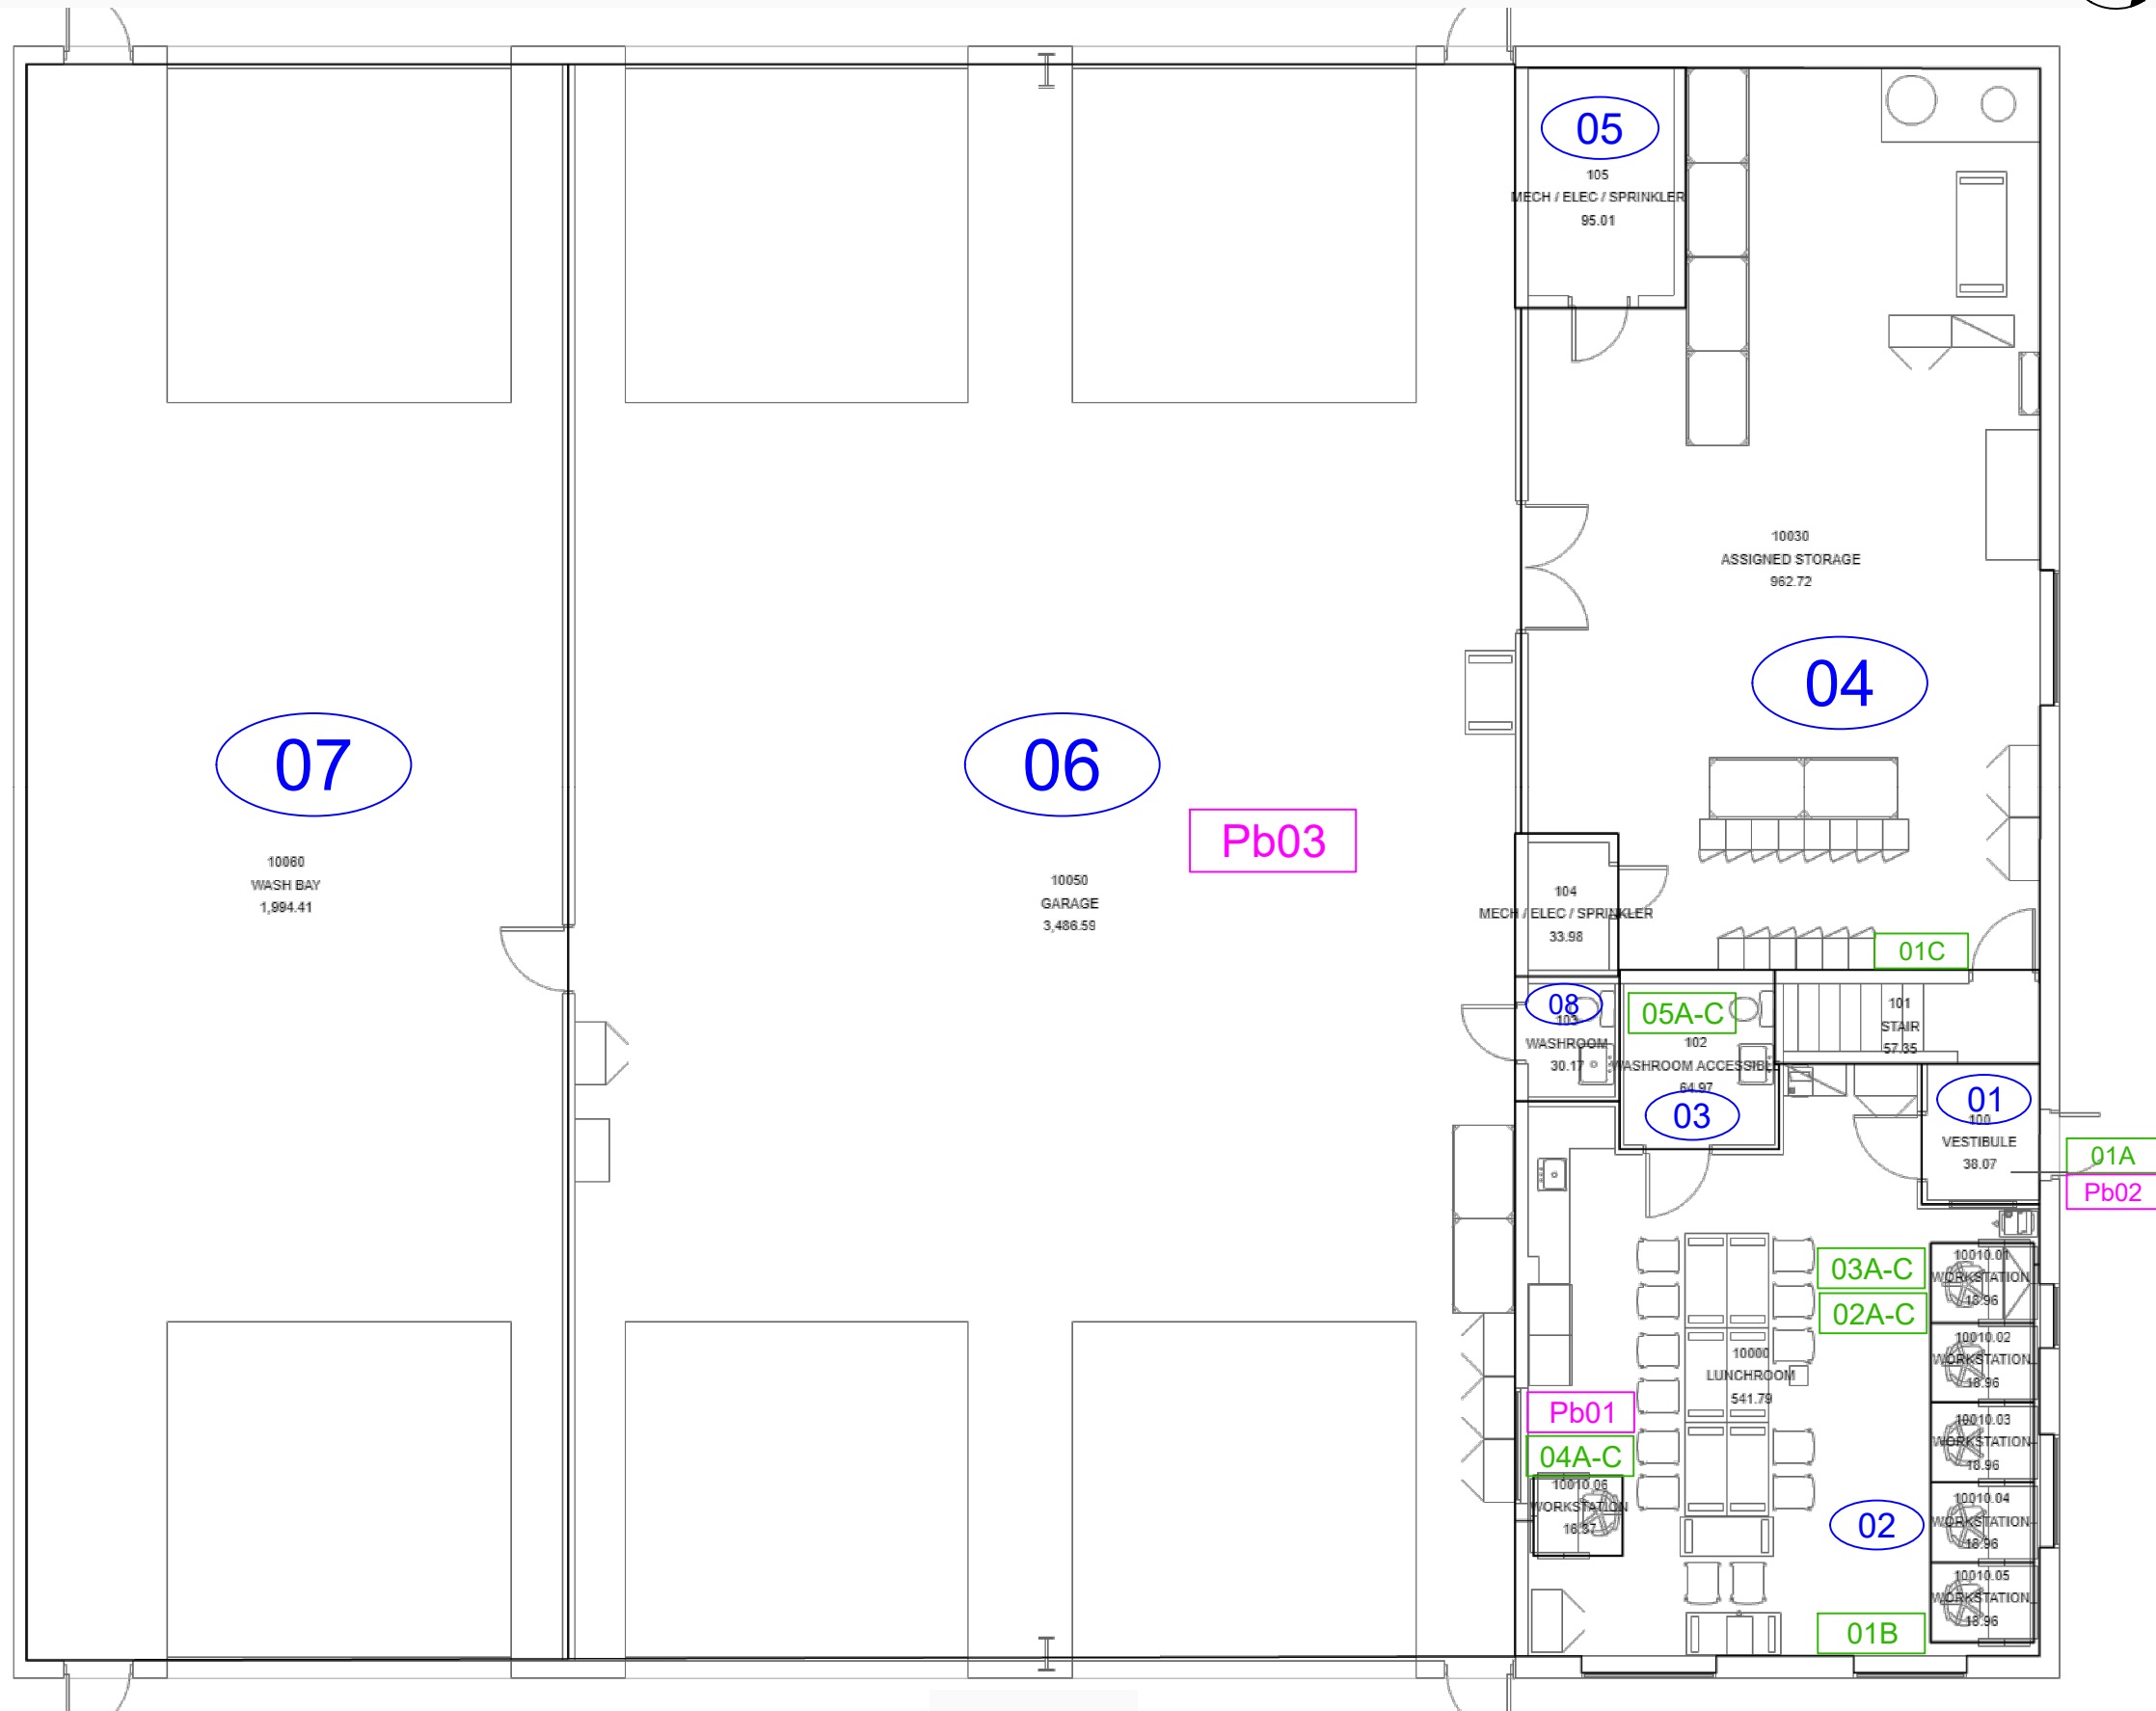
### Figure 1

- Appendix I – Survey Drawing, depicting the location of presumed and assumed asbestos-containing materials and room location numbers referenced throughout the report.
- Appendix II – Inventory of Hazardous Materials, providing a general description of the quantity or nature of the designated substance identified in each location within the facility.
- Appendix III – Observation Report, documenting instances of damaged hazardous materials and/or mould growth.
- Appendix IV – Results of Bulk Sample Analysis, providing a summary of all bulk sampled collected as well as laboratory chain of custodies and certificates of analyses.
- Appendix V – Scope of Work Methodology. General recommendations for compliance with applicable regulations have been provided in overview document titled “Designated Substances Survey Scope of Work and Methodology Report”, dated November 2019, prepared by ECOH.

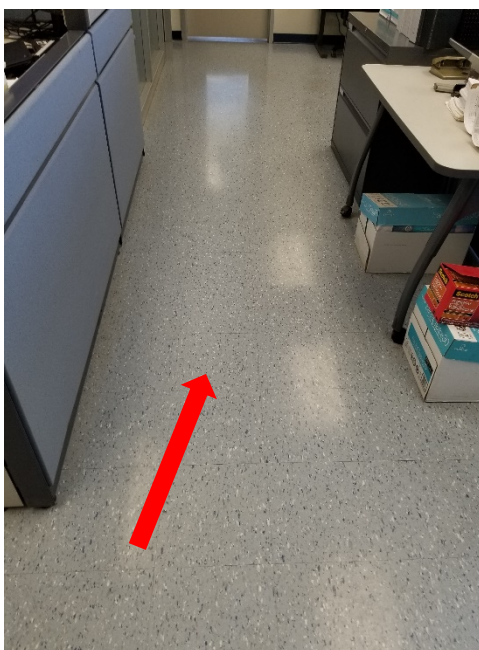
VFT3 – 12'x12" Blue  
with White Specks

This material was  
sampled, and  
results indicate non-  
asbestos.
