PROJECT: **MOUNT HOPE ELEMENTARY SCHOOL
RENOVATION & ADDITION**

BINDER: **C** ARCHITECTURAL DETAILS,
DESIGNATED SUBSTANCE REPORT &
GEOTECHNICAL REPORT

REVISED
Hazardous Building
Materials Assessment
(Pre-Construction)

Additions and Renovations
Project

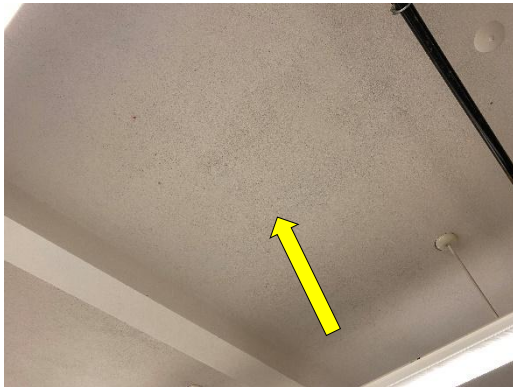
Photo 1

Texture coat, confirmed to contain asbestos, is present on ceiling finishes/structure in the Special Education Classroom 131 (samples S0034A-E, location 8751, photo 1). Overspray from the asbestos-containing texture coat is present above the ceiling at light fixture openings, on the deck, ducts, and within junction boxes.

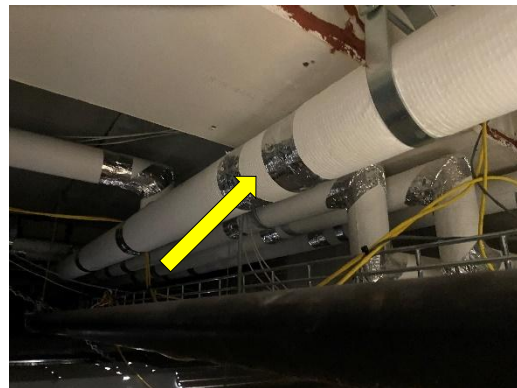
Photo 2

Remaining pipes in the assessed area are either uninsulated or insulated with non-asbestos fiberglass or other non-asbestos insulation such as mineral fibre or elastomeric foam insulation (photos 2 and 3).

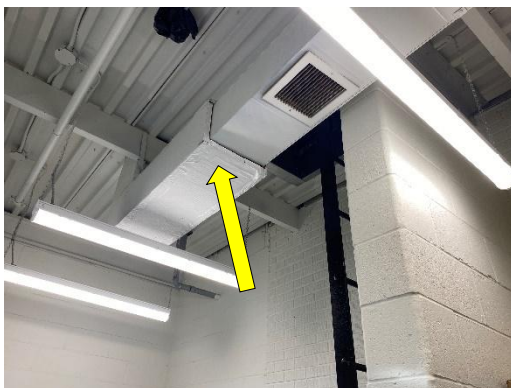
Photo 1

Ducts are either uninsulated or insulated with non-asbestos fibreglass (foil-faced or canvas jacketing, photo 1).

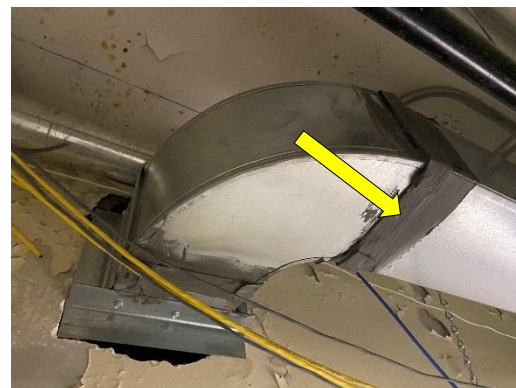
Photo 2

Grey duct mastic present at seams / joints on the exterior of ducts throughout the assessed area does not contain asbestos (samples S0025A-C, photo 2).

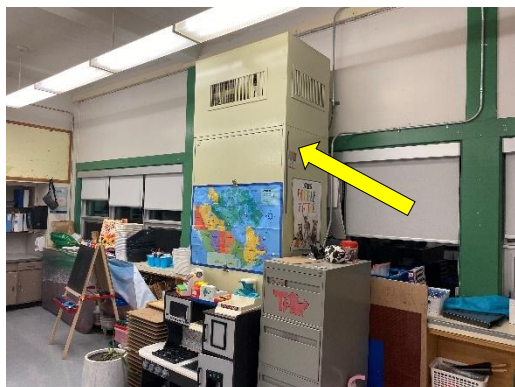
Photo 1

Mechanical equipment (e.g., furnace, hot water tanks, boilers) is either uninsulated or insulated with non-asbestos fibreglass (photo 1).

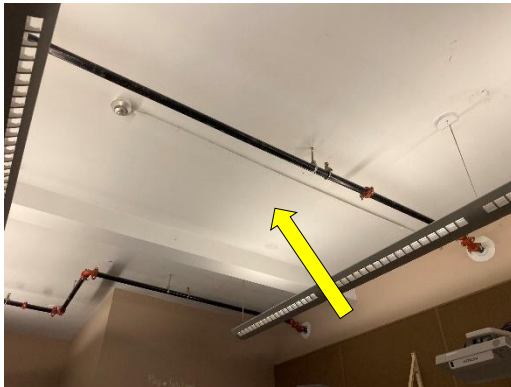
Photo 1

Plaster present on walls and ceilings throughout the assessed area does not contain asbestos (samples S0026A-E, photo 1).

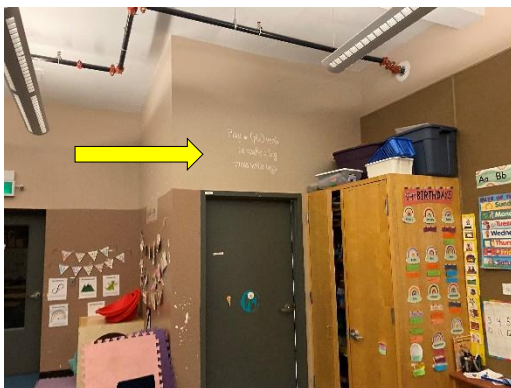
Photo 1

Drywall joint compound present on bulkhead and wall finishes throughout the assessed area does not contain asbestos (samples S0030A-C and S0035A-C, photo 1).

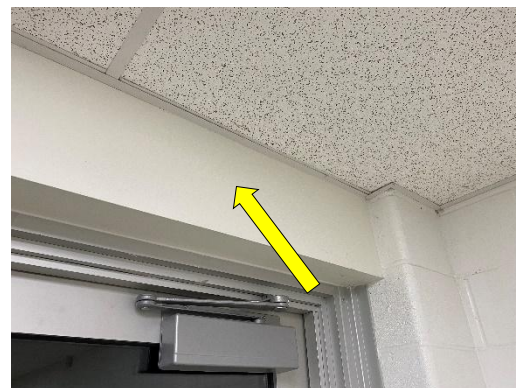
Photo 2

Asbestos in drywall joint compound was banned in Canada in 1980. Drywall joint compound in the 2016 era of construction was installed on or after 2016 and is presumed to contain no asbestos (photo 2).

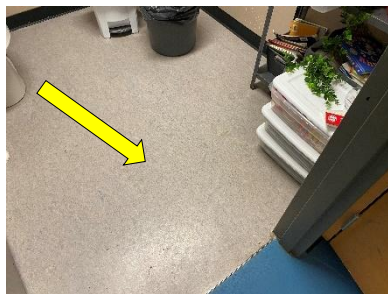
Description	Sample Location (Loc #)	Sample Number	Asbestos (Backing / Adhesive)	Photo
Light brown and blue pattern	Coat Room 126B (Location 8754) Washroom 126A (Location 8755)	S0031A-C	No / No

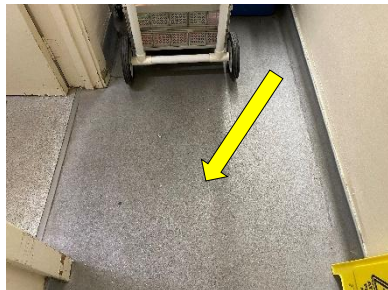
Grey with black dots	Resource Room 132 (Location 8749)	S0033A-C	No / No

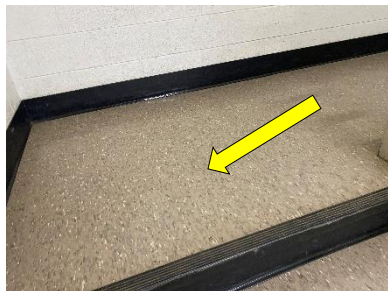
Description	Sample Location (Location #)	Sample Number	Asbestos (Tile / Adhesive)	Photo
12" x 12", light brown with white and dark brown flecks	Stairwell E1 (Location 8732) Stairwell E2 (Location 8777)	S0006A-C	No / No

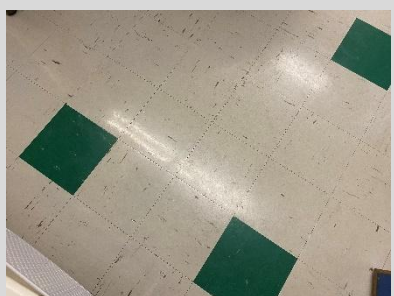
Description	Sample Location (Location #)	Sample Number	Asbestos (Tile / Adhesive)	Photo
9" x 9", beige with streaks and green	Library 210A (Location 8770)	S0018A-C	Yes / Yes

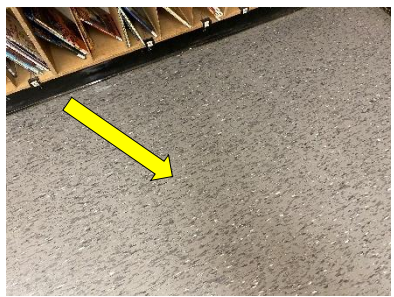
12" x 12", grey with dark grey and white flecks	Library 210 (Location 8770)	S0020A-C	No / No

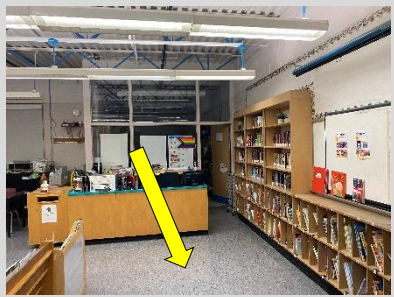
Beige tiles (concealed below non-asbestos floor tiles)	Library 210 (Location 8770)	S0021A-C	Yes / No

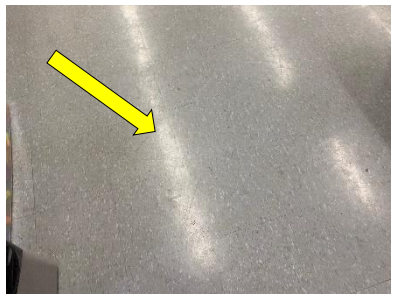
12" x 12", light blue with flecks	Special Education Classroom 131 (Location 8751)	S0028A-C	No / No

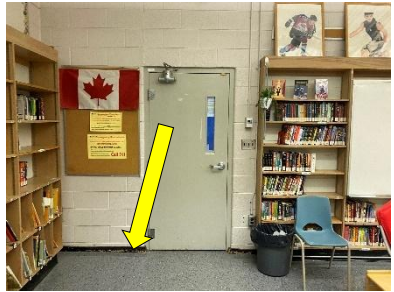
Description	Sample Location (Location #)	Sample Number	Asbestos (Tile / Adhesive)	Photo
Adhesive on black rubber baseboards	Not sampled	N/A	None*

*Baseboard mastic was presumed to be non-asbestos based on the material's application to newer rubber-type baseboards.

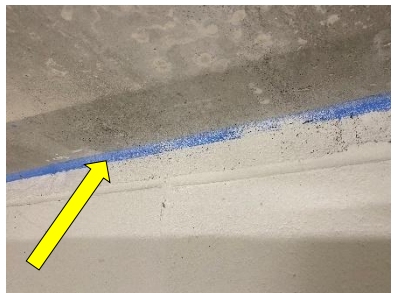
Colour, Type	Sample Location	Sample Number	Asbestos	Photo
Blue, mastic	Receiving Area 142 (Location 1010)	S0003A-C	No

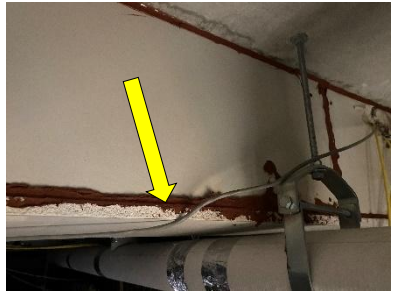
Red, mastic	Corridor 106 (Location 8741)	S0004A-C	No

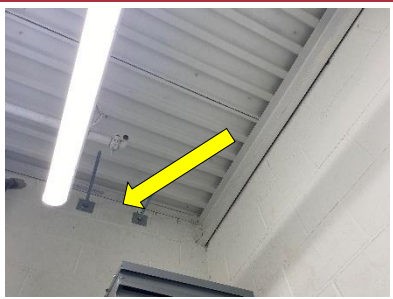
Colour, Type	Sample Location	Sample Number	Asbestos	Photo
Grey, mastic	Custodial Area 211 (Location 1003)	S0010A-C	No

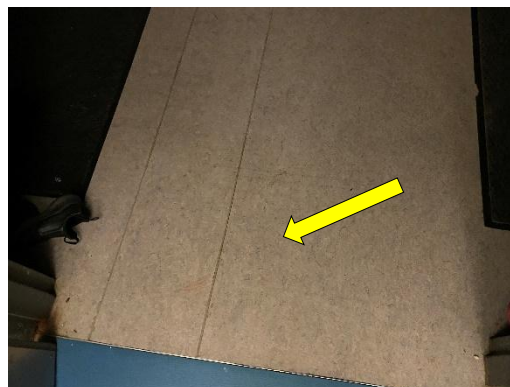
Photo 2

The levelling compound associated with the non-asbestos light brown and blue pattern vinyl sheet flooring does not contain asbestos (samples S0031A-C; layer 2, photo 2).

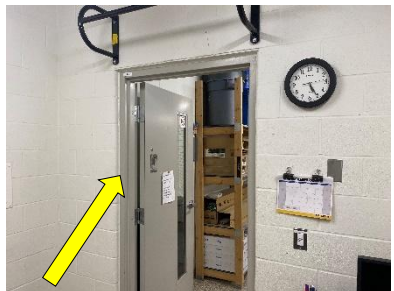
Material, Description and Application	Sample Location (Location #)	Sample Number	Asbestos	Photo
Caulking, white on interior door frames	Receiving Area 142 (Location 1010) Classroom 143 (Location 1013) Corridor 201 (Location 8778)	S0001A-C	No

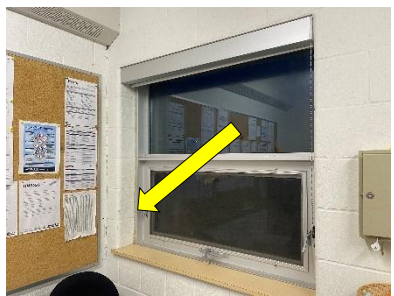
Caulking, off-white/grey on interior windows	Receiving Area 142 (Location 1010) Classroom 143 (Location 1013) Corridor 201 (Location 8778)	S0002A-C	No

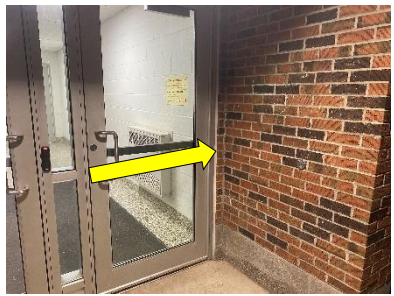
Caulking, grey on exterior door frames and windows	Exterior (Location 1002)	S0007A-C	No

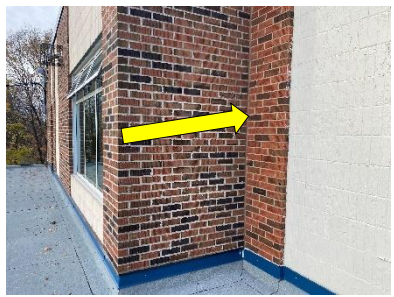
Caulking, brown on expansions joints	Roof (Location 1000)	S0013A-C	No

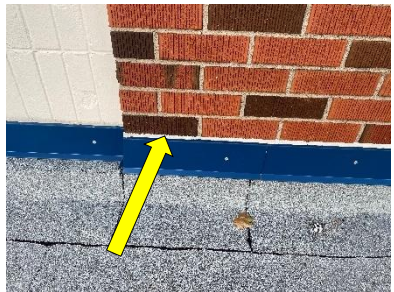
Material, Description and Application	Sample Location (Location #)	Sample Number	Asbestos	Photo
Caulking, white/light grey on metal roof flashing	Roof (Location 1000)	S0014A-C	No

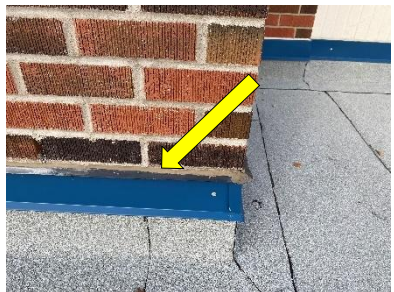
Caulking, dark grey/blue on metal roof flashing	Roof (Location 1000) Canopy (Location 1001)	S0015A-C	No

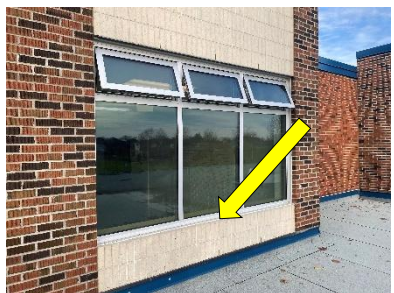
Caulking, light grey on exterior door frame and window	Roof (Location 1000)	S0016A-C	No

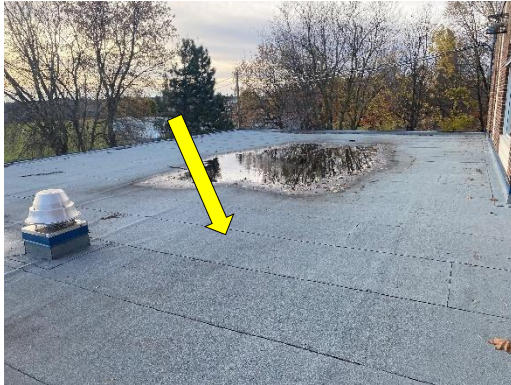
Photo 1

The materials associated with the modified bitumen roofing system of the 2016 addition within the assessed area does not contain asbestos (samples S0011A-C, photo 1).

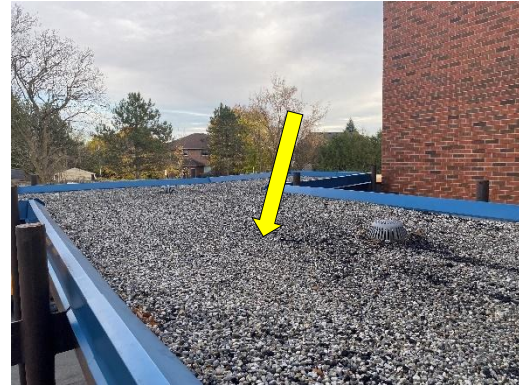
Photo 2

The materials associated with the built-up roofing system on the exterior canopy (Location 1001) does not contain asbestos (samples S0017A-C, photo 2).

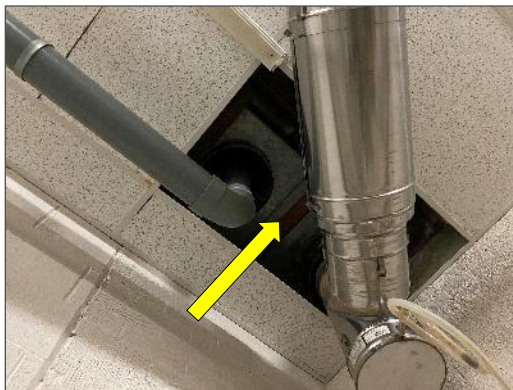
Photo 1

Textile vibration dampers, presumed to contain asbestos, are present as duct connectors in the mechanical room (photo 1).

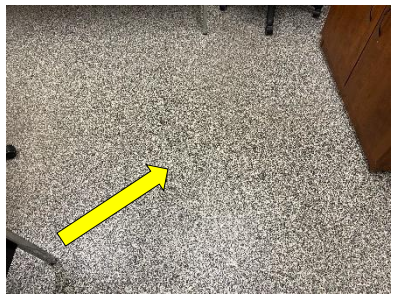
Description	Sample Location (Location #)	Sample Number	Asbestos	Photo
White/dark grey with light grey flecks epoxy flooring	Receiving Area 142 (Location 1010) Corridor 144 (Location 1012) Corridor 201 (Location 8778)	S0005A-C	No

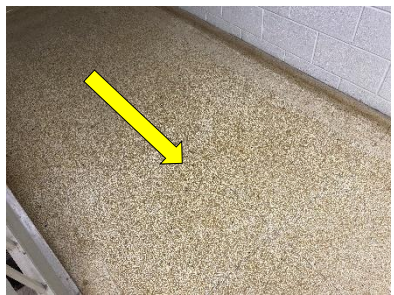
Light orange and green terrazzo flooring	Stairwell E1 (Location 8732)	S0008A-C	No

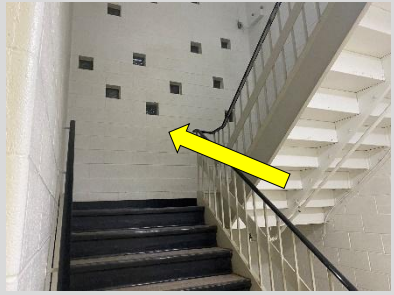
Paint/block filler on concrete block walls (1965 era)	Stairwell E1 (Location 8732) Stairwell E2 (Location 8777) Corridor 201 (Location 8778)	S0009A-C	Yes

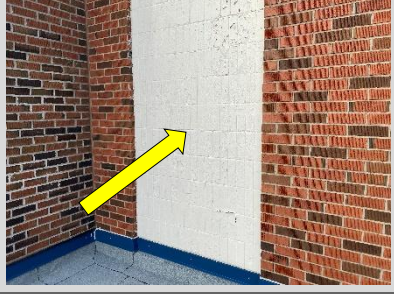
Paint/block filler on exterior masonry walls	Roof (Location 1000) Exterior (Location 1002)	S0012A-C	Yes

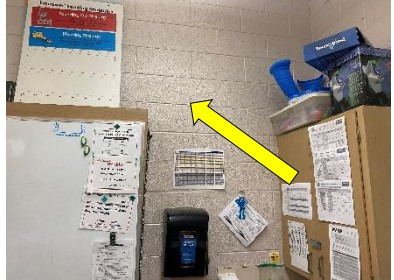
Smooth and textured paint on concrete block walls (1952 era)	Various locations	S0019A-C and S0027A-E	No

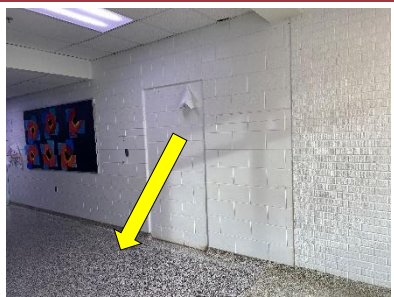
Description	Sample Location (Location #)	Sample Number	Asbestos	Photo
White and black terrazzo flooring	Corridor 201 (Location 8778)	S0022A-C	No

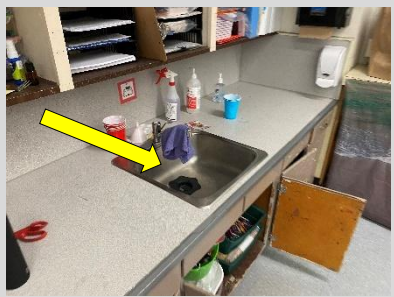
Grey/gold sink mastic	Special Education Classroom 131 (Location 8751)	S0024A-C	Yes

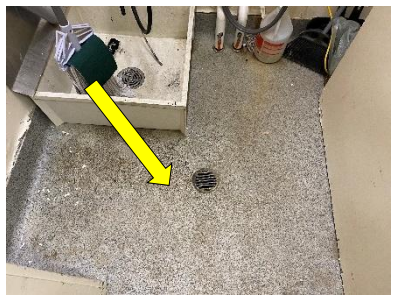
Grey with blue and black specks epoxy flooring	Resource Room 132A (Location 8749)	S0029A-C	No

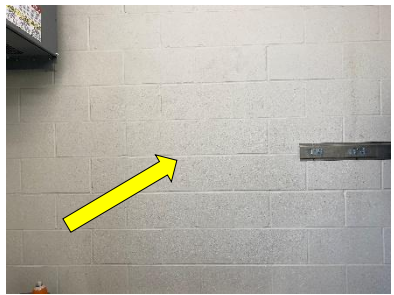
Paint on concrete block walls (2016 era)	Not sampled	N/A	None*

*These materials were determined to be non-asbestos based on the manufacture date and known end of use of asbestos in these products.

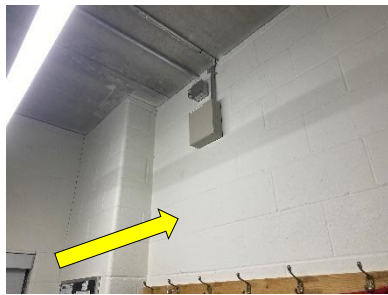
Sample Number	Colour, Substrate Description	Sample Location	Lead (%)	Photo
L0001	White on concrete block walls (2016 era)	Receiving Area 142 (Location 1010)	0.00038

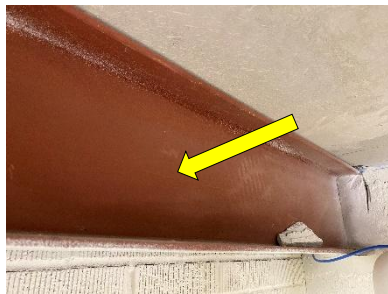
L0002	Red primer on structural steel	Receiving Area 142 (Location 1010)	<0.0014

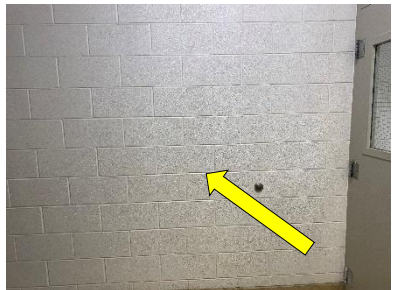
Sample Number	Colour, Substrate Description	Sample Location	Lead (%)	Photo
L0003	White on concrete block walls	Stairwell E2 (Location 8777)	0.024

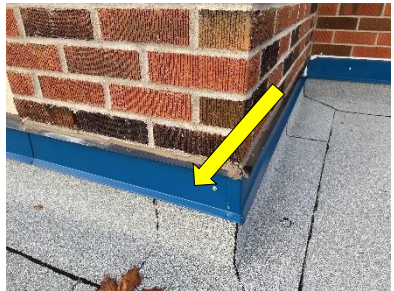
L0004	Blue on metal roof flashing	Roof (Location 1000)	<0.0020

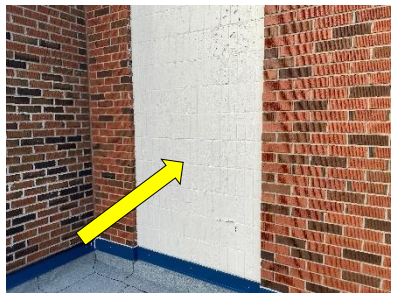
L0005	Off-white on exterior masonry walls	Roof (Location 1000)	0.00083

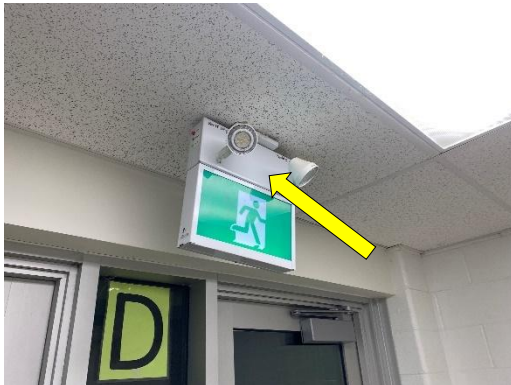
Photo 1

Lead-containing batteries are present in emergency lighting (photo 1).
