ASBESTOS SURVEY 2023 ANNUAL UPDATE REPORT

Queensway Health Centre
150 Sherway Drive
Toronto, Ontario
M9C 1A5

March 2023

OHE Project No.: 28418

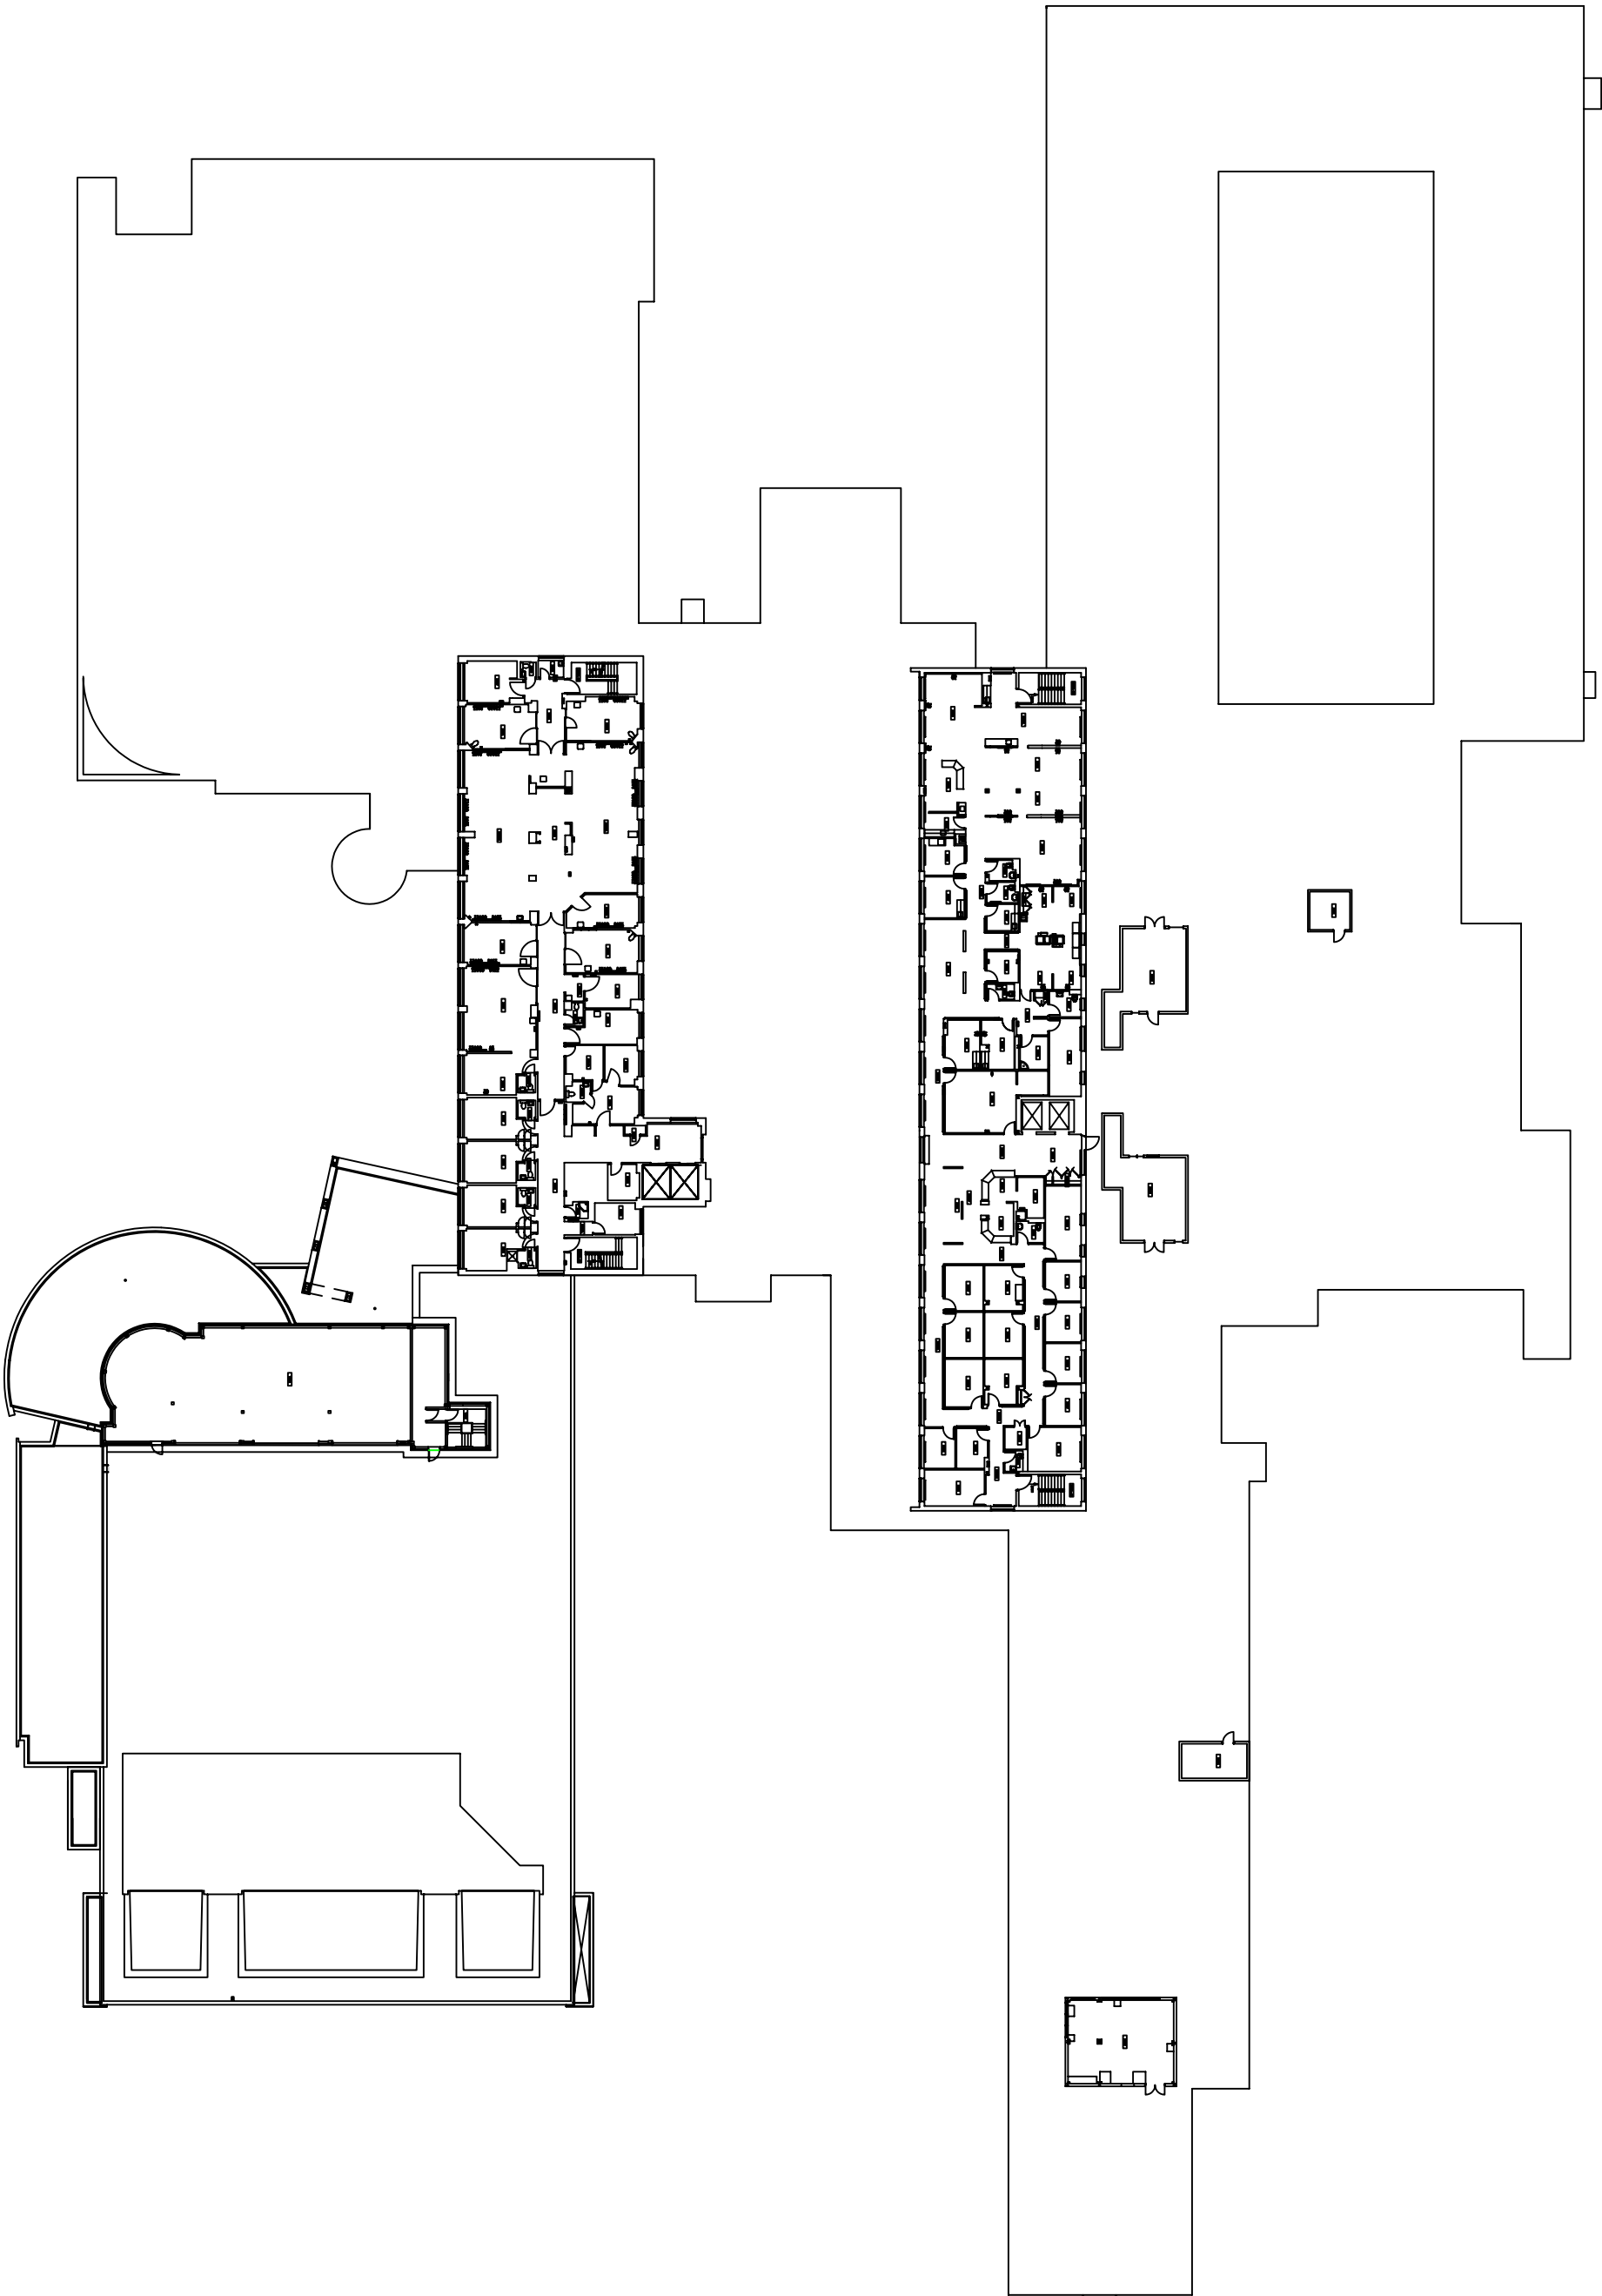
Drawn By			
Project N°		FB	
Date		MA1014	N
Oct 2008		DWG N°	
Scale		NTS	4.3

NOTE:
1. All Drywall Joint Filling Compound present in all the locations shown in this drawing shall be assumed Asbestos-Containing.
