# DESIGNATED SUBSTANCES AND HAZARDOUS BUILDING MATERIALS ASSESSMENT REPORT

Accessibility Upgrades Project  
Downsview Public School  
2829 Keele Street  
North York, Ontario  
M3M 2G4

Safetech Project Number: 1-3260212

Date of Site Work: March 6, 2026  
Date of Issue: March 19, 2026

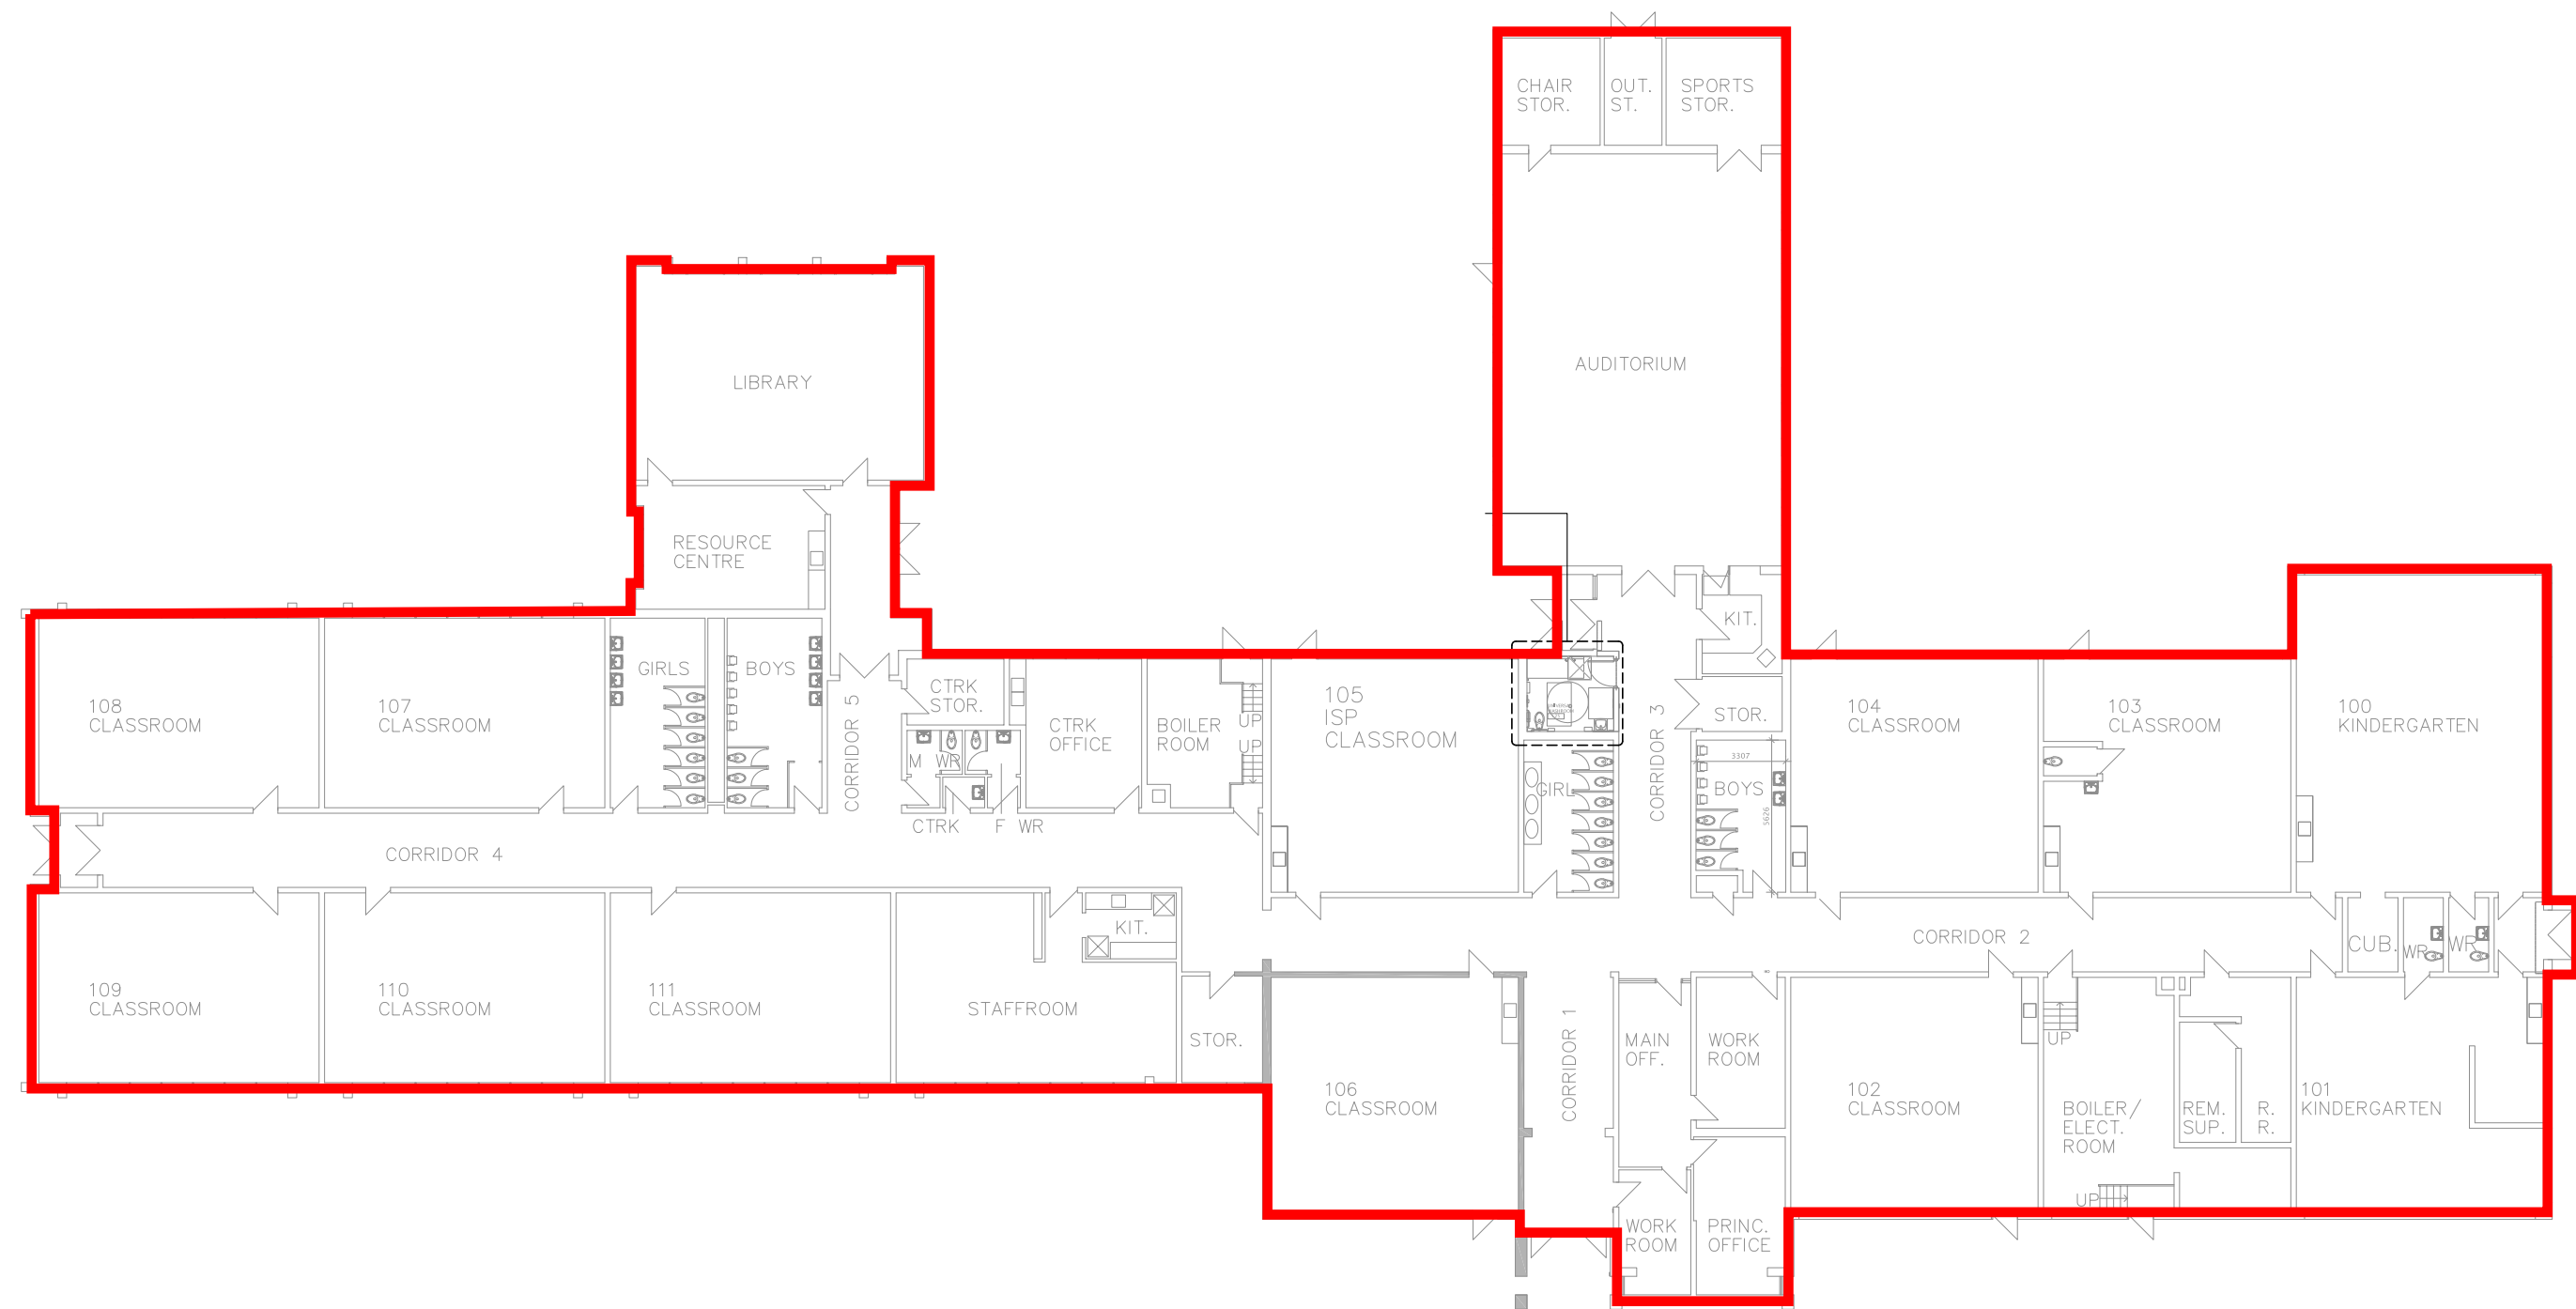
LEVEL 1

Floor	Room No.	Room Description	System	Material	Description	Classification	Friable/ Non-Friable	Condition	Est. Quantity	Unit	Access	Action
No sources of asbestos were identified in the project specific areas
