DESIGNATED SUBSTANCES AND HAZARDOUS BUILDING MATERIALS ASSESSMENT REPORT

**Accessibility Upgrades Project
Downsview Public School
2829 Keele Street
North York, Ontario
M3M 2G4**

Safetech Project Number: 1-3260212

**Date of Site Work: March 6, 2026
Date of Issue: March 19, 2026**

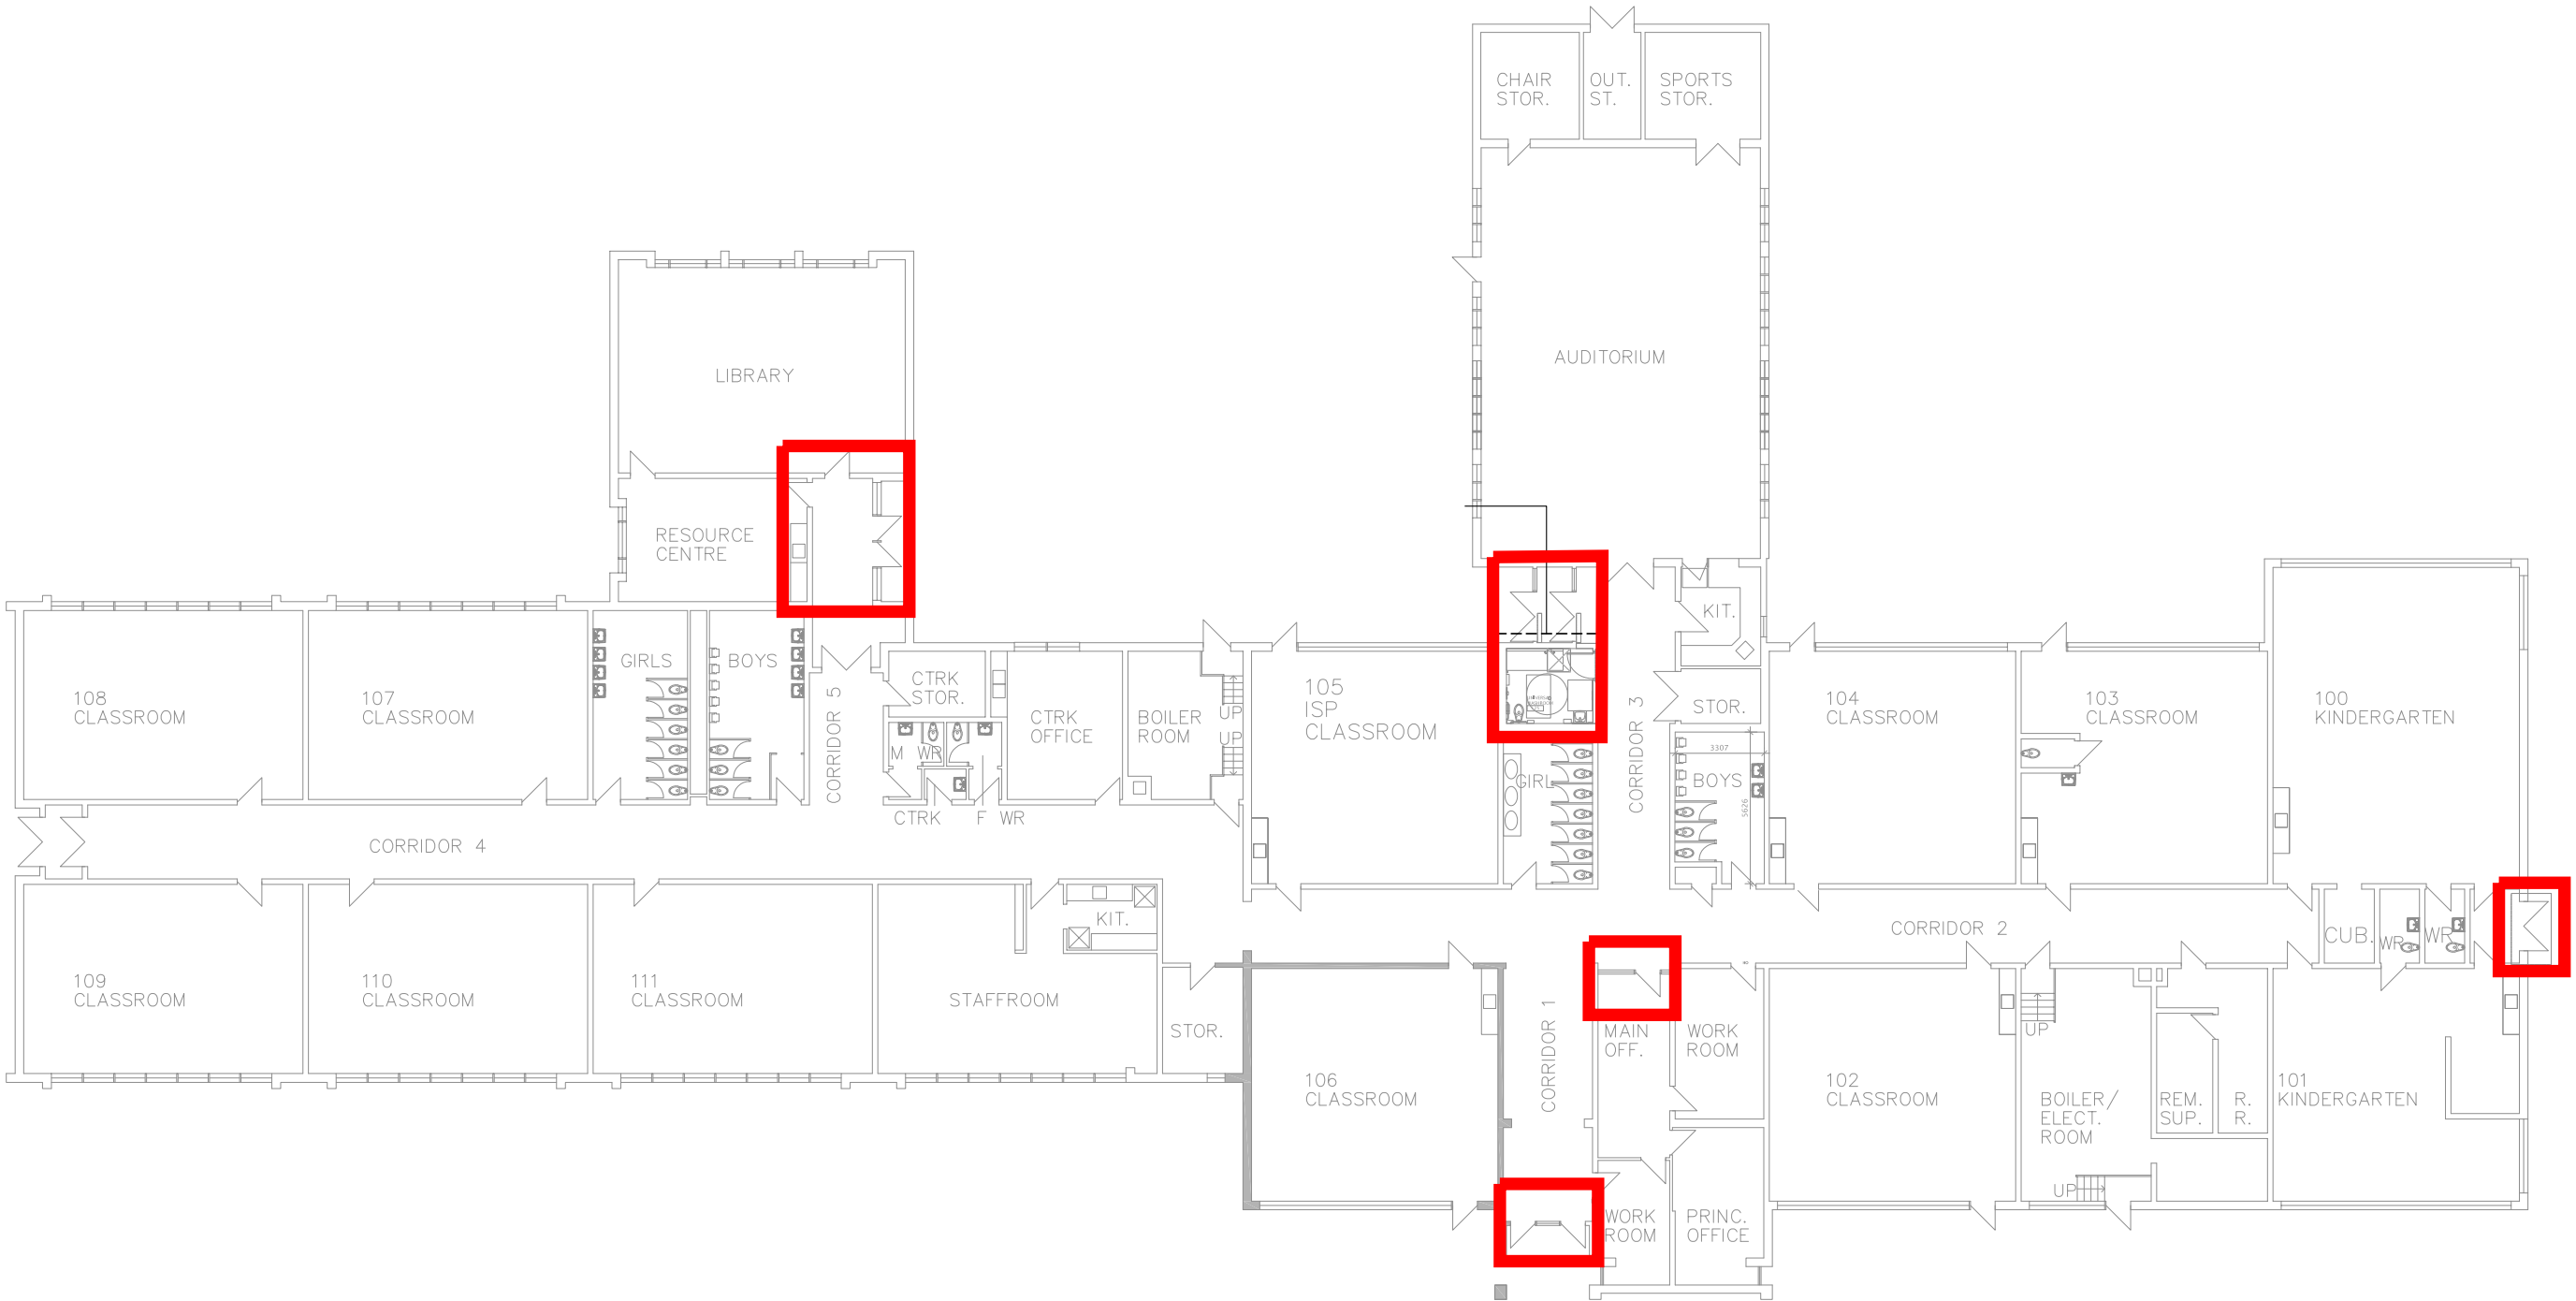
LEVEL 1

Floor	Room No.	Room Description	System	Material	Description	Classification	Friable/ Non-Friable	Condition	Est. Quantity	Unit	Access	Action
No sources of asbestos were identified in the project specific areas
