DESIGNATED SUBSTANCES AND HAZARDOUS BUILDING MATERIALS ASSESSMENT REPORT

**Roof Replacement & Window Rehabilitation Project
Eva Phoenix Transitional Housing
60 Brant Street
Toronto, Ontario**

Safetech Project Number: 1-3260479

**Date of Site Work: May 29, 2026
Date of Issue: June 8, 2026**

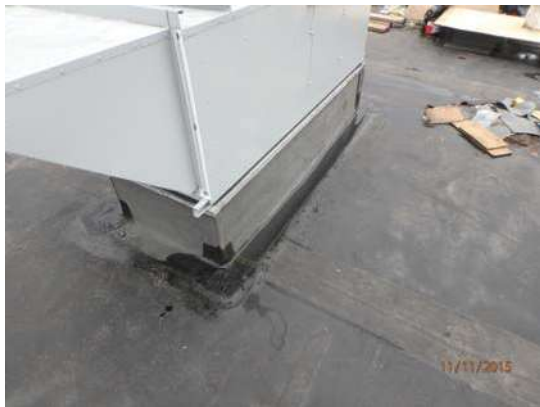
Picture 148

This is an EPDM roof and new equipment is being placed on this roof.

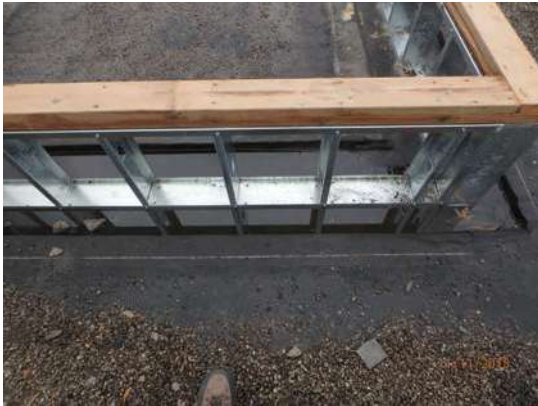
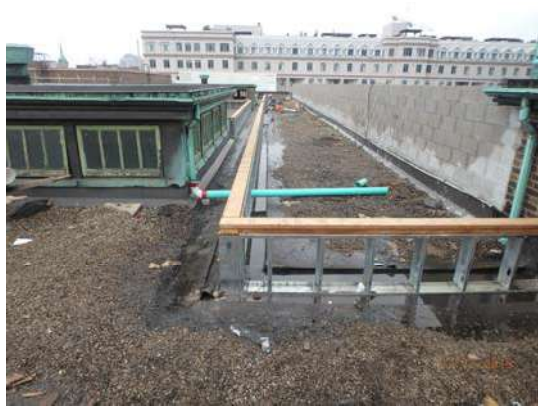
On the higher level the existing roof is thicker leading to a deeper “trench.”

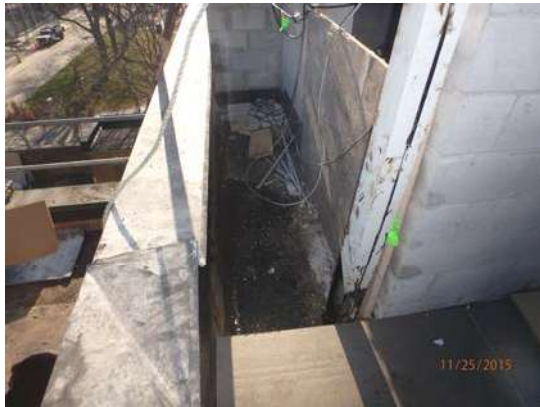
Picture 393

Roofing was in progress on the upper roof level.

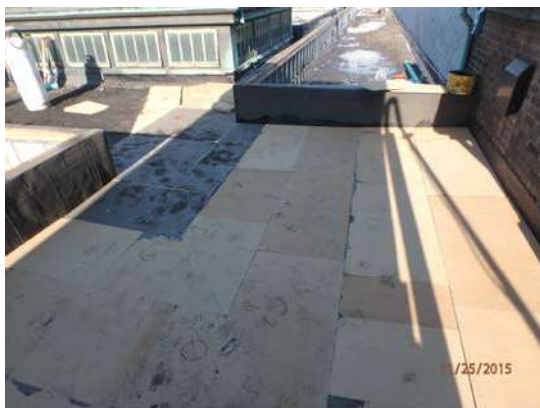
Picture 394

1. At the new elevator structure the tapered insulation [Section B on the tapered drawing] was not installed as there was some problem with the shaft. I advised the roofer to roof in open "end" of the tapered insulation as it may be days before this area is released.

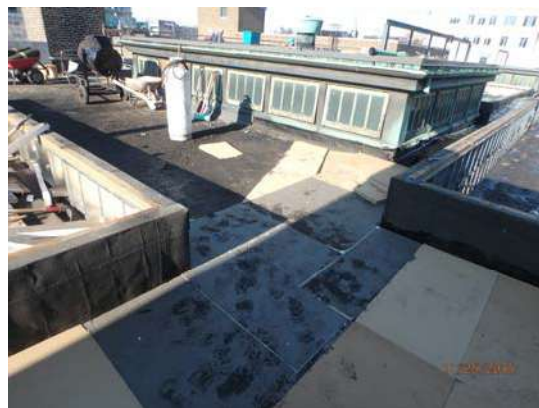
Picture 395

2. At the Southeast corner the crew was assembling the base insulation layers and the top tapered fibreboard. None had yet been adhered in hot asphalt.

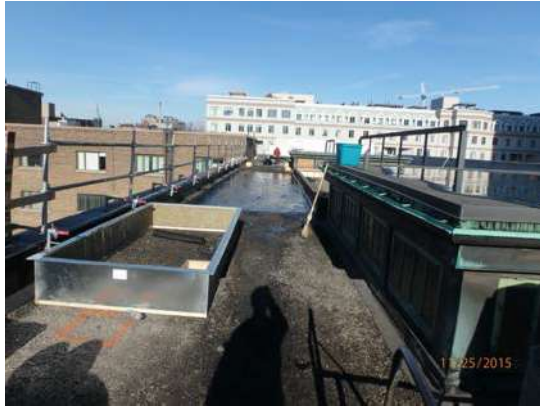
Picture 396

3. Most of the East side is now roofed, no gravel will be installed until all details and flashings are installed.

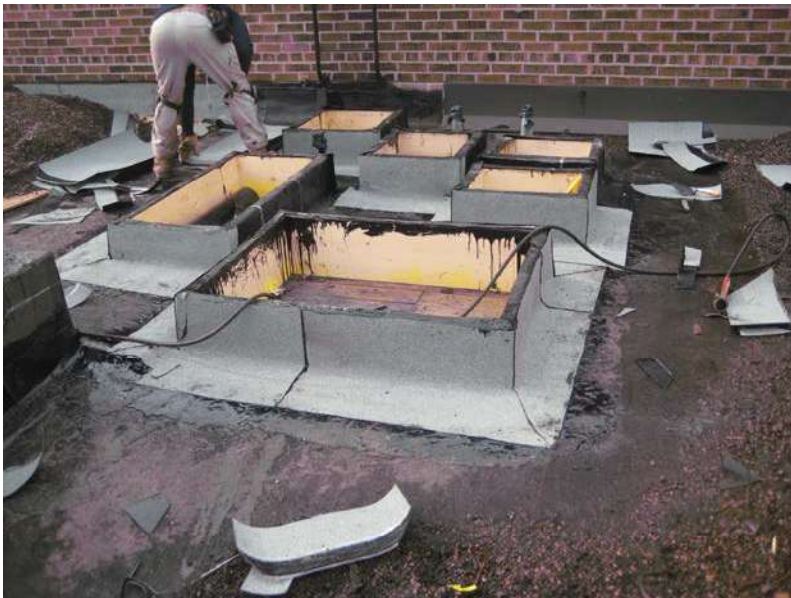
Picture 004

Work is underway flashing in the multiple curbs at the Northwest corner.

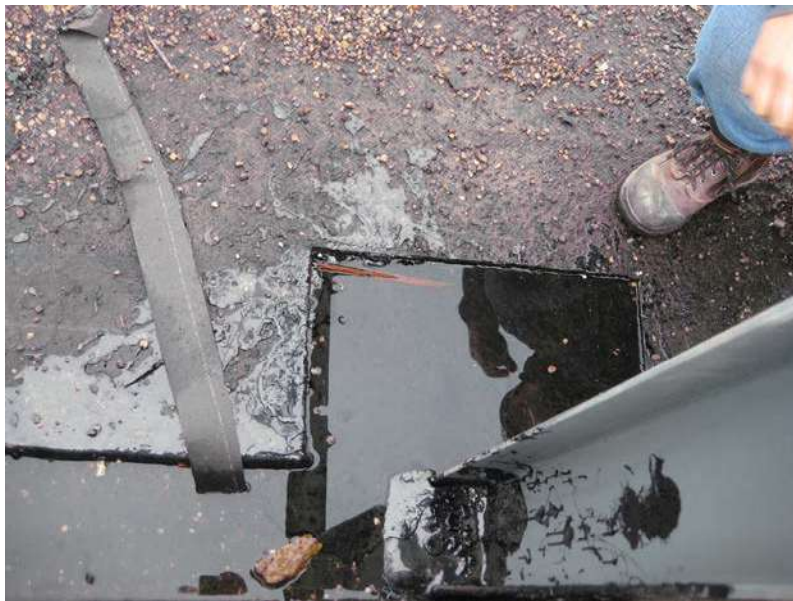
Picture 007

The seal on the interior of the skylight curb was not properly carried round the cut out for the structural steel. The crew are going to repair these.

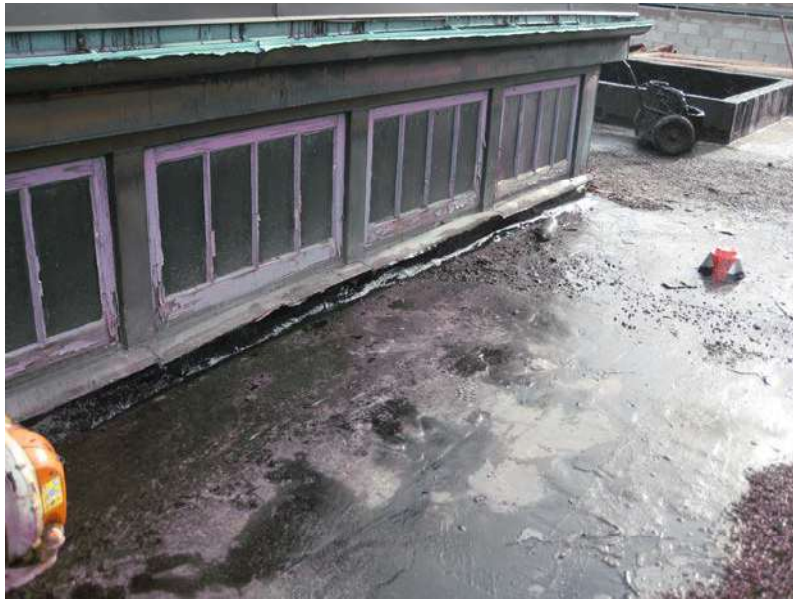
Picture 011

There is sufficient height at the North side of the two existing monitors to provide proper flashing.

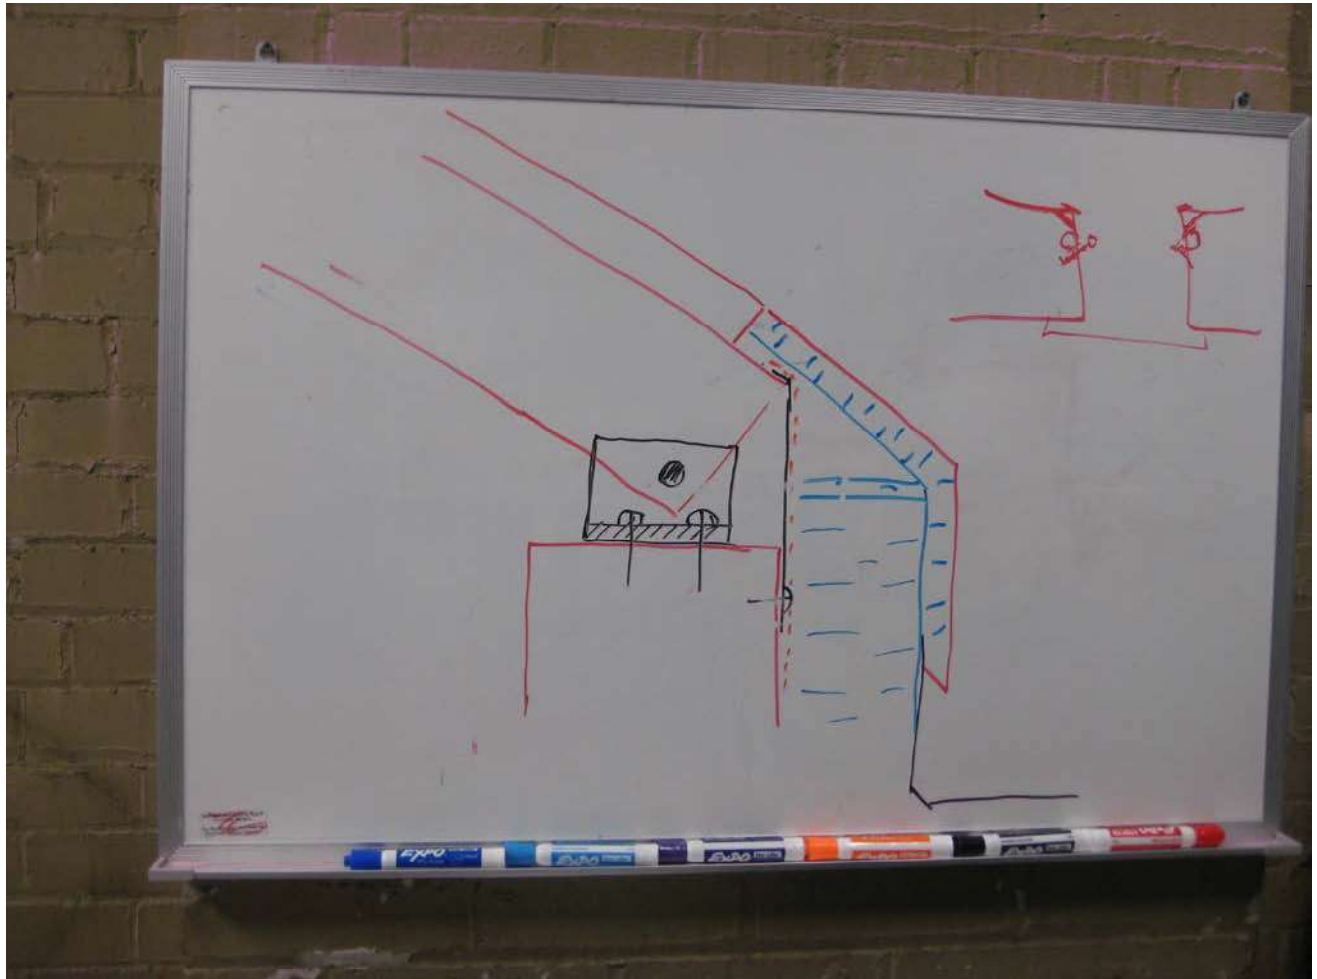
Picture 017

The Metro West skylight shop drawing will be a problem if it goes ahead as per the sketches above.

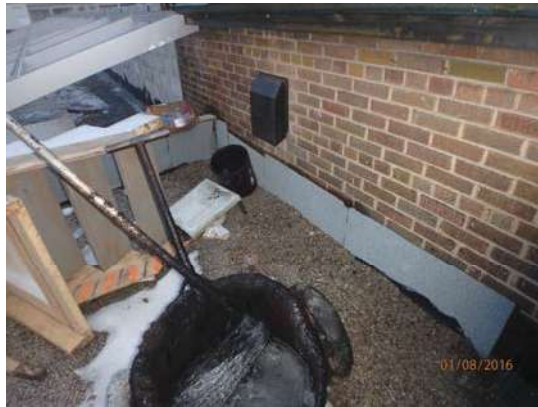
Picture 1078

2. Torch applied cap sheet flashings are in progress, a termination bar is required to complete the install, before the metal counterflashing is placed.

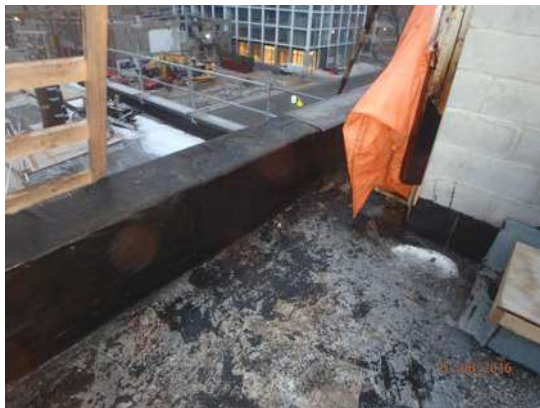
Picture 1079

3. At the Southeast access ladder the roof gravel has yet to be installed, the flashings must be done first.

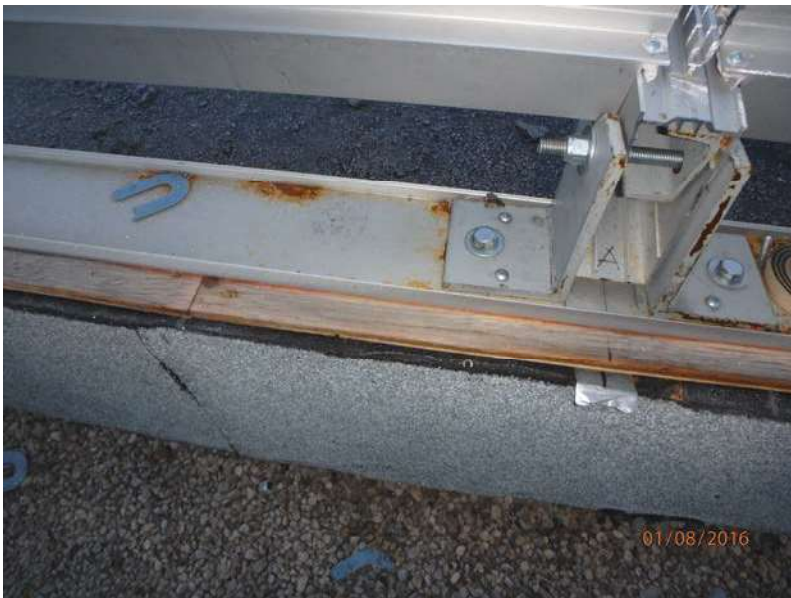
Picture 1074

5. The skylights are in process of being installed. The roof flashing is in position but junction between the wood packer and the horizontal skylight base needs to be waterproofed. A piece of Blueskin connecting the two would be an effective seal.
6. In view of the coming heavy rain over the weekend and into the early part of the week I requested the roofer open up the drains. The drain bodies are in position but the roofer has only 2"± holes in his felts.

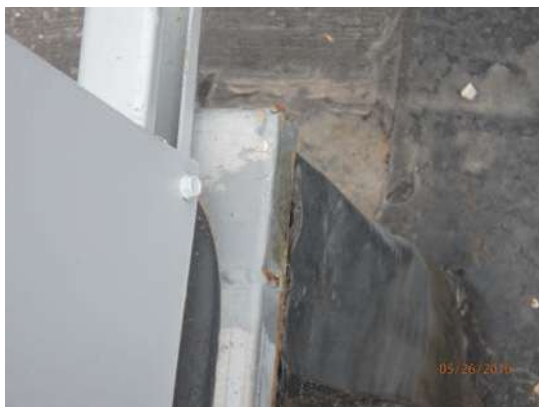
Picture 330

A fan base has the top edge of the E.P.D.M. protruding past the metal base plate. It looks as though the fan installers cut the new E.P.D.M. to make the fan fit the base. Nortex will repair the corner and supply and install a 3" brown flashing, slid under the base plate to improve the termination.

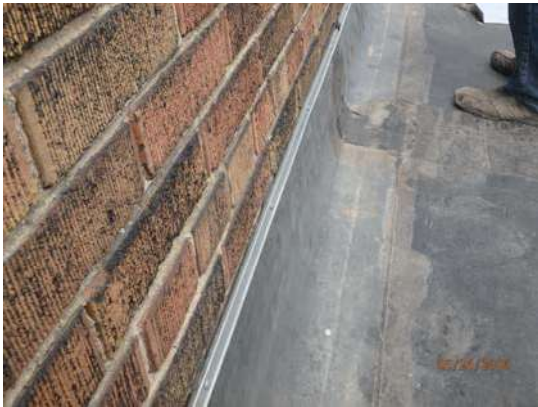
Picture 332

The E.P.D.M. termination along the North/South level change needs work. The termination bar is satisfactory but the struck mortar joints in the old brick will let water pass the seal as it runs down the wall.

Nortex will caulk the top of the termination bar; install a 3" deep flashing with a turn-back edge, caulked to the brickwork.

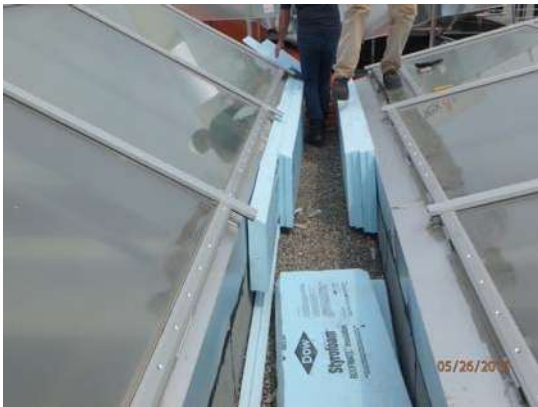
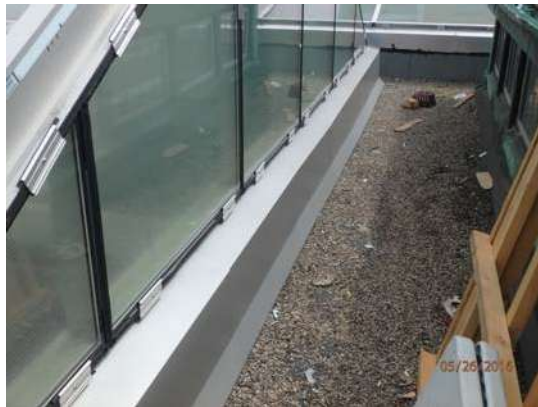
The crews are installing the six inch insulation to the skylight curbs, and fitting the exterior metal.

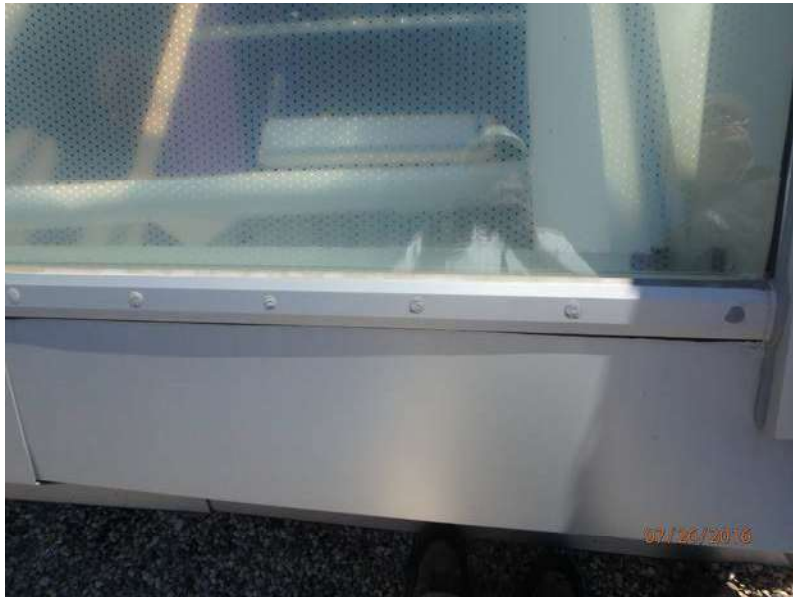
During the recent water test, which showed the skylights to be watertight, we observed that the low rise pressure plates had all had the screws changed to stainless counter sunk screws.

Some have silicone caps, shown in Picture 1138 above but others have no sealant cap, Picture 1139 above.

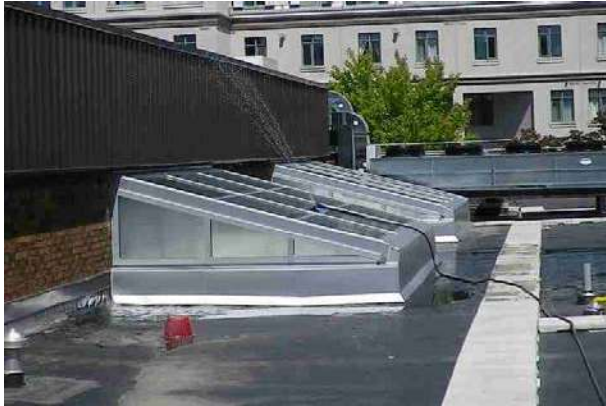
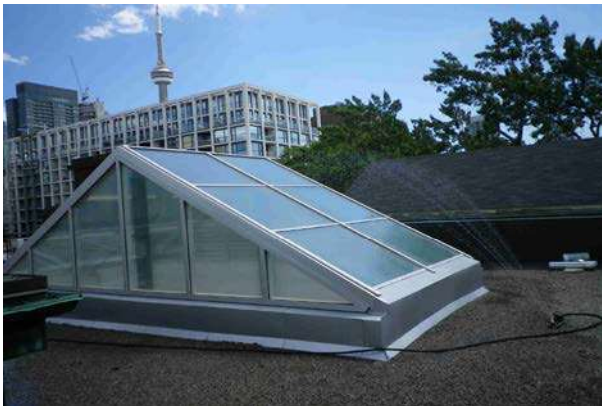
Water was sprayed on each of the smaller skylights for a minimum of 15 minutes on each face. At the end of the test, no leaks were produced and the skylights were deemed to have passed the test.

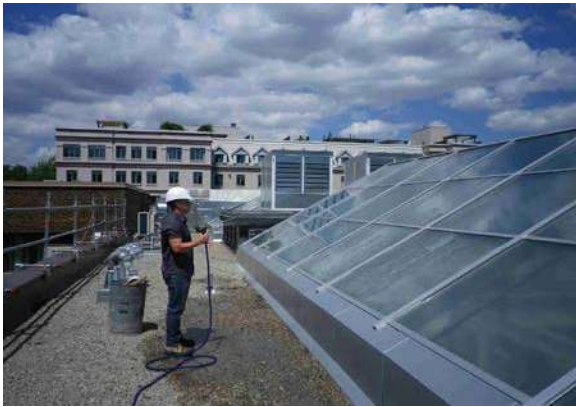
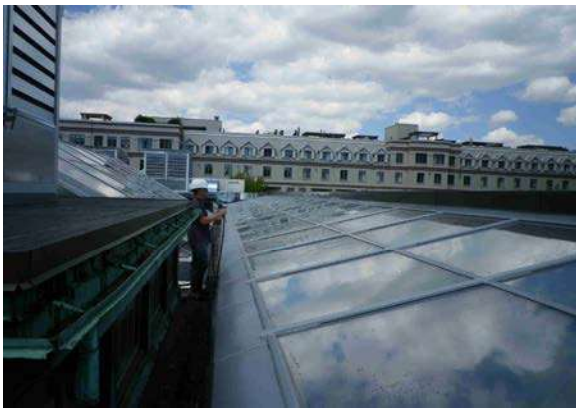
On the longer skylights, water was sprayed on the skylight in 10' sections for 15 minutes in each section. At the end of the tests, no leaks were produced and the skylights were deemed to have passed the test.
