## **SURVEY FOR DESIGNATED SUBSTANCES AND HAZARDOUS MATERIALS**

**COMMUNICATION, TRAFFIC, COMPUTER CENTRE AND PARKING GARAGE  
703 DON MILLS ROAD  
TORONTO, ONTARIO**

**Prepared for:**  
**City of Toronto**  
Corporate Real Estate Management  
**Attention: Inder Bhamra**

**ECOH Project No.: 29129.04-14**  
**December 19, 2025**

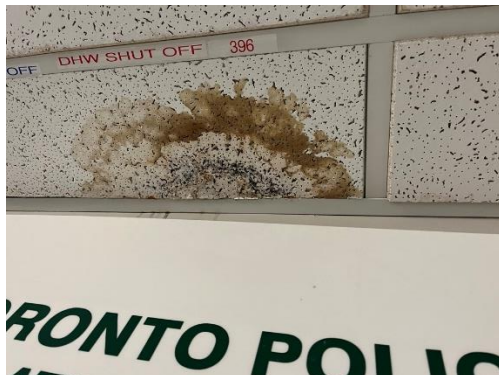
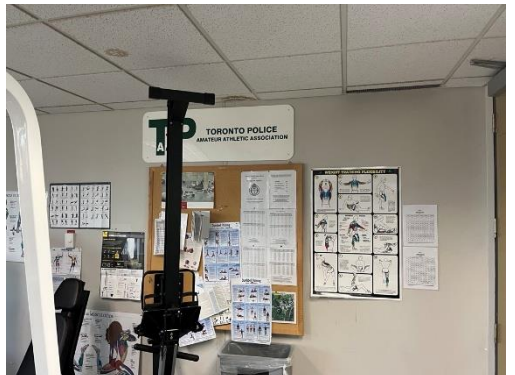
| <b>Photo No. 6.</b> | | | |

| <b>Details:</b> | | One (1) water damaged non-asbestos ceiling tile observed.<br><br>Remove and replace one (1) ceiling tile. | |

| <b>Location:</b> Loc 8-08<br><b>Name:</b> Gym | | | |
