**Re: Pre-Renovation DSS Report, 9 Neilson Road, Toronto, ON**

## **Attachment B - Site Plans**

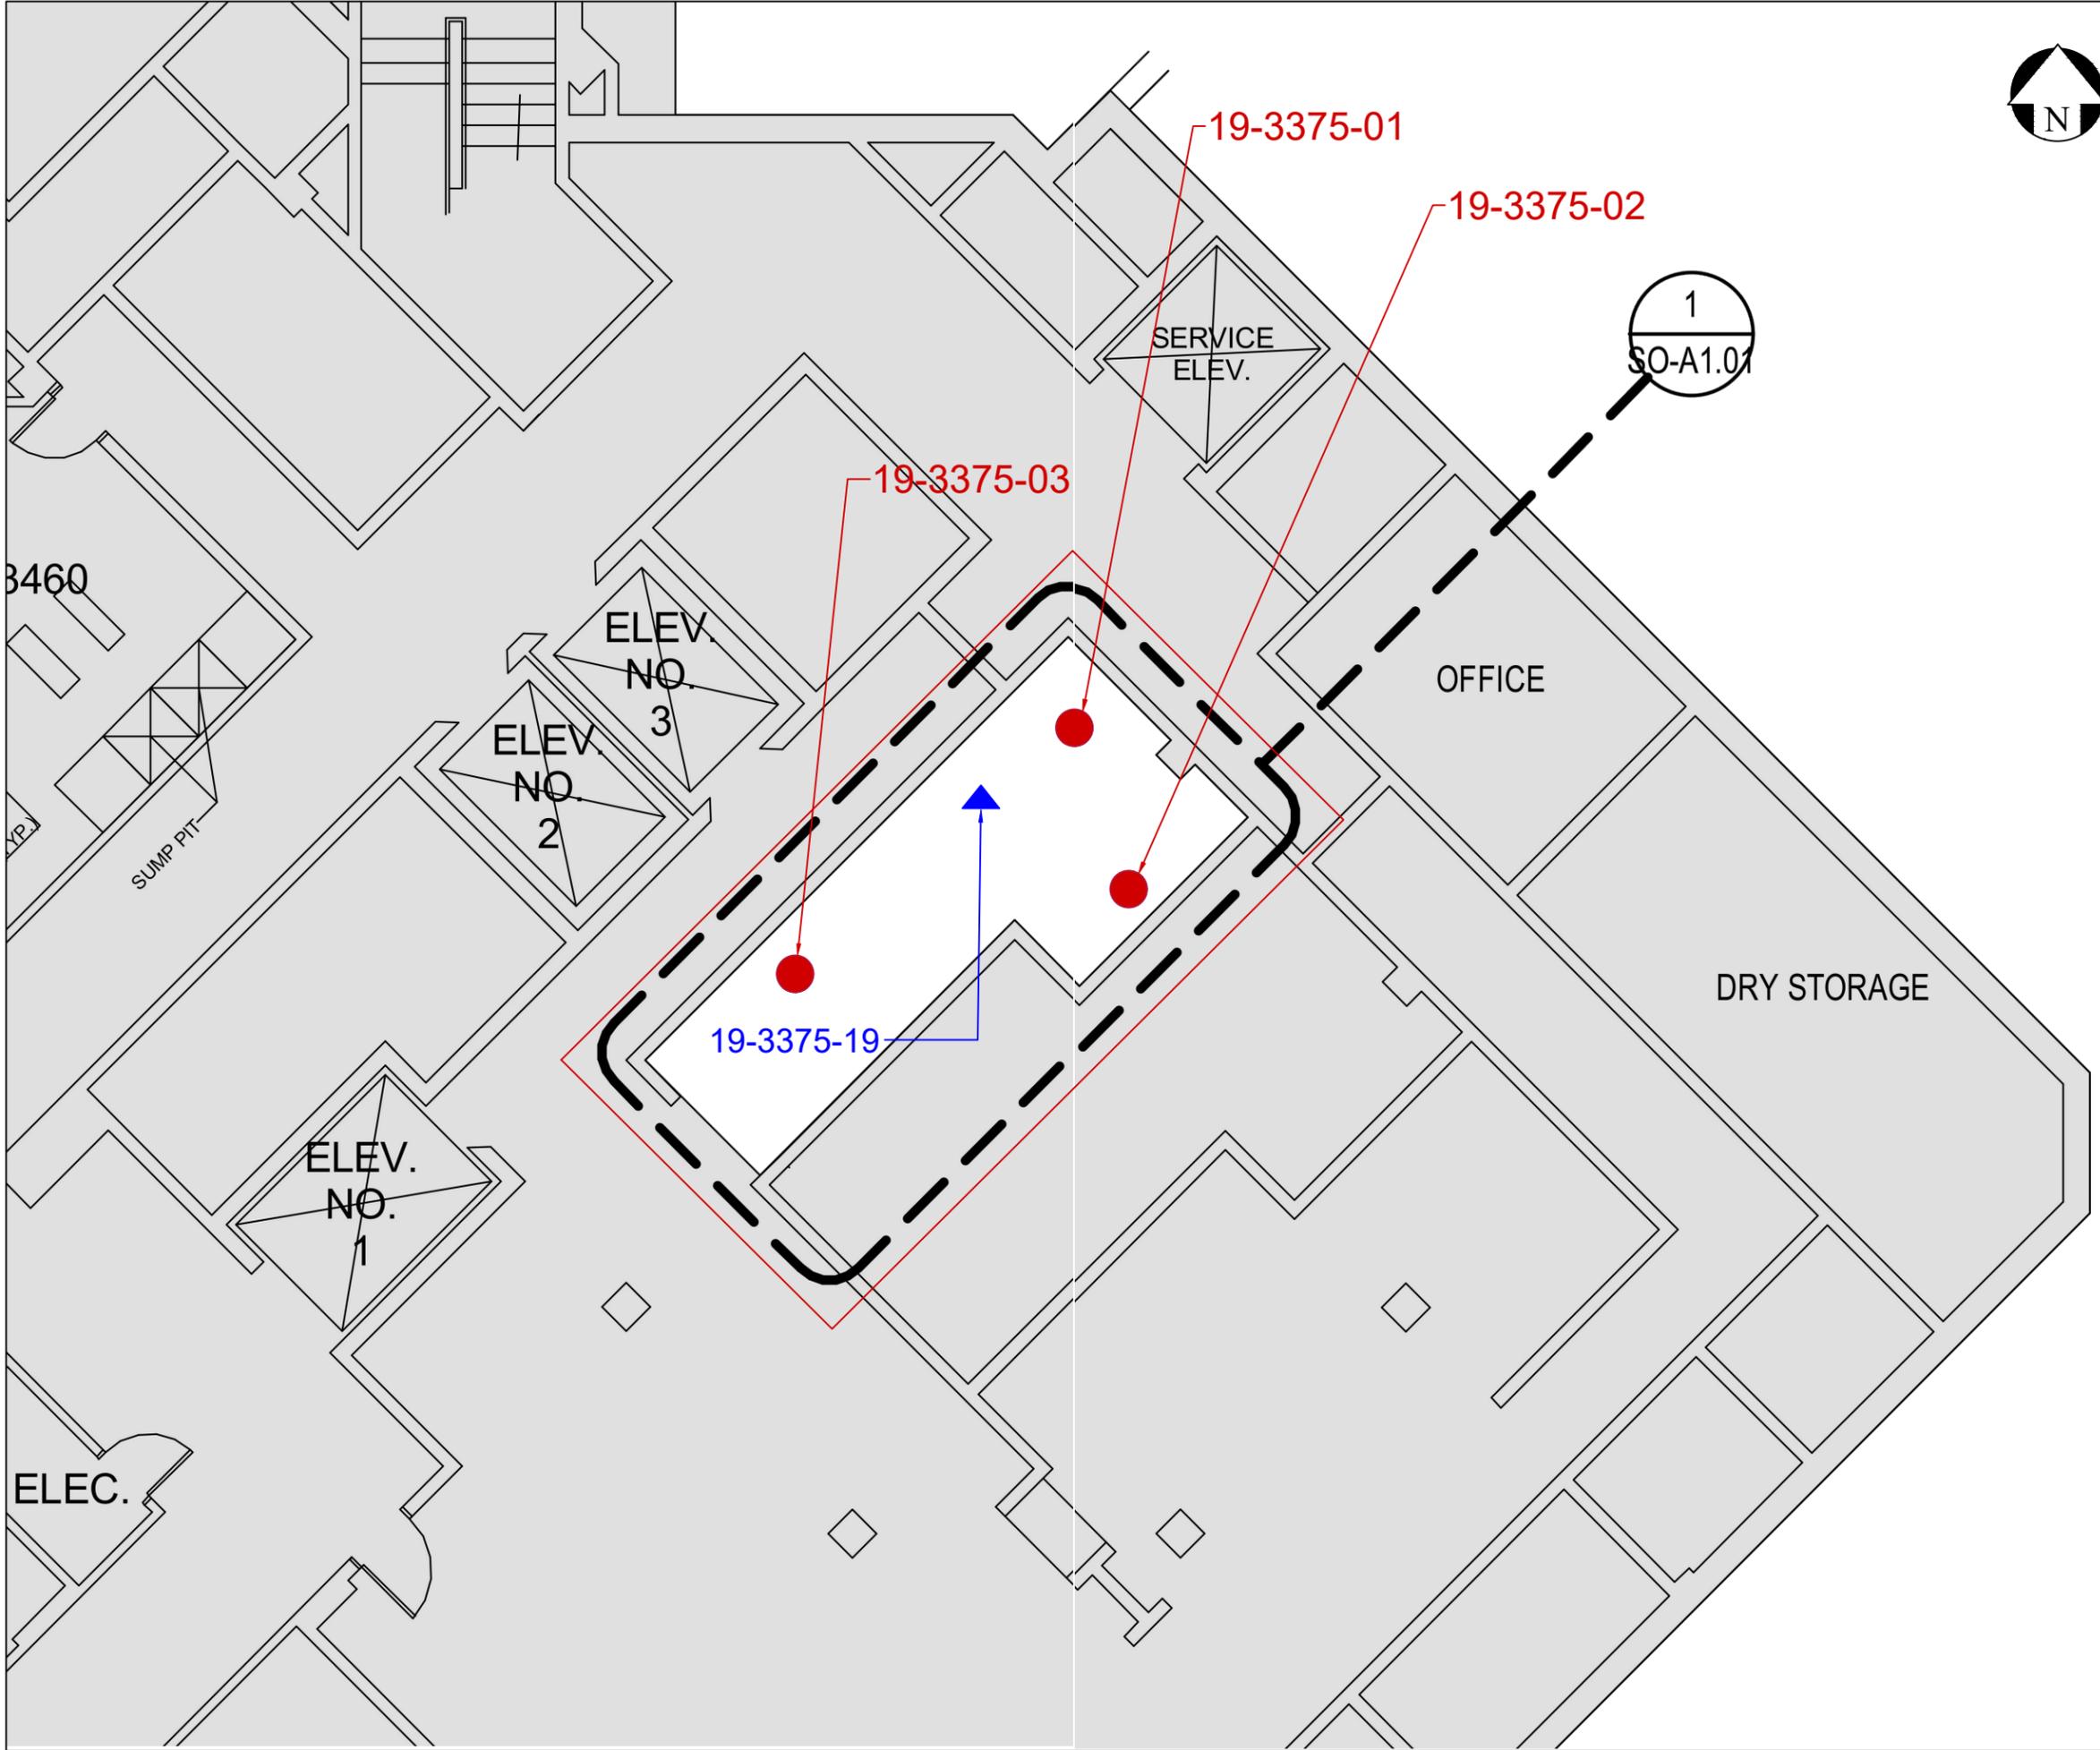
**Figure 1**

- 1-01 Location Number
- ▲ Lead Sample Location
- Asbestos Sample Location
- Area of Pre-Reno DSS

Location names and numbers where current bulk sampling was conducted are referenced from the most recent Annual Designated Substance report of the Site (under separate cover).

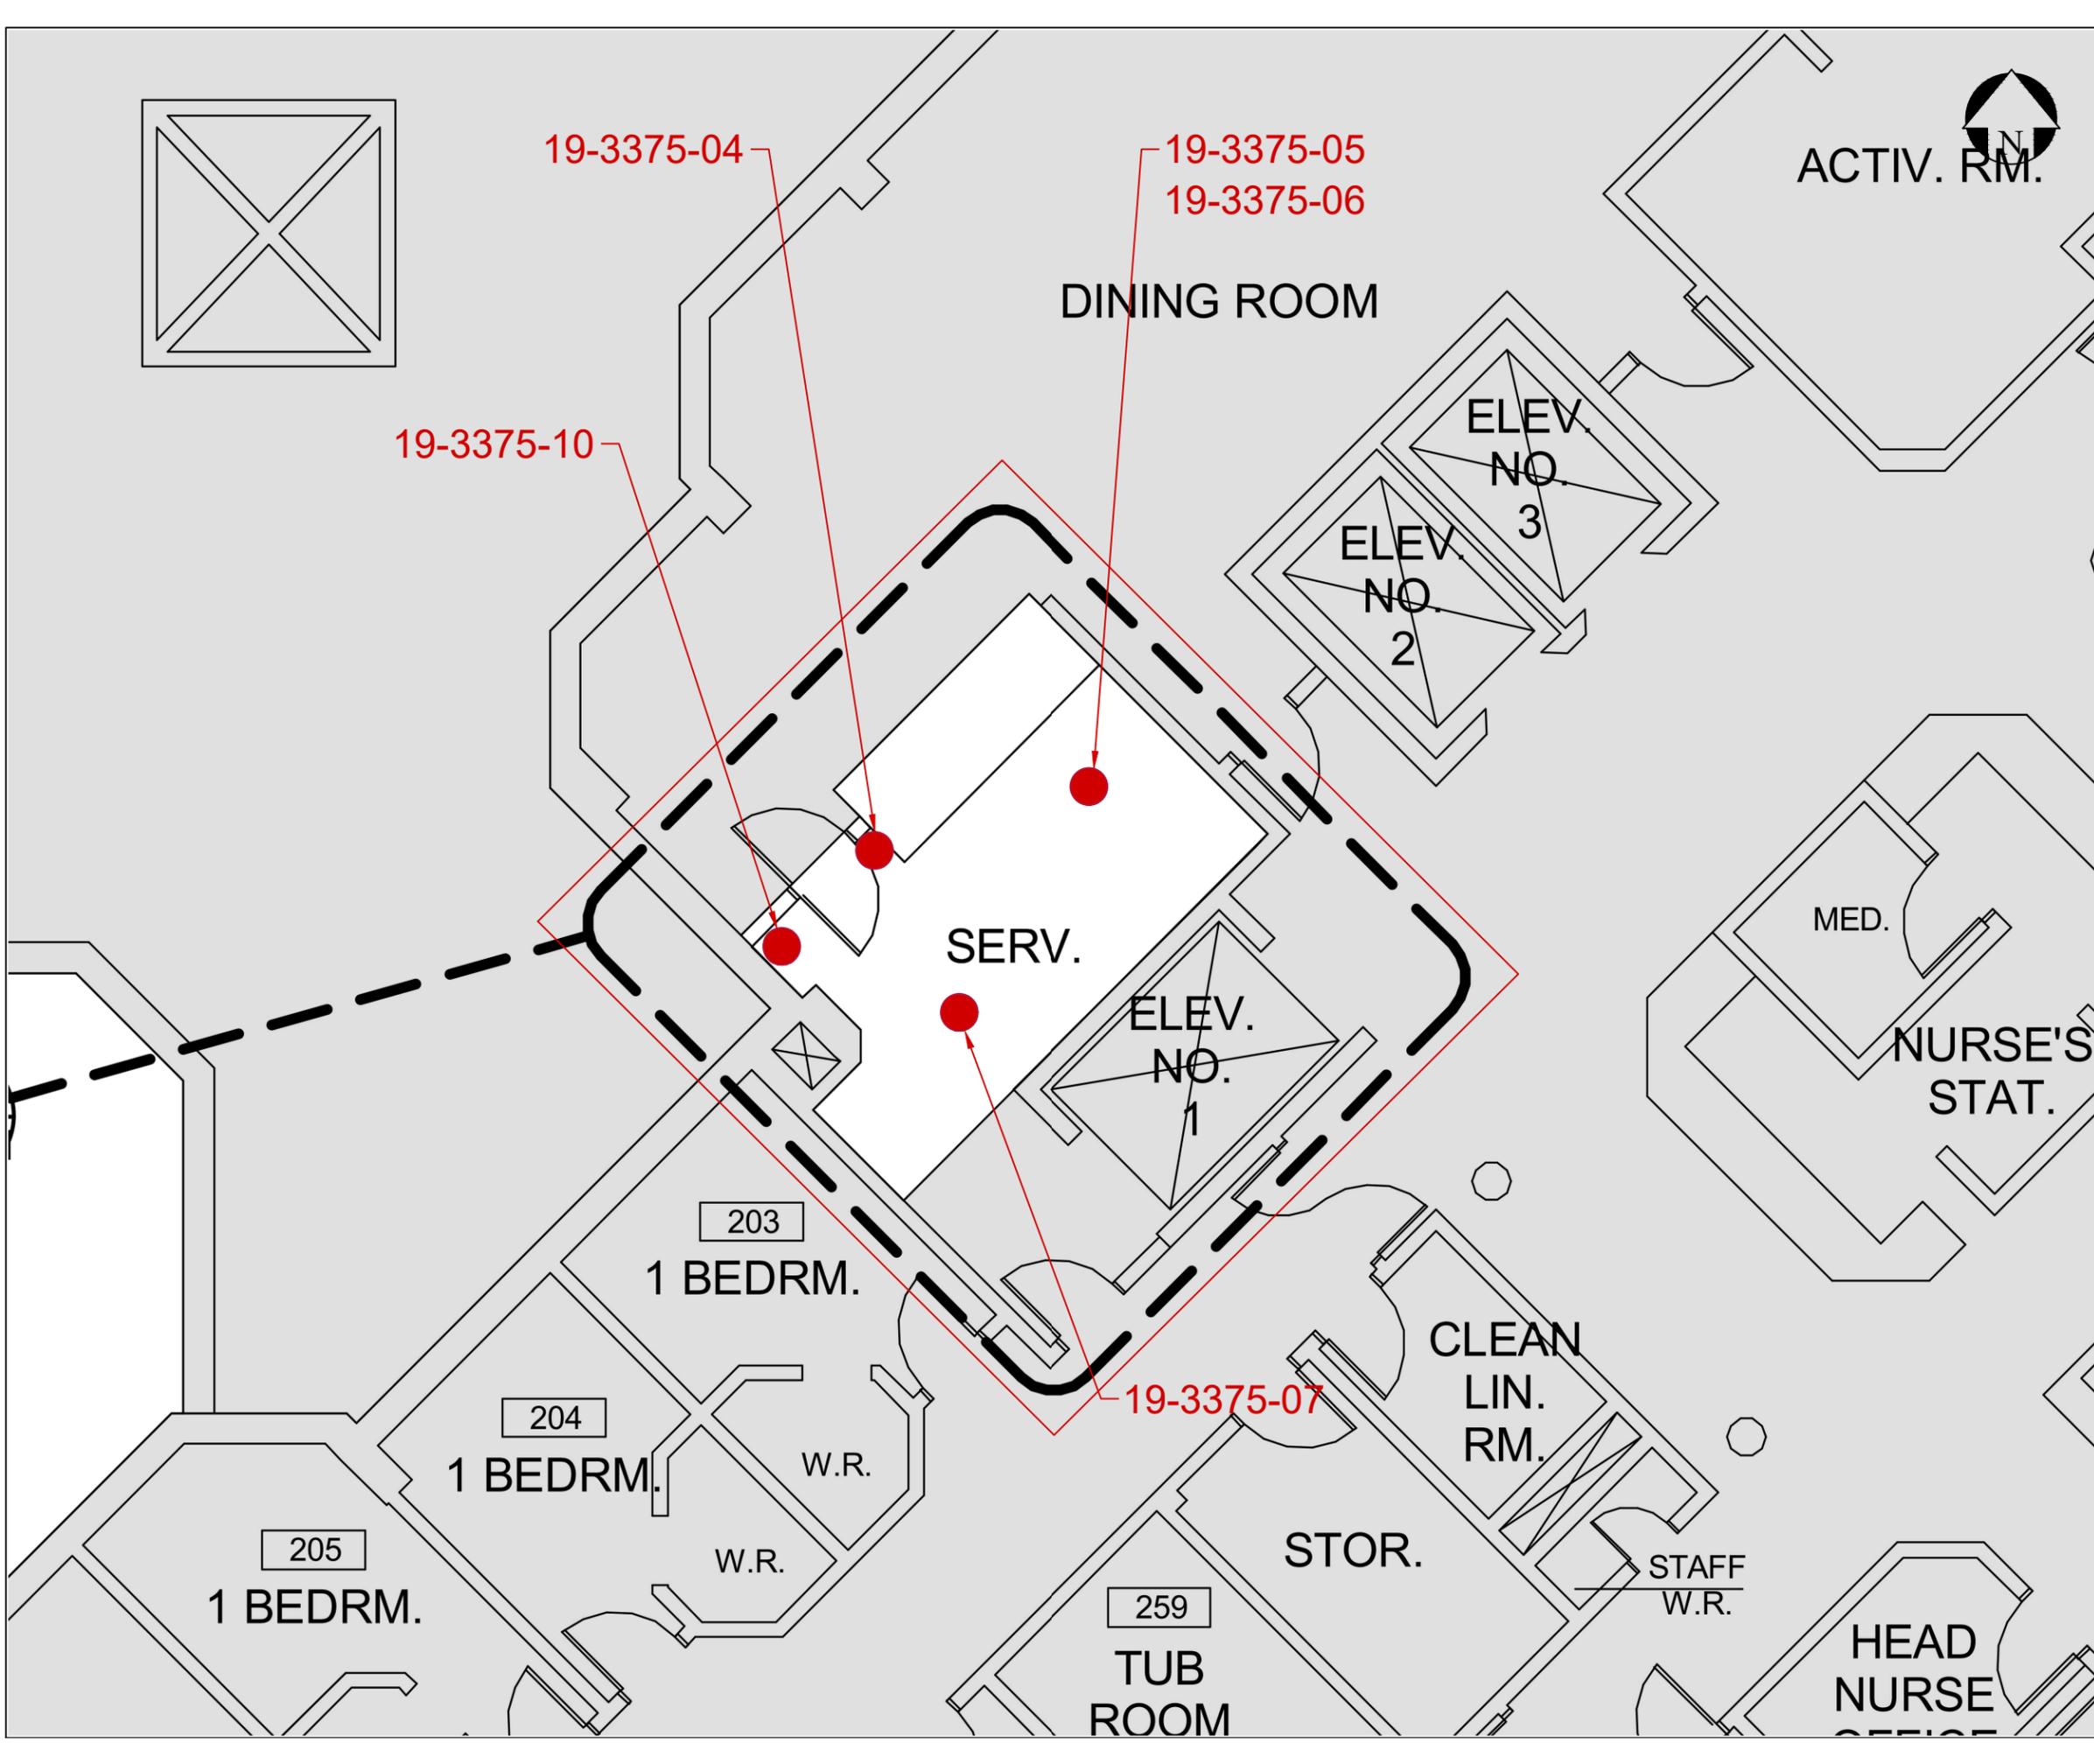
Figure 2

- 1-01 Location Number
- Asbestos Sample Location
- Area of Pre-Reno DSS

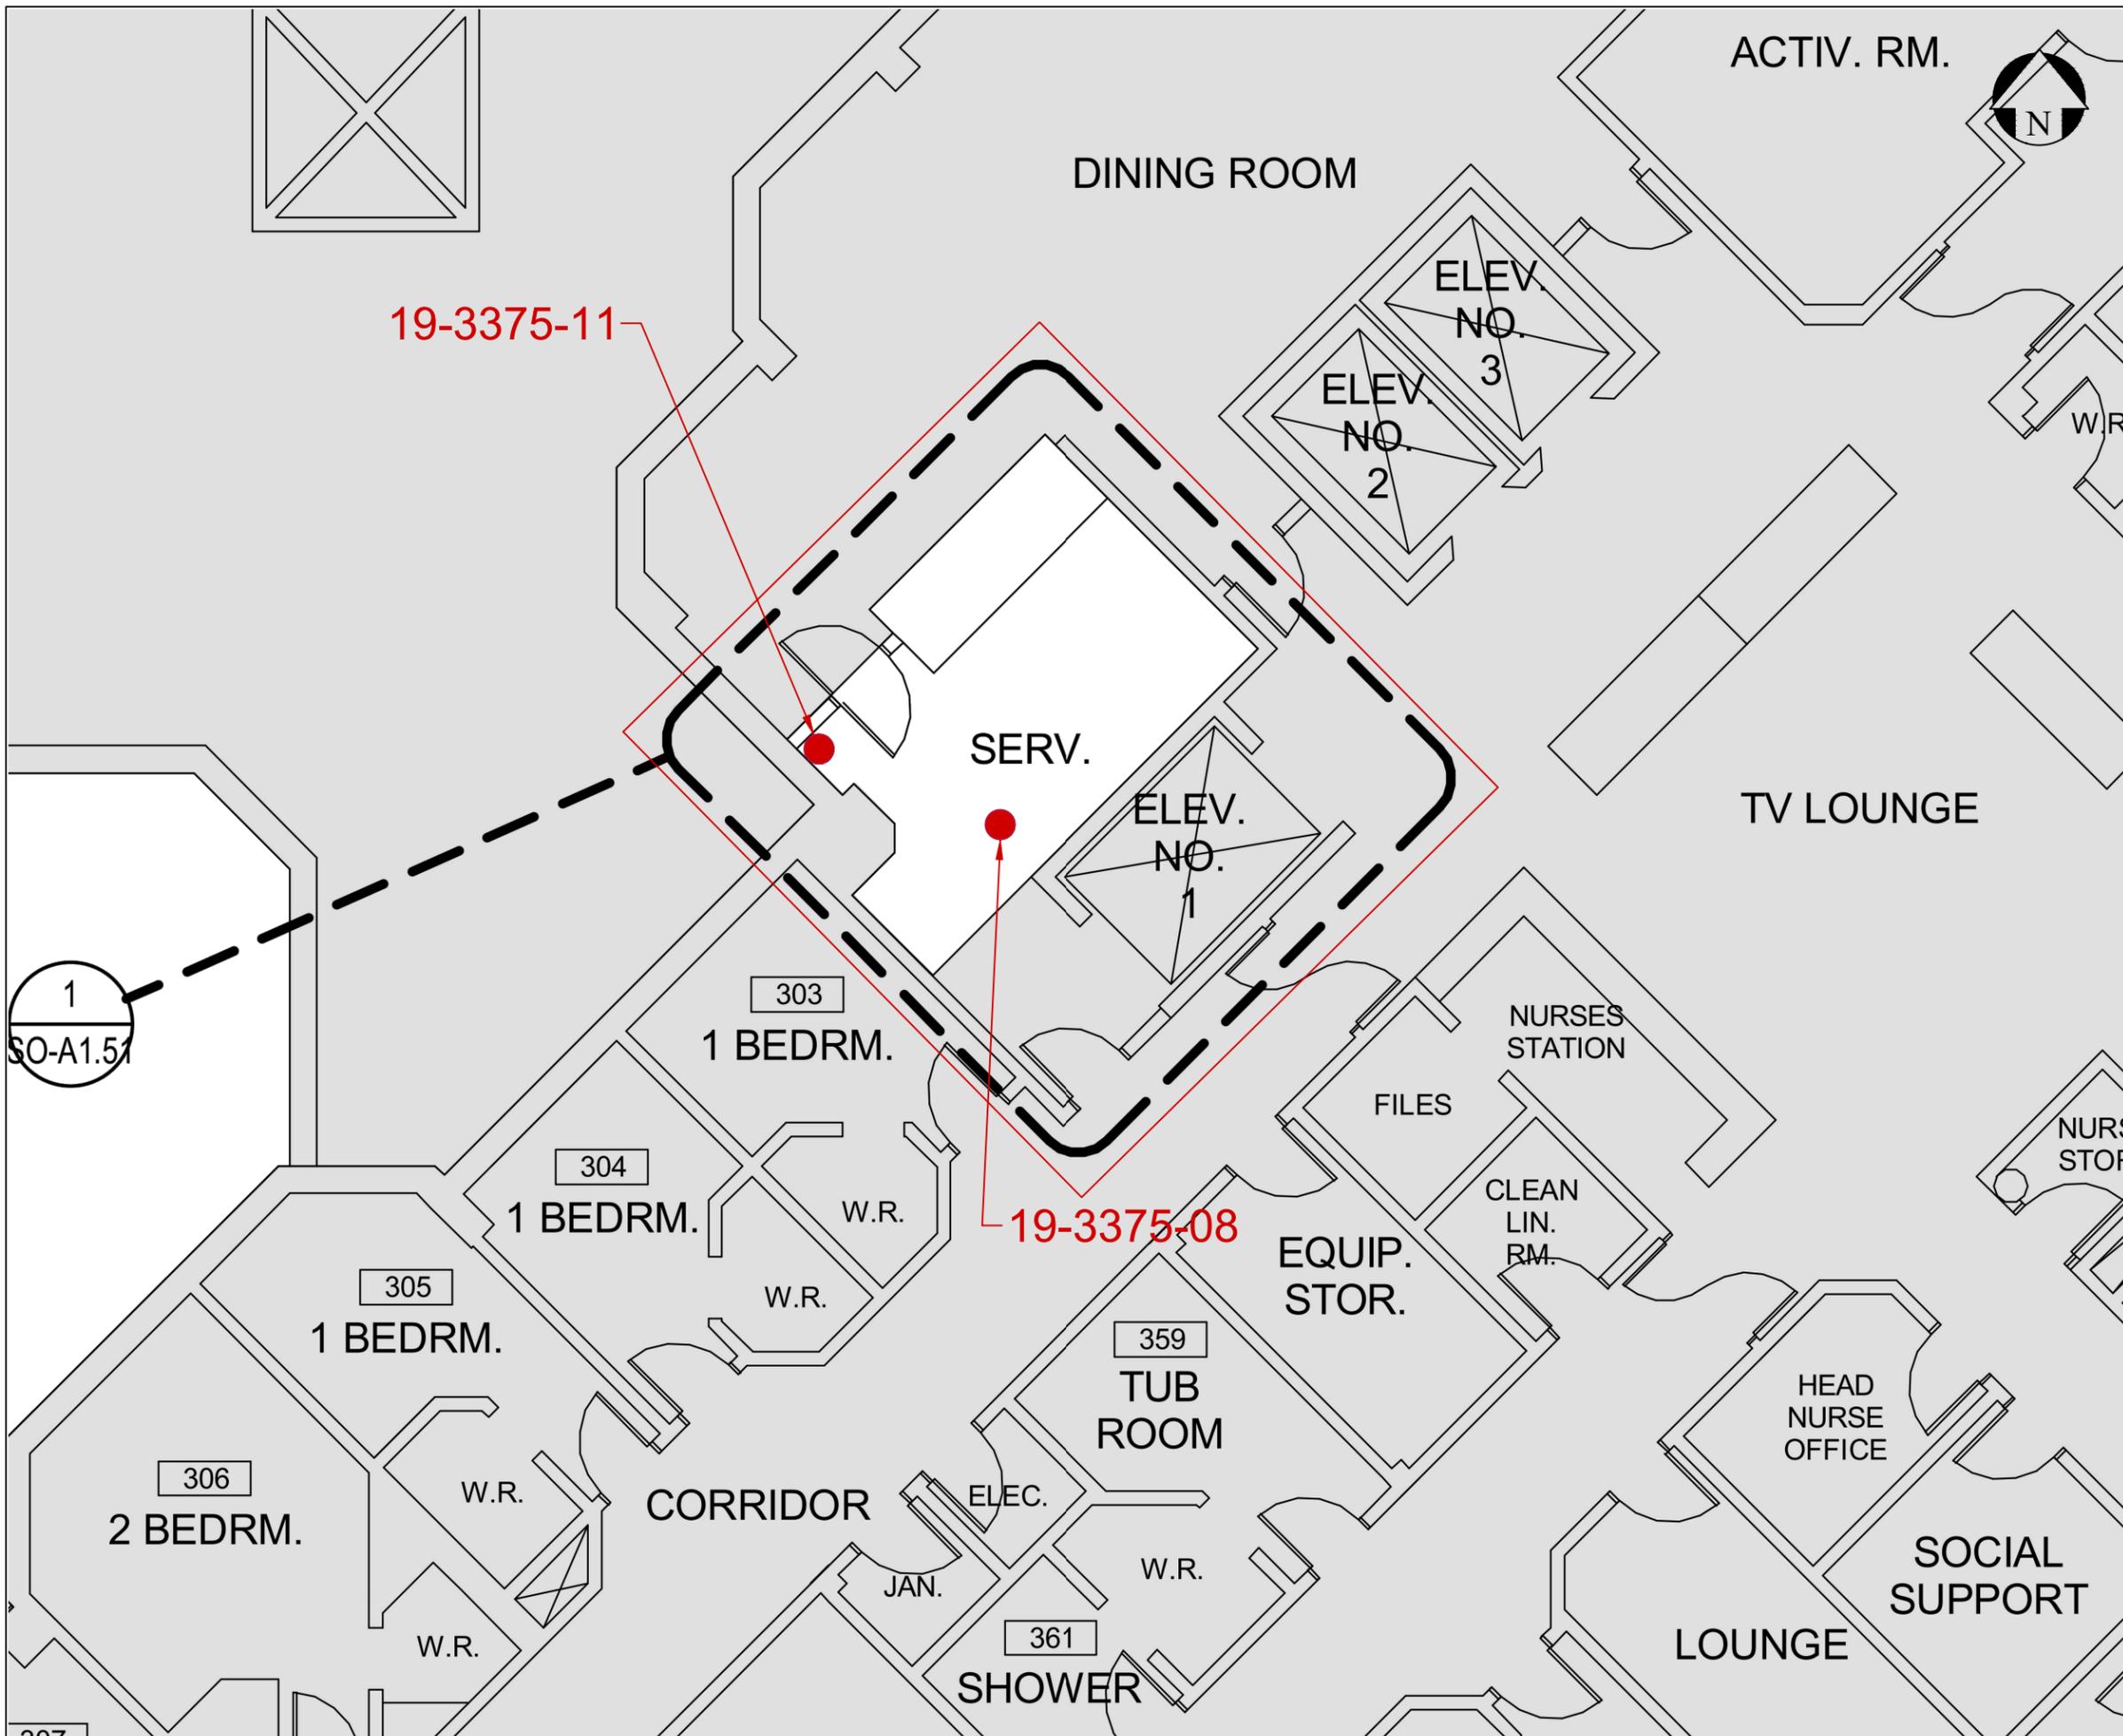
**Figure 3**

- 1-01 Location Number
- Asbestos Sample Location
- Area of Pre-Reno DSS

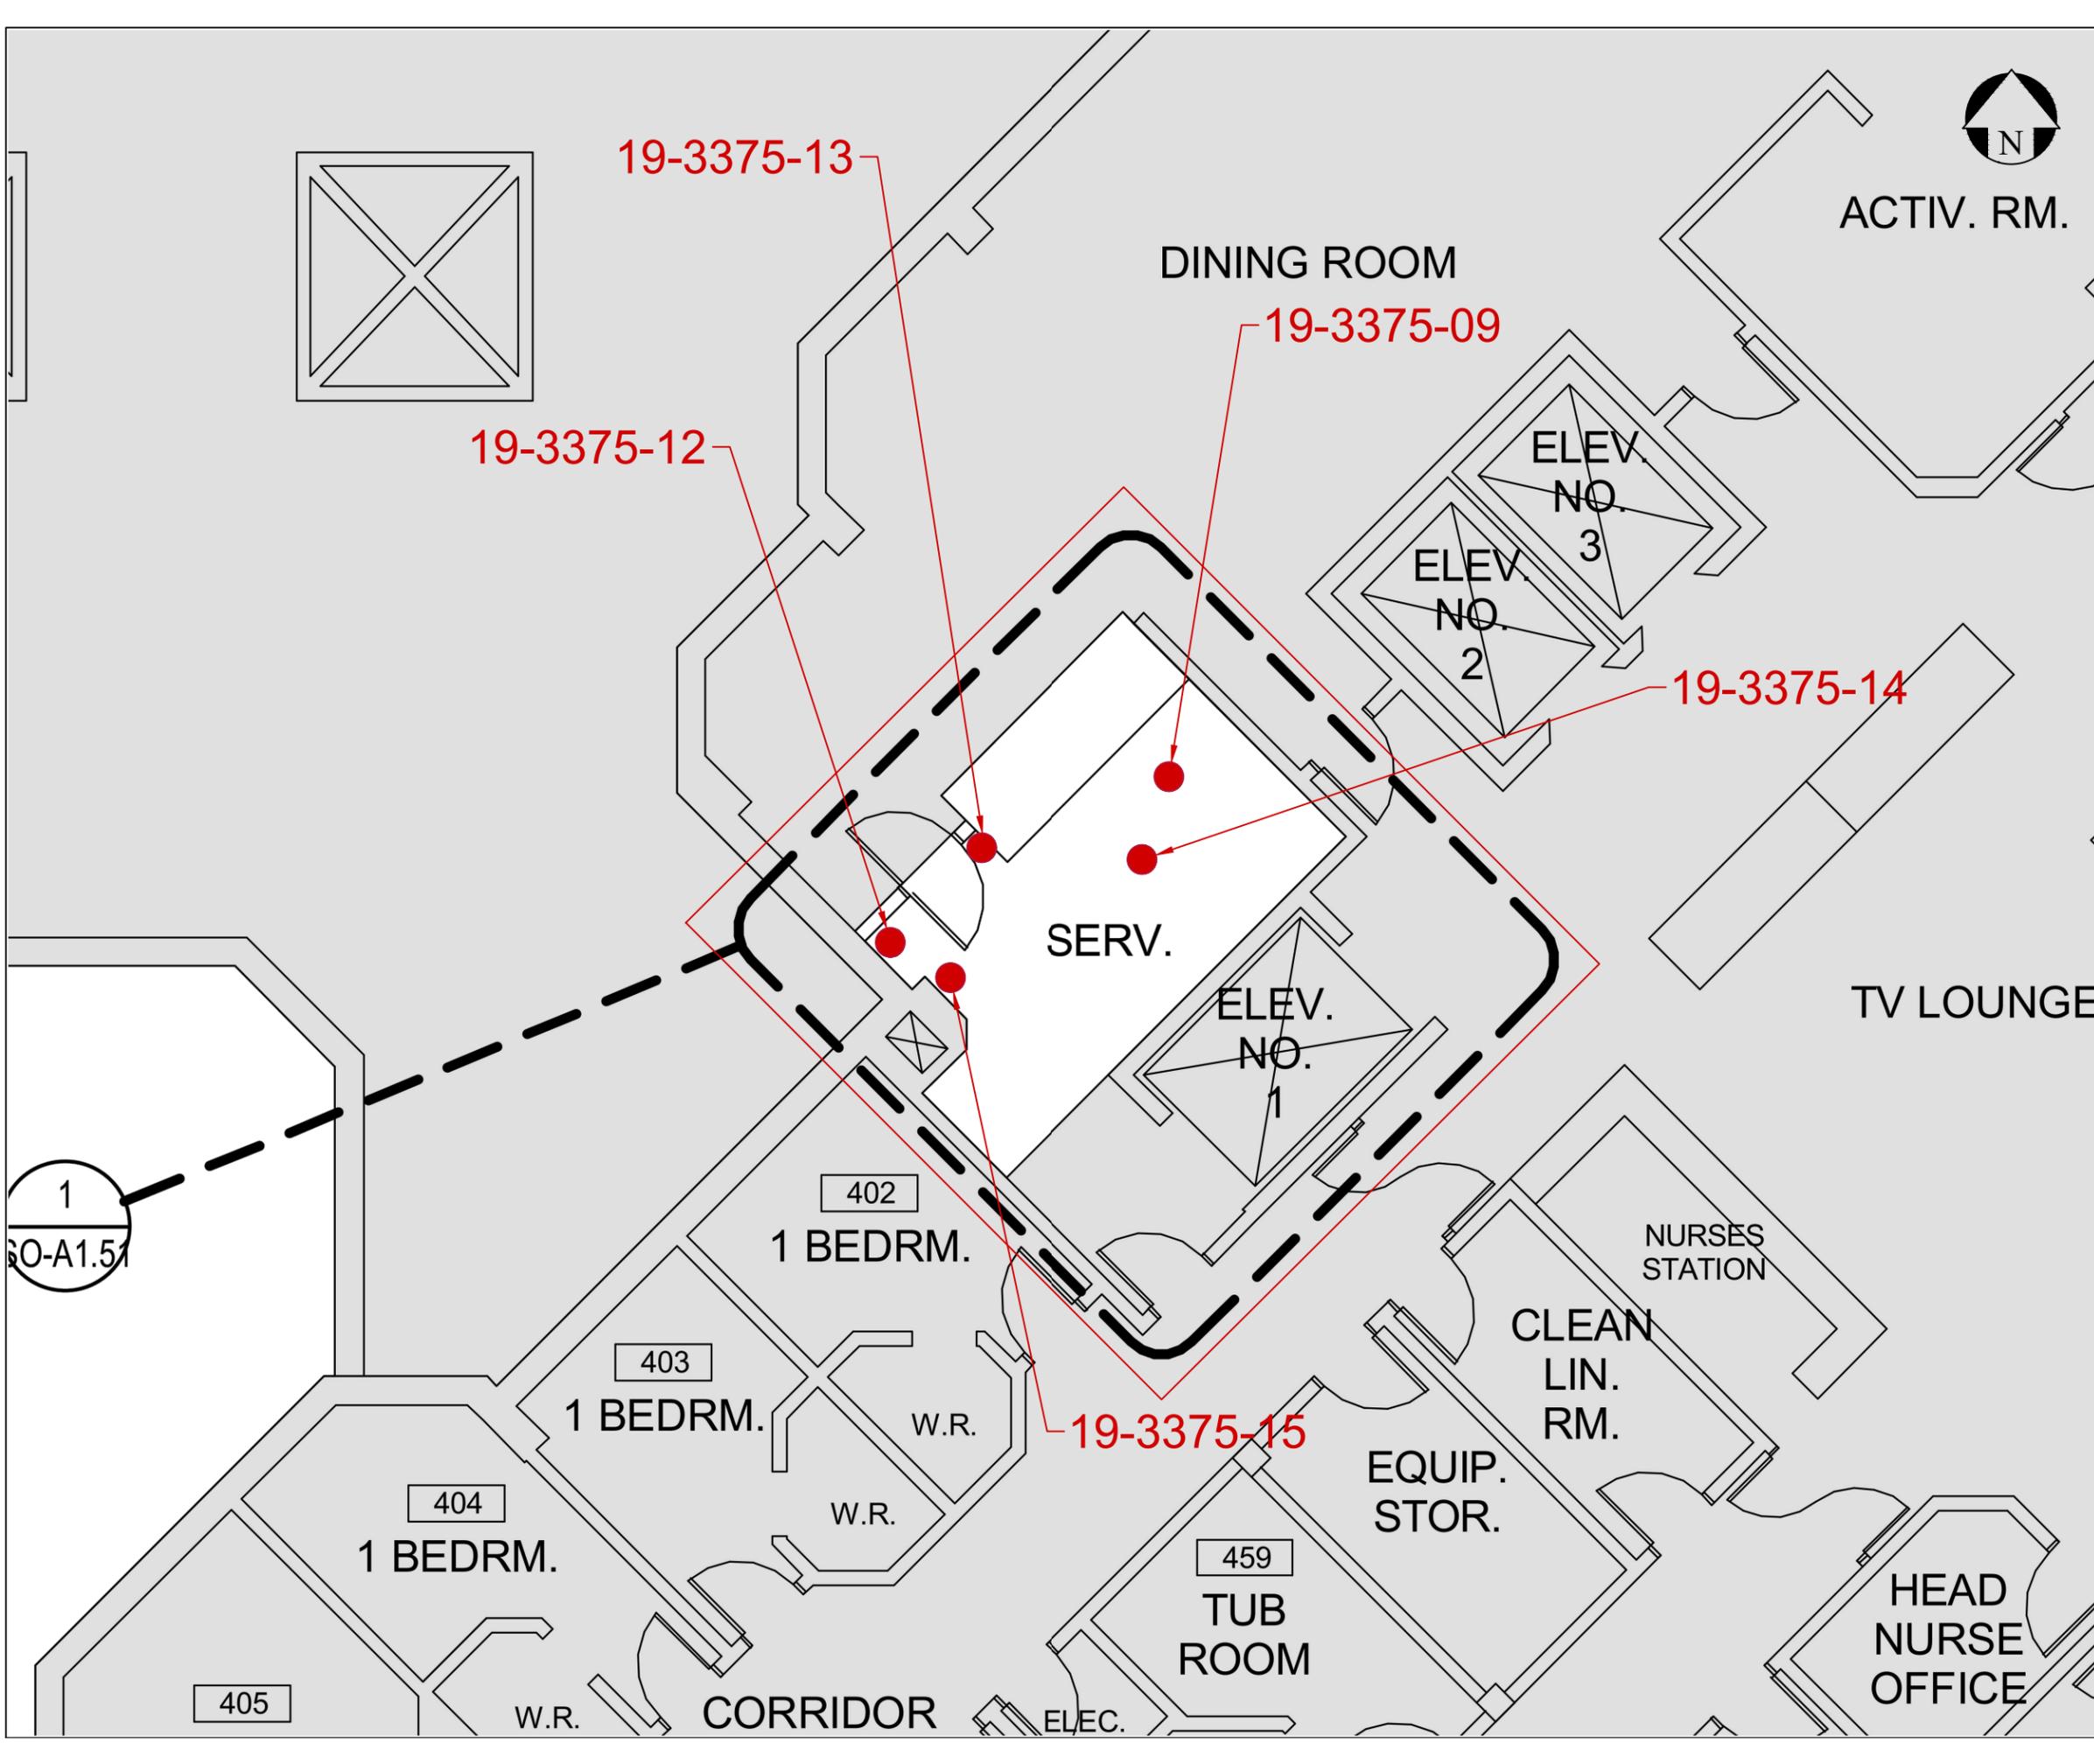
**Figure 4**

- 1-01 Location Number
- Asbestos Sample Location
- Area of Pre-Reno DSS

<b>LOCATION:</b>	9 Neilson Road, Toronto, Ontario		
<b>BUILDING NAME:</b>	Seven Oaks		
Pot Wash and Servery Renovation 4-th Level Asbestos Bulk Sample Location			
<b>CLIENT:</b>	City of Toronto		
<b>PROJECT NUMBER:</b>	FE-P 19-9400	<b>DATE:</b> SEPTEMBER 2019	<b>DRW BY:</b> NL
<b>CAD FILE:</b>	FIG4	<b>SCALE:</b> Not to Scale	<b>CHK BY:</b> IF
