**Reassessment of Asbestos-Containing  
Building Materials  
Forensic Identification unit & Radio and  
Electronic Services  
2050 Jane Street A and B  
Toronto, Ontario**

Prepared for:  
The City of Toronto  
Corporate Services  
Facilities Management  
55 John Street, 2<sup>nd</sup> Floor, Toronto, ON

Pinchin File 83714.003

November 15, 2013

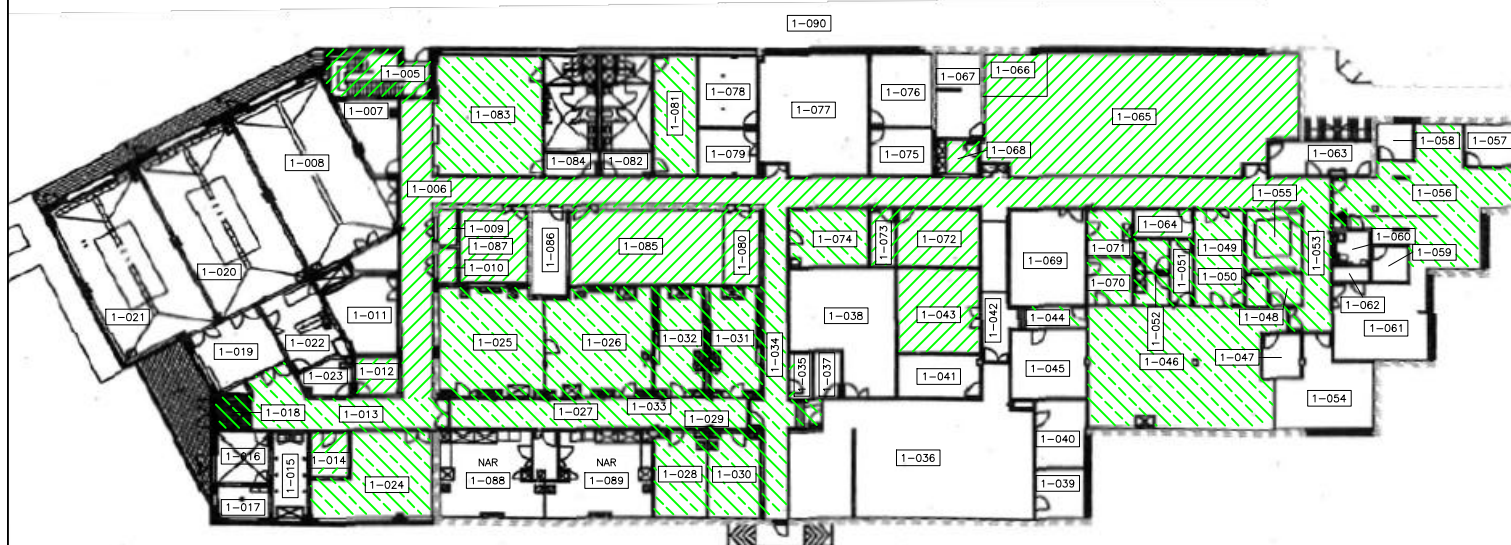
## FIGURE 1 OF 4

THE DRAWING DOES NOT ILLUSTRATE LOCATIONS OF DRYWALL JOINT COMPOUND, PLASTER, WINDOW CAULKING OR ROOFING MATERIALS, FOR REASONS AS DISCUSSED IN SECTION 6 OF THE STANDARD OPERATING PROCEDURE FOR ASBESTOS REASSESSMENT SURVEYS. PLEASE REFER TO THE ASBESTOS REASSESSMENT SURVEY FORM IN APENDIX I FOR INFORMATION REGARDING THE LOCATIONS AND ASBESTOS CONTENT OF THESE MATERIALS.

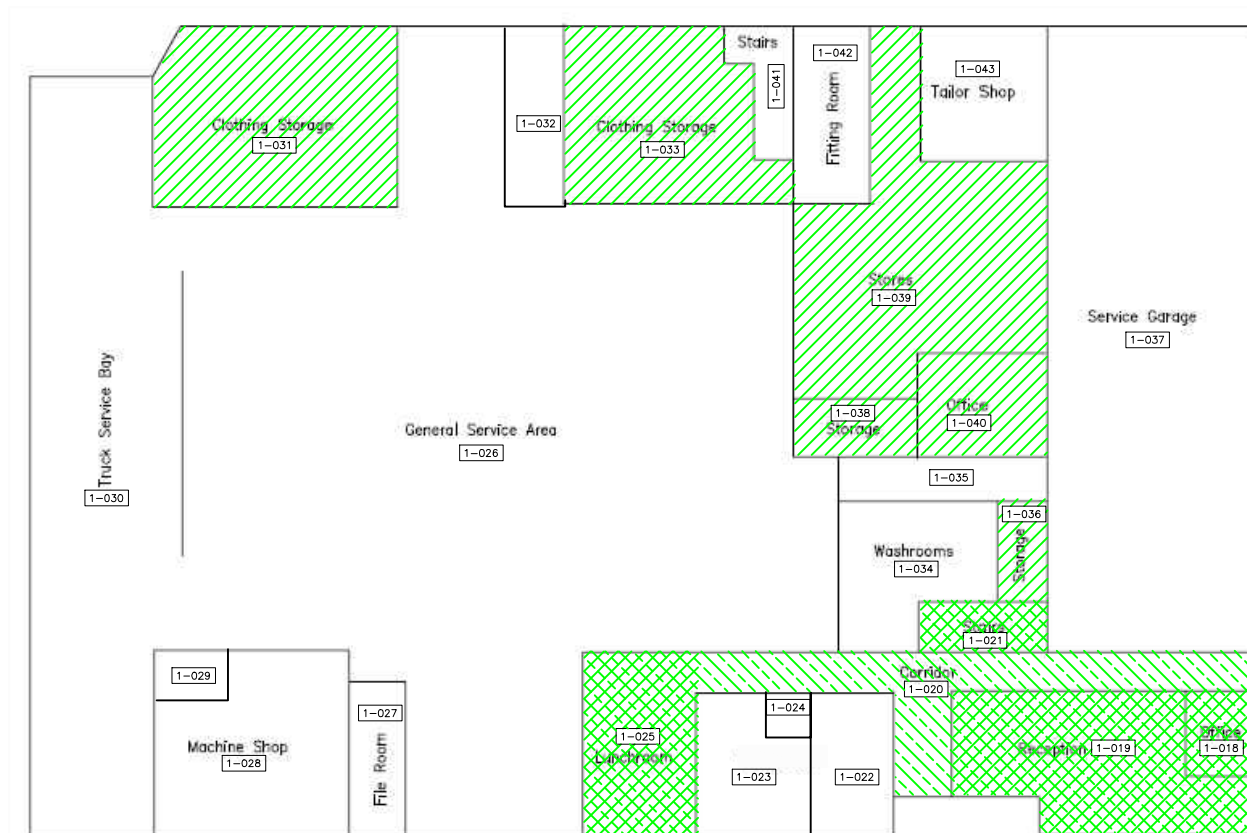
## FIGURE 3 OF 4

THE DRAWING DOES NOT ILLUSTRATE LOCATIONS OF DRYWALL JOINT COMPOUND, PLASTER, WINDOW CAULKING OR ROOFING MATERIALS, FOR REASONS AS DISCUSSED IN SECTION 6 OF THE STANDARD OPERATING PROCEDURE FOR ASBESTOS REASSESSMENT SURVEYS. PLEASE REFER TO THE ASBESTOS REASSESSMENT SURVEY FORM IN APENDIX I FOR INFORMATION REGARDING THE LOCATIONS AND ASBESTOS CONTENT OF THESE MATERIALS.
