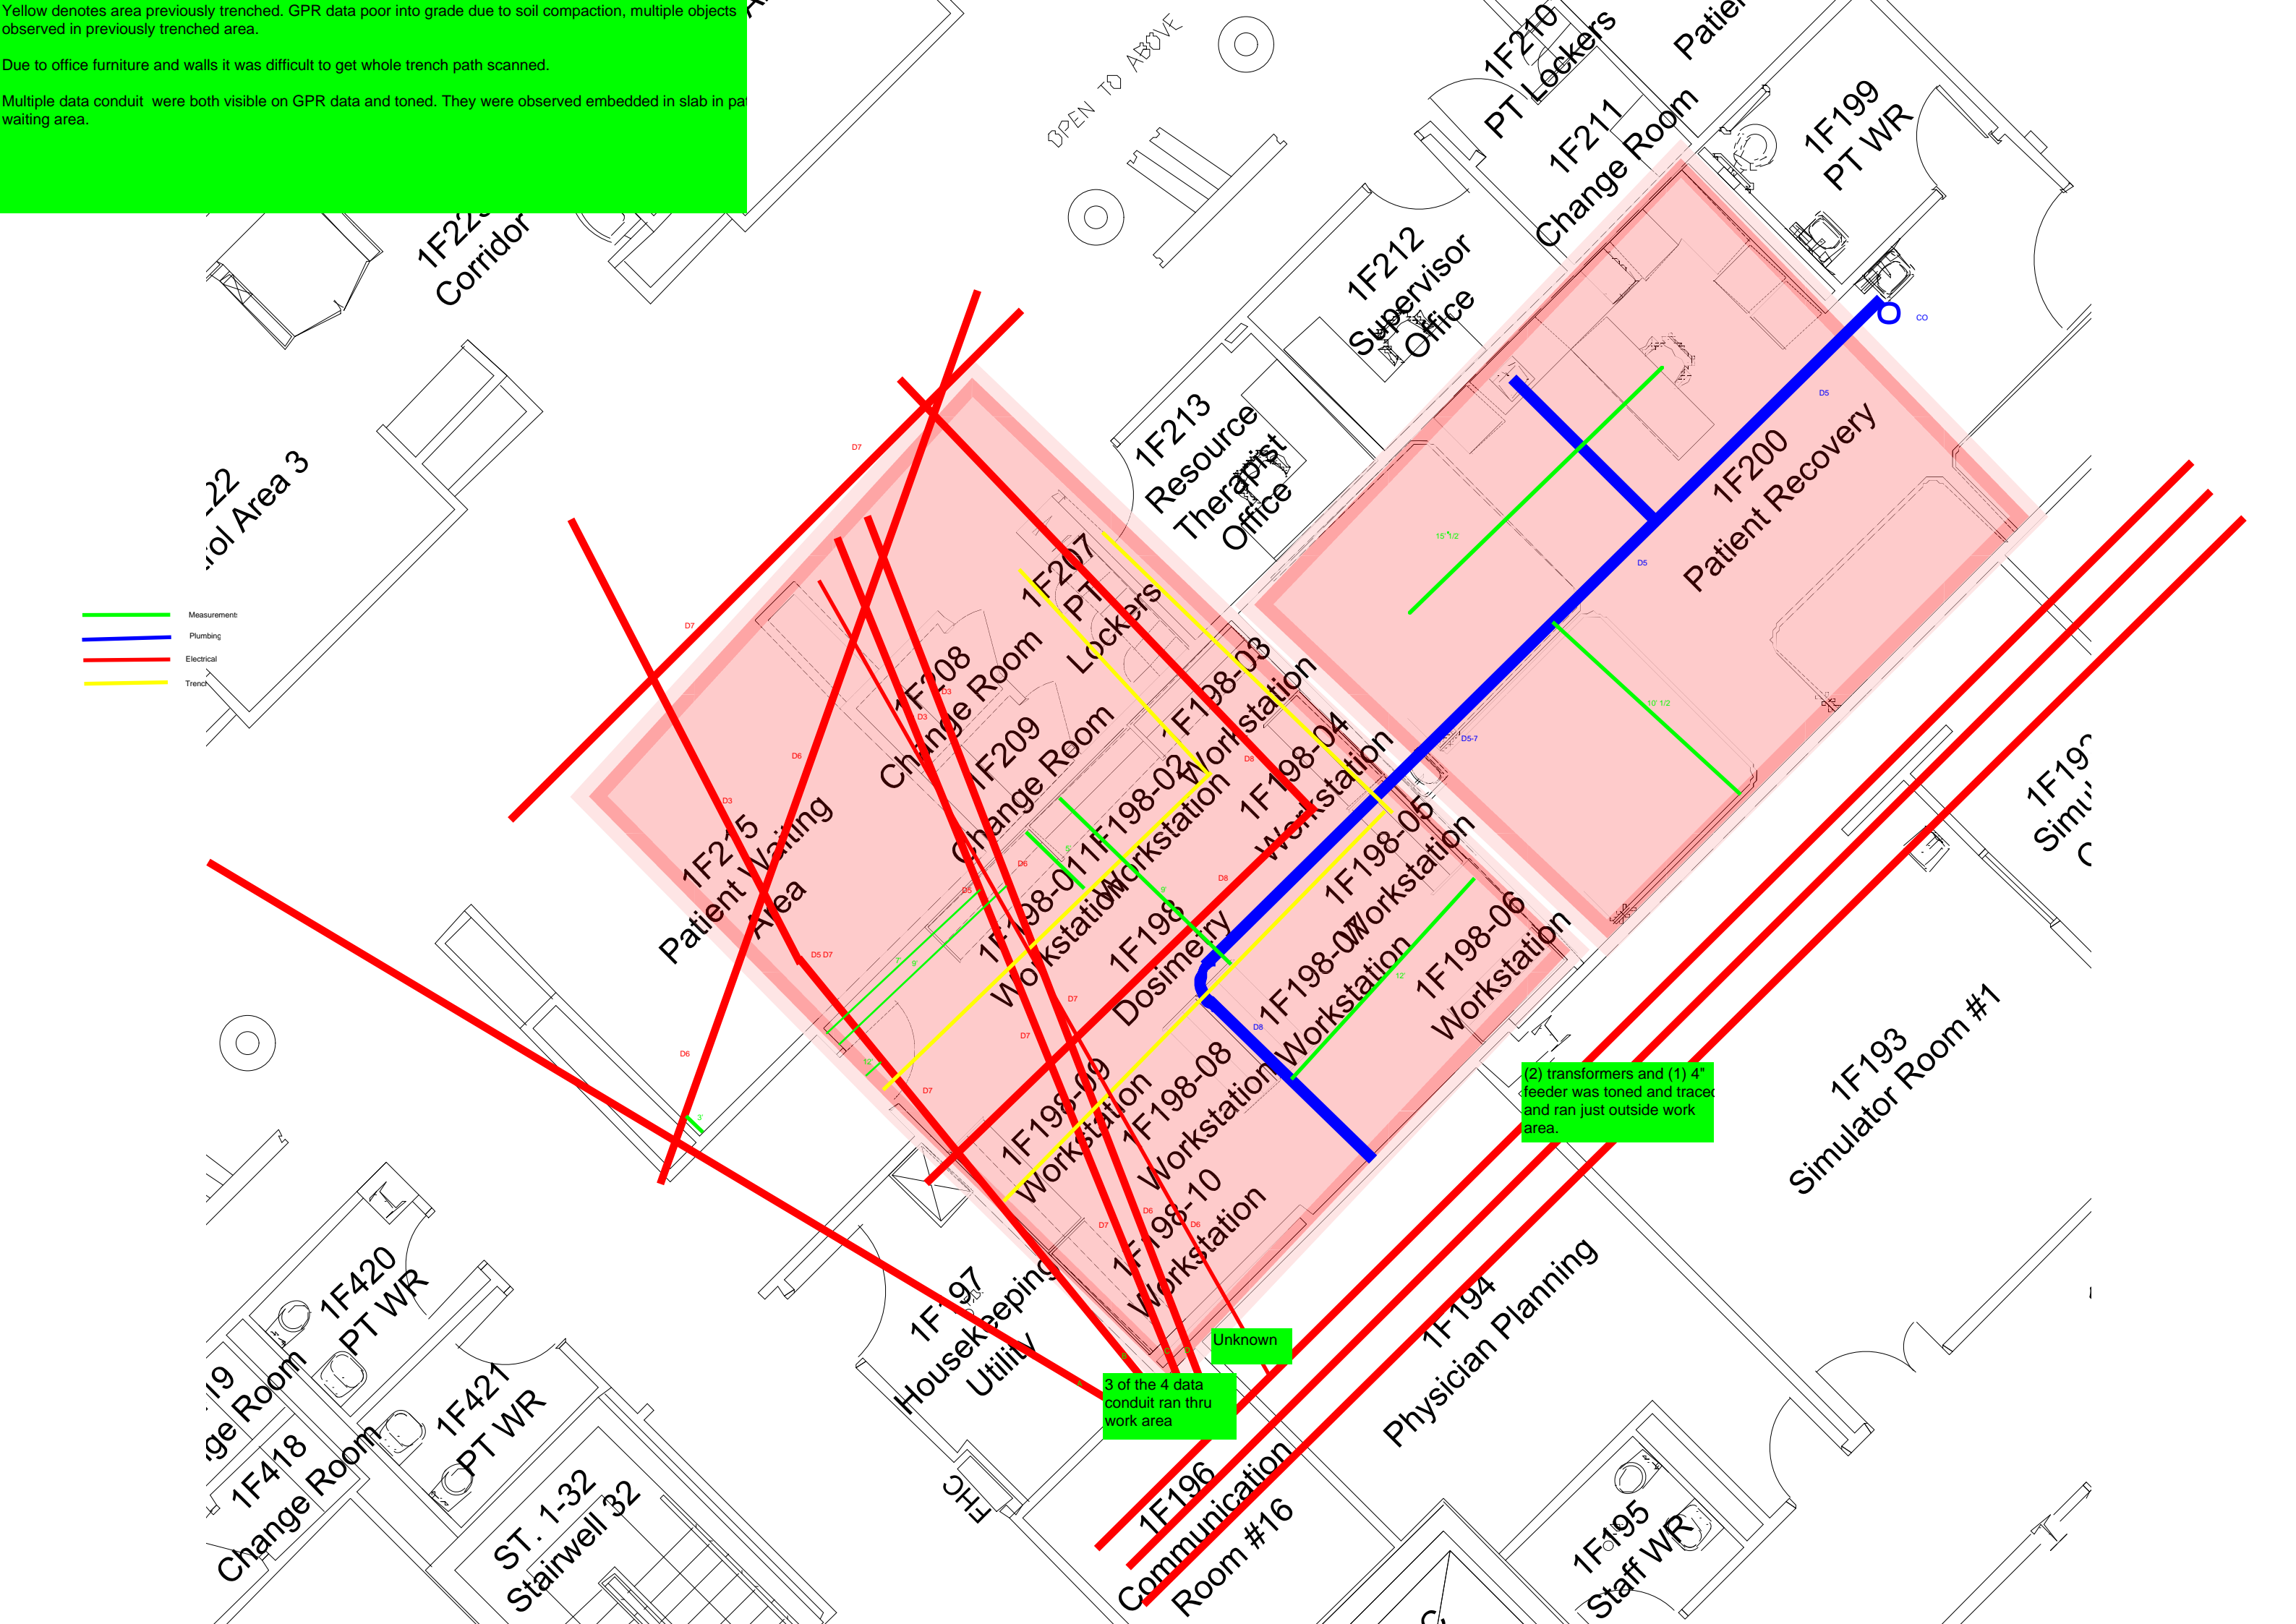
Yellow denotes area previously trenched. GPR data poor into grade due to soil compaction, multiple objects observed in previously trenched area.

Due to office furniture and walls it was difficult to get whole trench path scanned.

Multiple data conduit were both visible on GPR data and toned. They were observed embedded in slab in patient waiting area.
