Designated Substances and Hazardous Materials Survey

Lakeridge Health, Bowmanville Hospital
(Project 185-LHBSR)
47 Liberty Street South, Bowmanville, Ontario

Infrastructure Ontario

22 November 2023

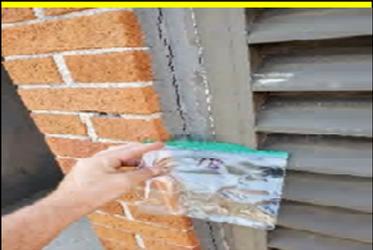
Exterior North Wing	Wall/Ceiling	M	H	CA	20	m					2% Chrysotile	N2 A-C	Caulking - hard, grey north wall, sealing metal louvers to brick

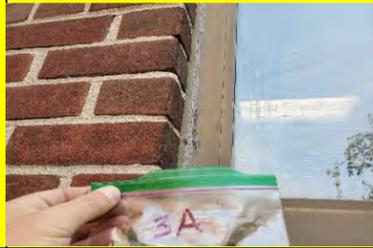
Sample Location	Surface	Material Type	Accessibility	Building Material	Estimated Quantity	Units	Damaged Material	Material Condition			Asbestos Content	Sample ID	Comments	Photographs
		S T M	H M L N					I D SD	NPD PD PSD	F NF				
Exterior North Wing	Wall/Ceiling	M	M	CA	all	Each, m, sm, NQ	%				2% Chrysotile	N3 A-C	Caulking - hard, brown north wall, sealing metal window frame to brick

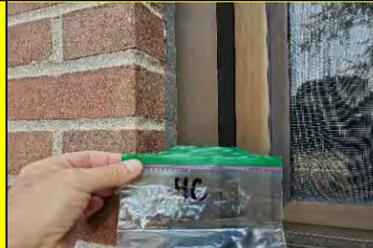
Exterior North Wing	Wall/Ceiling	M	M	CA	all						3% Chrysotile	N4 A-C	Caulking - hard, black north wall, sealing metal window frame to brick

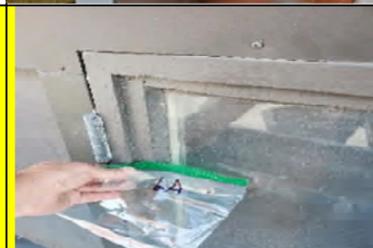
Exterior North Wing	Wall/Ceiling	M	H	WP	80	m	20%	D		NF	2% Chrysotile	N6 A-C	Window Putty northwest corner

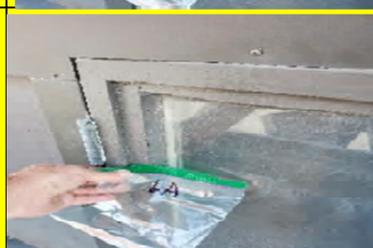
Exterior North Wing	Wall/Ceiling	M	H	CA	2	m		I		NF	2% Chrysotile	N7 A-C	Caulking - hard, white single window in courtyard / service entrance

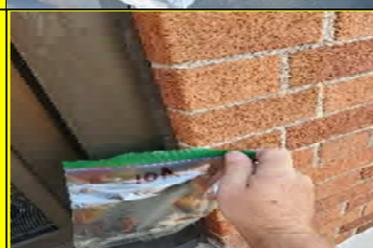
Exterior South Wing	Wall/Ceiling	M	H	CA	all			I		NF	2% Chrysotile	S10 A-C	Caulking - hard, brown sealing metal windows to brick

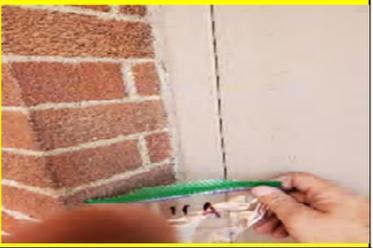
Sample Location	Surface	Material Type	Accessibility	Building Material	Estimated Quantity	Units	Damaged Material	Material Condition			Asbestos Content	Sample ID	Comments	Photographs		
								I	D	SD					NPD	PD
		S T M	H M L N			Each, m, sm, NQ	%									
Exterior South Wing	Wall/Ceiling	M	H	CA	30	m		I			NF	1% Chrysotile	S11 A-C	Caulking - soft, white east (service) wall, sealing metal door frame to brick

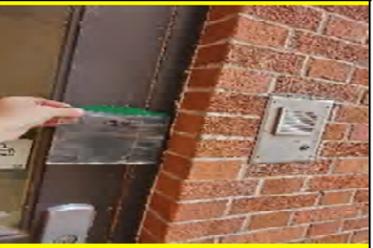
Exterior South Wing	Wall/Ceiling	M	H	CA	30	m		I			NF	2% Chrysotile	S12 A-C	Caulking - hard, white east (service) and south wall, sealing metal window and door frames to brick

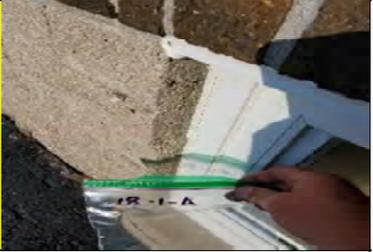
Sample Location	Surface	Material Type	Accessibility	Building Material	Estimated Quantity	Units	Damaged Material	Material Condition			Asbestos Content	Sample ID	Comments	Photographs
		S T M	H M L N					I D SD	NPD PD PSD	F NF				
Garage Exterior	Siding			Transite Panels	800	sf					10% Chrysotile	3 A-C	Transite Panels	
Basement	Floor			VSF							ND(0.1%)	4 A-C	Vinyl Sheet Flooring (White with Green Diamonds)	
Basement Furnace Room	Wall			IN							ND(0.1%)	5 A-C	Black Paper within Wall cavity	
Garage Exterior (behind transite paneling)	Siding			IN							ND(0.1%)	6 A-C	Exterior Black Paper	
18 Prince Street Residence, Bowmanville - GHD Sampling Conducted in September 2023														
House Exterior Windows and Doors	Window and Door Frames	M	M	CA	40	m	0.1	I	NPD	NF	5% Chrysotile	18-1 A-C	Black Tar behind white, rigid caulking

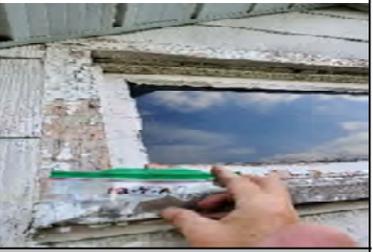
Garage Exterior	Window Frame	M	L	WP	6	m	30%	D	PD	NF	ND(0.1%)	18-2 A-C	Window Putty north garage window

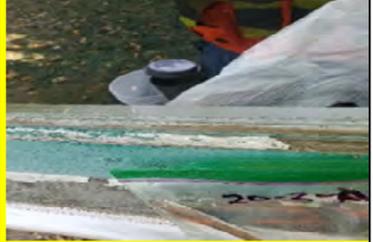
Garage	Window Frame	M	L	WP	6	m	0.3	D	PD	NF	2% Chrysotile	20-2 A-C	Window Putty north garage window

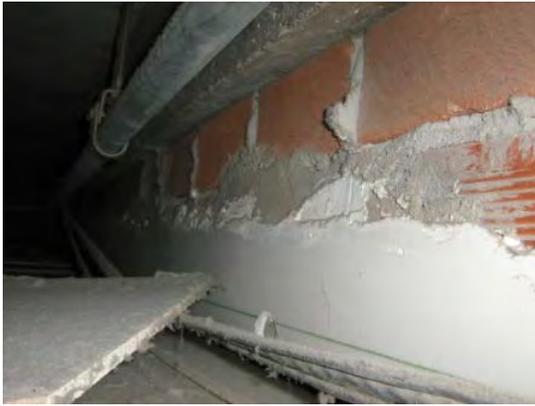
Photo 1 – Plaster on brick – Sample S002

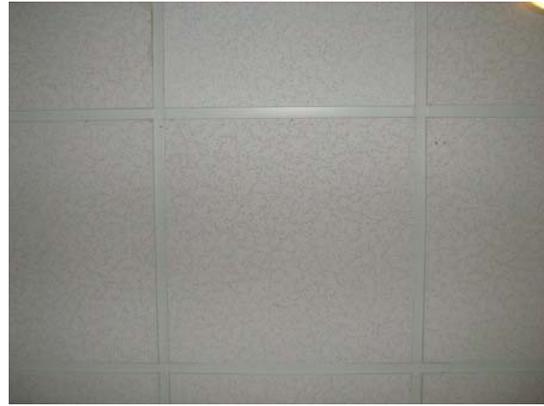
Photo 2 – 2' x 2' Acoustic ceiling tile –
Sample S001

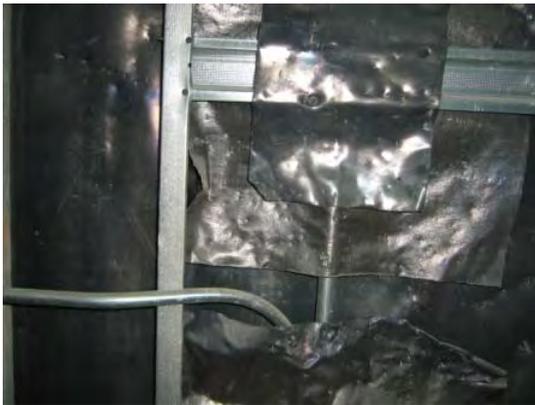
Photo 3 – Lead sheeting

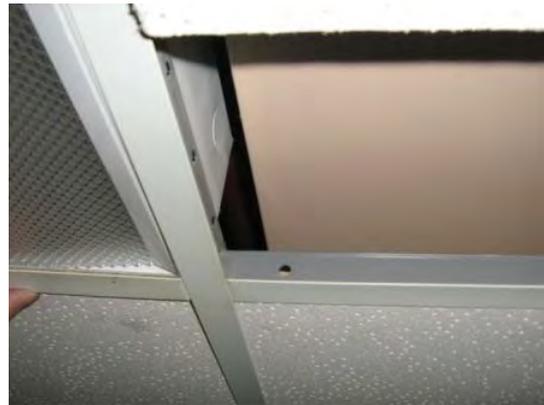
Photo 4 – 2' x 4' Acoustic ceiling tile
random pinhole – Sample S003

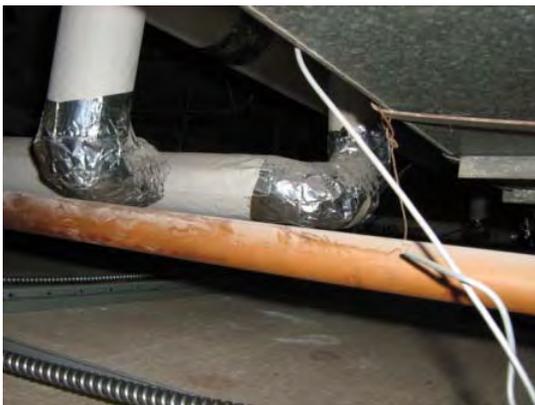
Photo 5 – Fiberglass insulated pipe with
paper covering and foil taped elbows

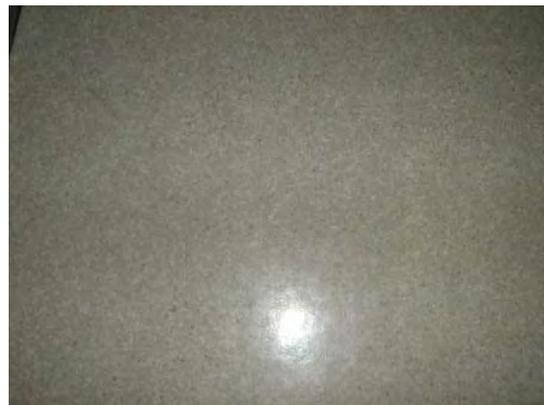
Photo 6 – Vinyl sheet flooring – Sample
S005

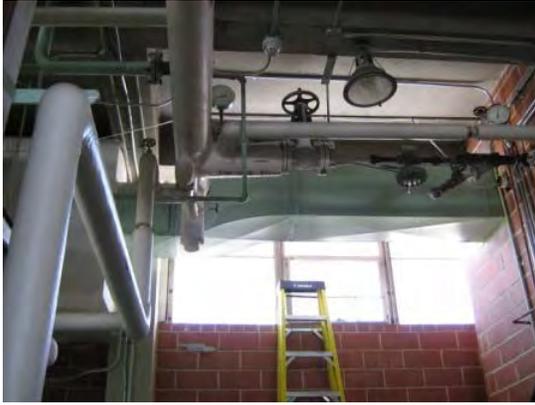
Photo 7 – Pipes insulated with fibreglass insulation

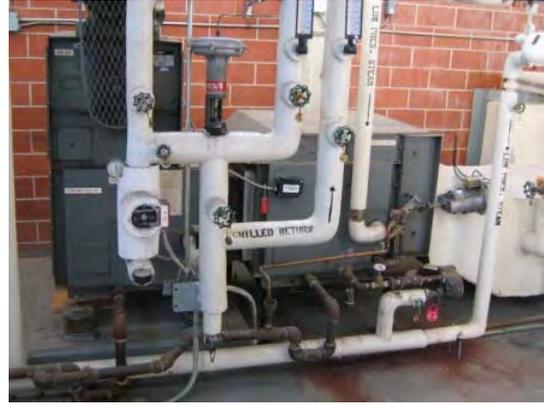
Photo 8 – Pipes insulated with fibreglass insulation

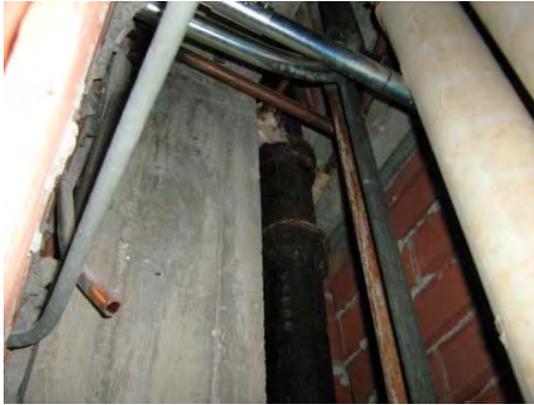
Photo 9 – Pipes inside pipe chase

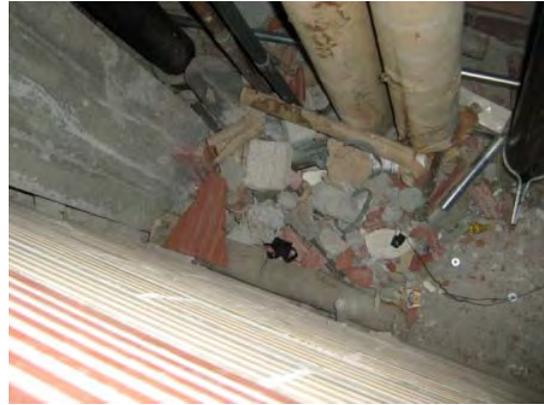
Photo 10 – Debris inside pipe chase

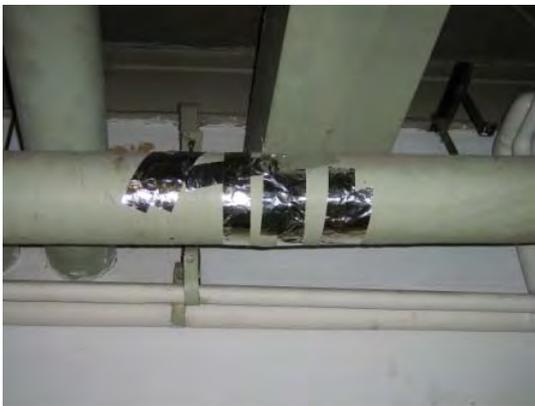
Sweatwrap not containing asbestos (samples 001A-C), parging cement on seams containing asbestos (sample 002A), room NG20

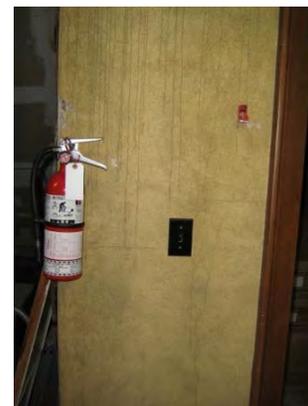
Plaster, containing asbestos, painted yellow, (sample 011A), attic level of Residence building

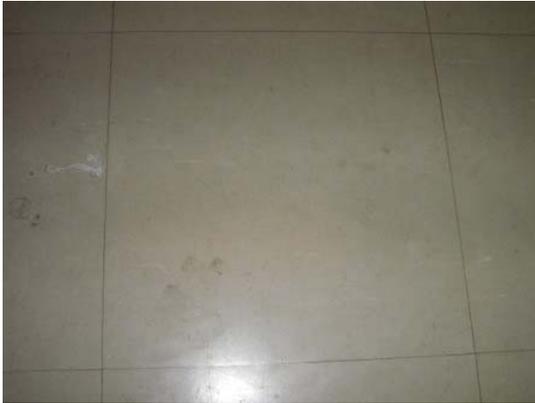
Vinyl floor tile, 12"x12", beige, pattern of white streaks, location NG29, Clean Linen, contains no asbestos (sample 003A-C)

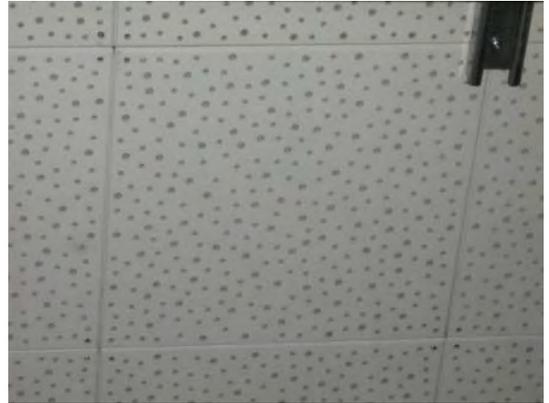
Screwed-on acoustic ceiling tile, 1'x1', white, pattern of large and medium round holes, location NG02, Bell Telecom room, contains no asbestos (sample 005A-C)

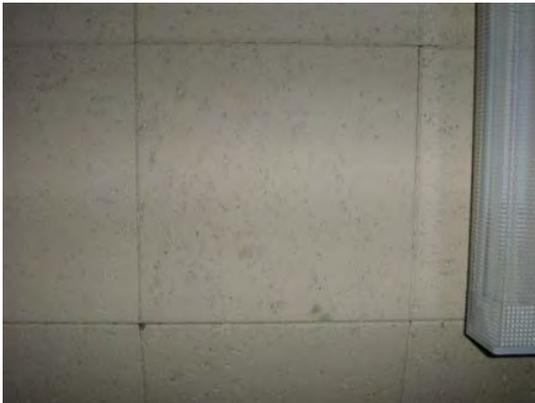
Glued-on acoustic ceiling tile, 1'x1', white, pattern of widthwise fissures, location SG38, Library, contains no asbestos (sample 007A-C)

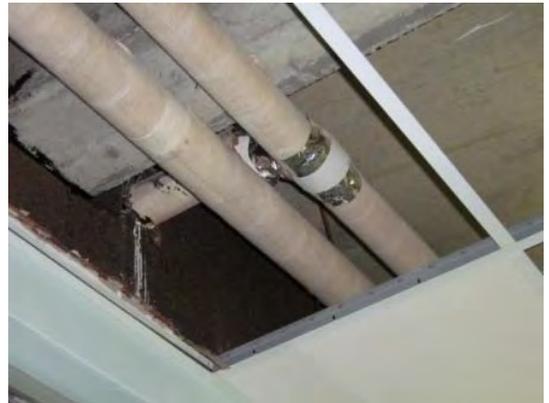
Typical above-ceiling view in South Wing. Note fiberglass straight sections with canvas covering, fiberglass fittings with paper and foil tape coverings, location: corridor outside room S110

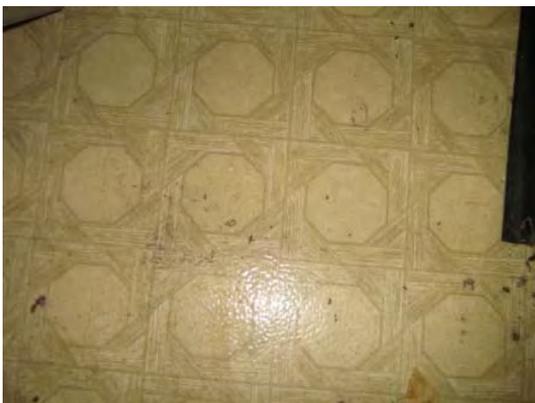
Vinyl sheet flooring, yellow with a beige pattern, present in old bathroom area in Blue Shed, assumed to contain asbestos in the paper backing layer

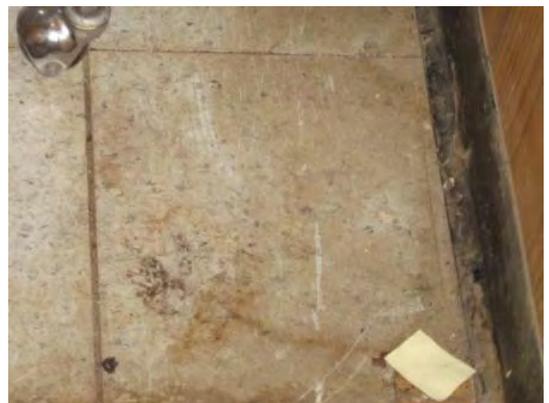
Vinyl floor tile, 12"x12", gray with black flecks, present in old bathroom area in Blue Shed, assumed to contain asbestos

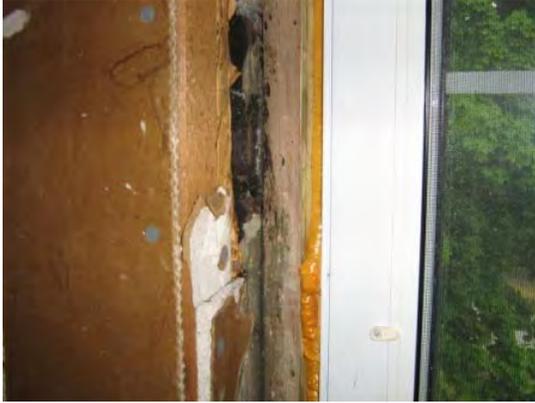
Black caulking, around window, location: Attic level of Residence building, contains no asbestos (sample 010A-C)

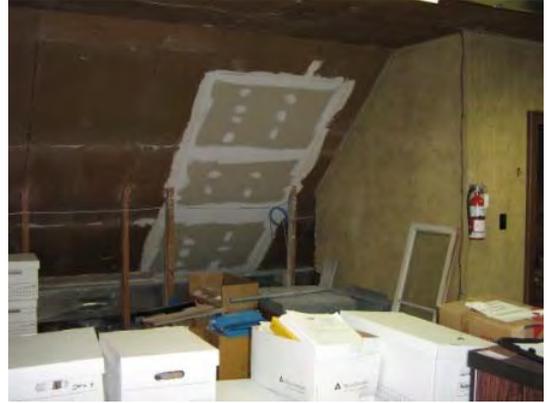
Typical view of new drywall in Residence Attic level, drywall compound contains no asbestos due to date of installation

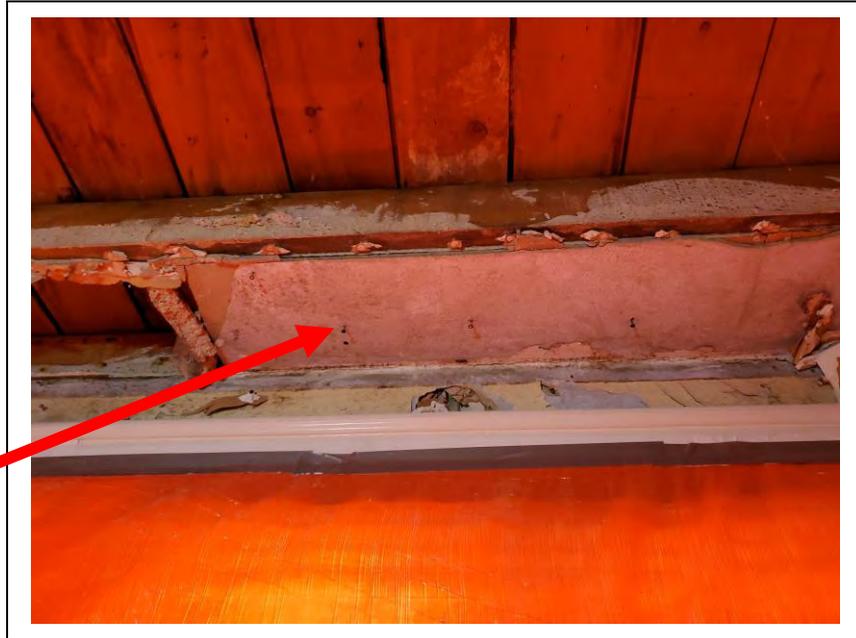
P1 – 1st Floor Board Room

View of the cement plaster finish confirmed to be Non-ACM.

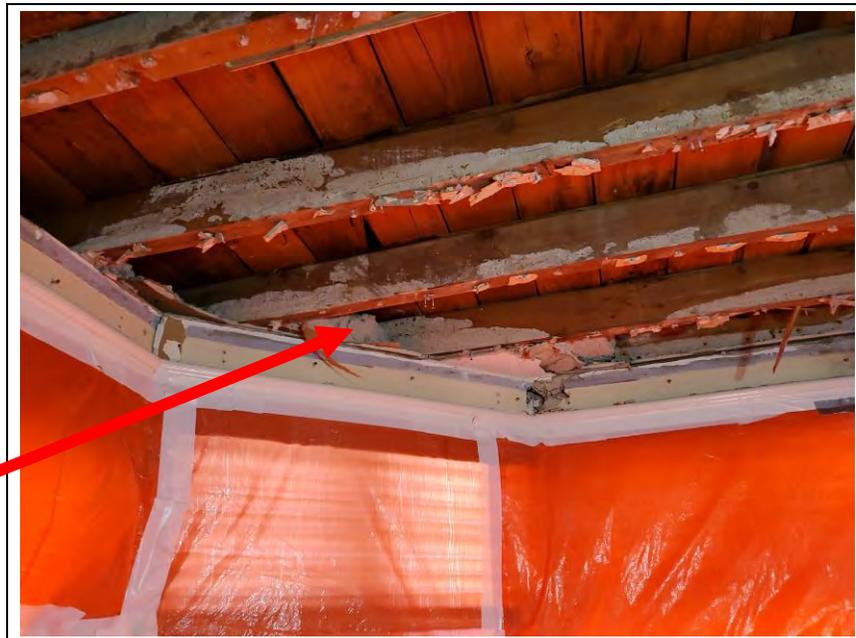
P1 – 1st Floor Board Room

View of the trowel cementitious material confirmed to be Non-ACM.

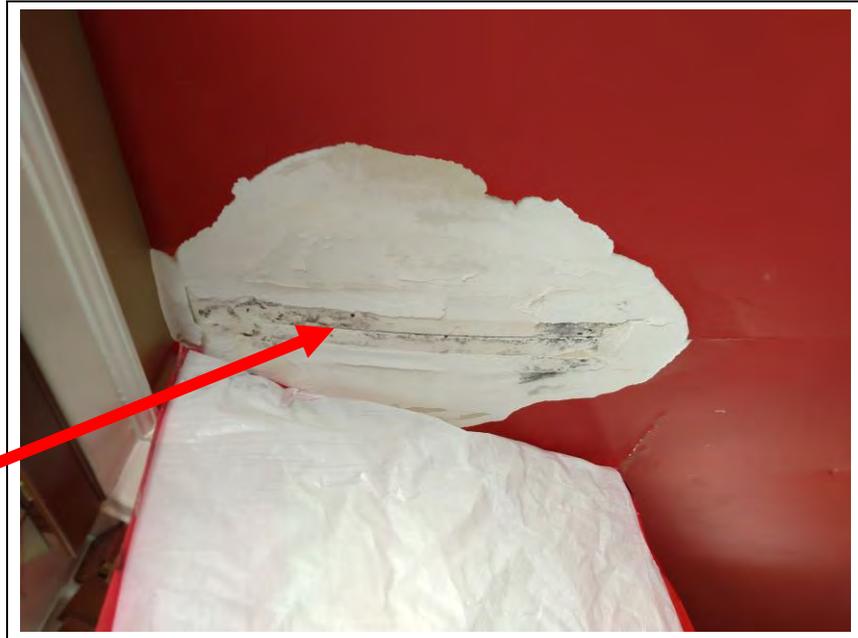
P1 – 1st Floor Board Room

View of the drywall joint compound – ceiling finishes confirmed to be Non-ACM.

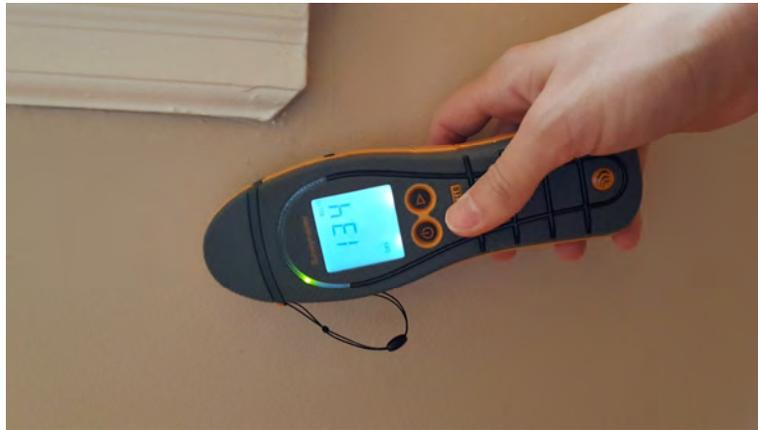
P4

Room #3: Moisture readings obtained from building finishes indicated dry moisture conditions (<200REL).

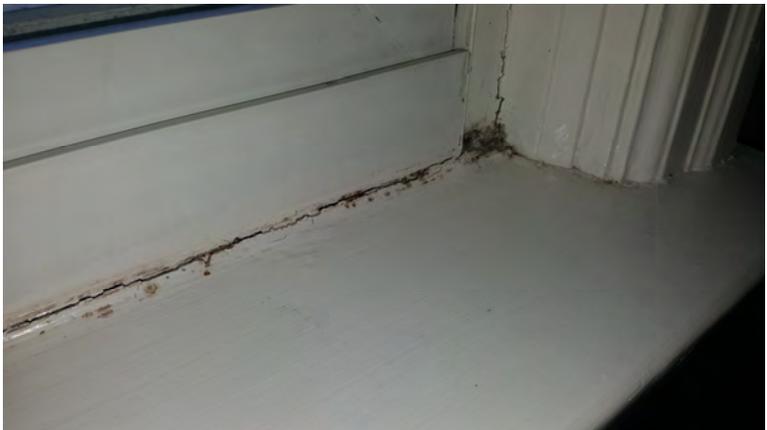
P6

Room #1: Superficial mould growth identified to the window framing.

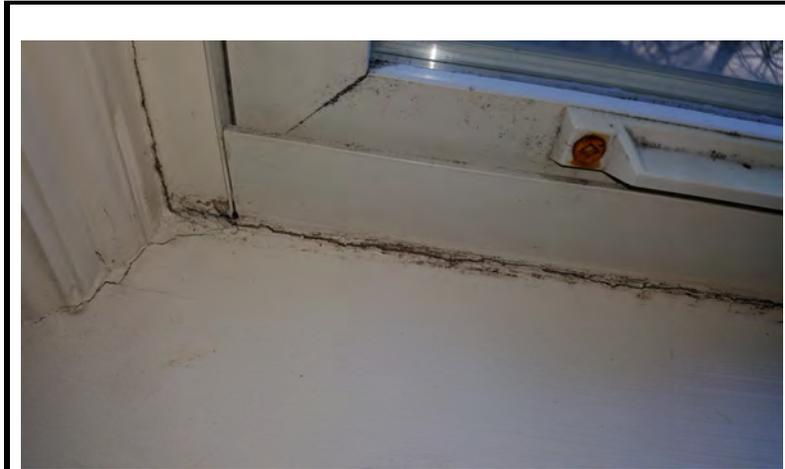
P7

Room #1: Superficial mould growth identified to the window framing.

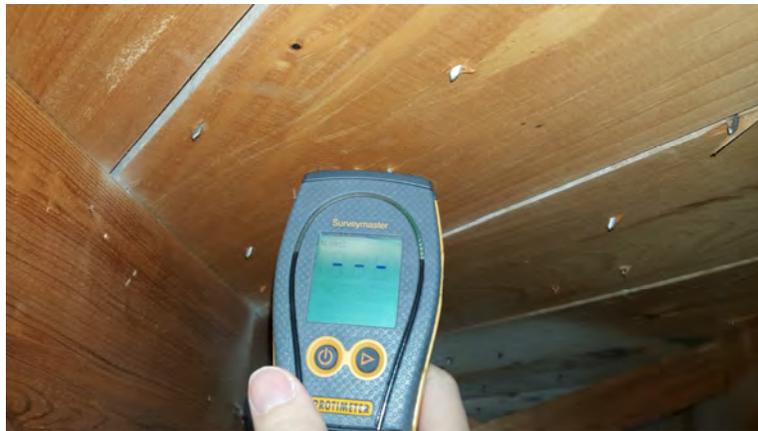
P14

Basement: Moisture readings obtained from the wooden ceiling deck exhibited dry moisture conditions (<15%MC).
