DESIGNATED SUBSTANCES AND HAZARDOUS BUILDING MATERIALS ASSESSMENT

FINAL REPORT

YWCA Kitchener-Waterloo, Emergency Shelter
84 Frederick Street, Kitchener, Ontario

July 5, 2024

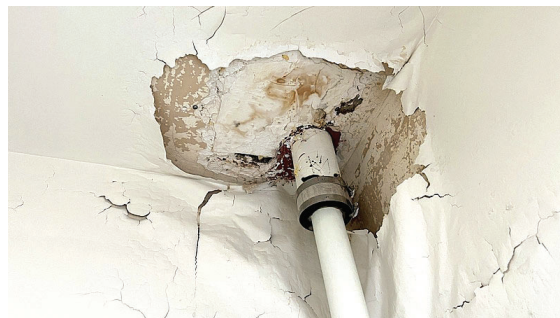
All paint and surface applications are presumed to be lead-containing. The paints were generally in good condition, though some areas exhibited loose and flaking applications.

Photo 2: Example of loose and flaking paint.

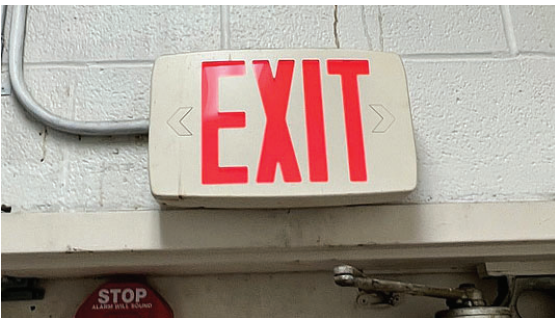
Photo 3: Example of emergency exit sign and lighting suspected to contain lead-acid batteries.

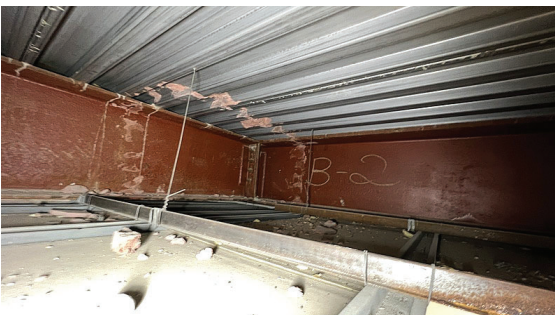
Photo 5: Example of structural steel primer suspected to contain lead.

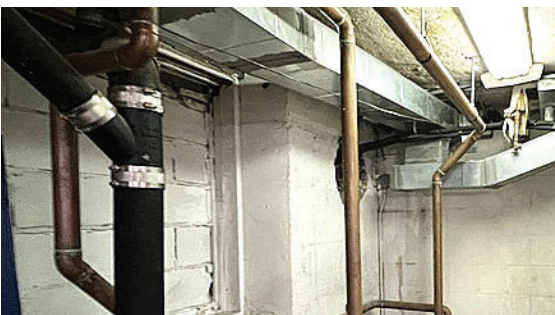
Photo 7: Example of solder used on domestic water lines suspected to contain lead.

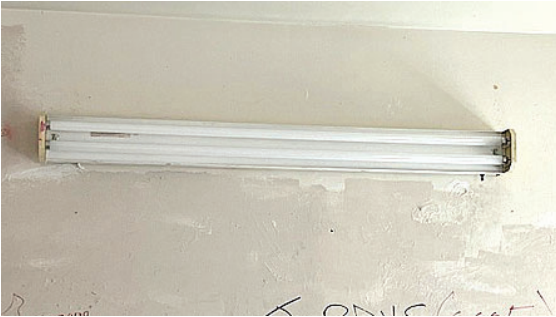
Photo 8: Example of light fixture with fluorescent light tubes suspected to contain mercury (vapour form).

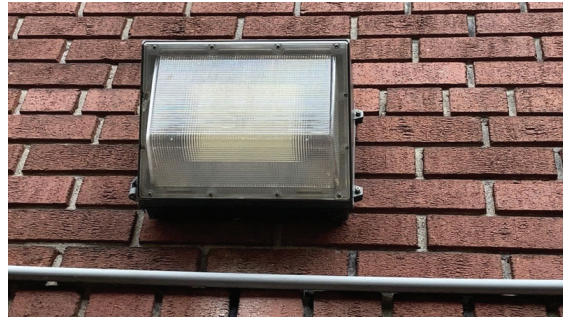
Photo 9: Example of high intensity discharge light fixture suspected to contain mercury (vapour form).

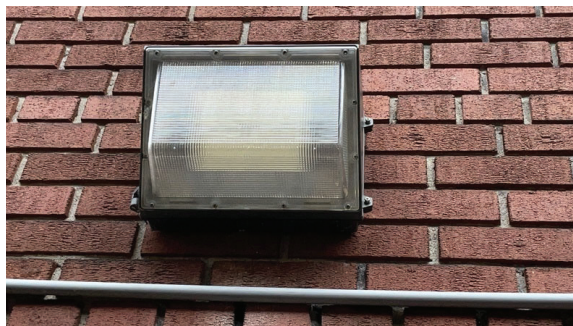
Photo 11: Example of high intensity discharge light fixture suspected to contain PCB ballast.

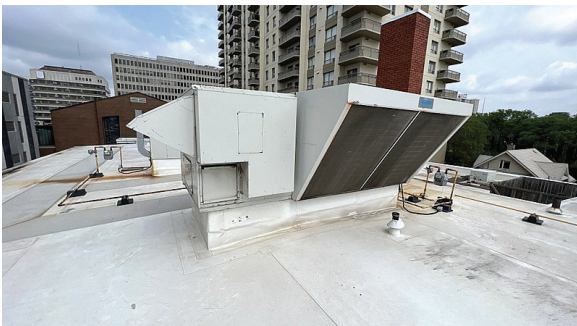
Photo 12: Example of rooftop HVAC units suspected to contain ODS.

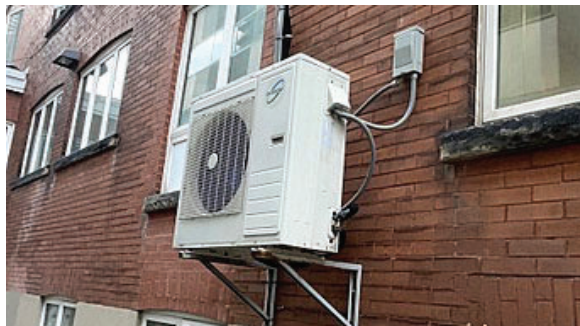
Photo 13: Example of air conditioning unit suspected to contain ODS.

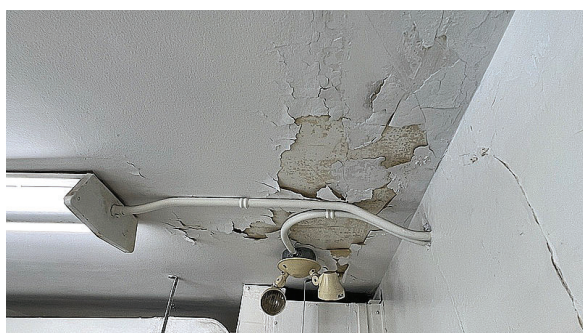
Mould Growth Indicator	Location	Building Material Impacted	Quantity (approx.)
Water damage	Room 332 (1937)	ceiling	5 sf
Water damage	Room 322 (1937)	ceiling	5 sf
Water damage	Room 234 (1937)	ceiling	5 sf
Water staining	First Floor Lounge (1914) (L1-11)	ceiling tiles	-
Water staining	First Floor Dining (L1-14), Kitchen Corridor (L1-17) (1914)	ceiling tiles	-

Photo 16: Example of water damage to paint coating on ceiling in Room 332 (L3-23).

- The degree of mould growth noted may change with time if water or humidity issues continue or develop beyond the assessment date(s). As such, it is recommended that any sources of water infiltration or high humidity be corrected to prevent the continuation or reoccurrence of mould growth prior to remedial efforts and reinstatement of removed materials.

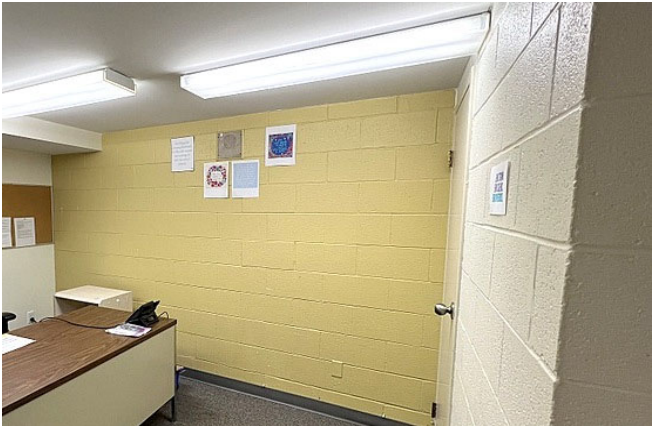
Samples: 018B
Lab Result: 0.5% Chrysotile
Comment: Block wall primer tested contains asbestos.

Location #	Area Description	Quantity	Condition	Damaged	Qty.	Acc.	Vis.	Comments	Recommendation
Various	Where present in the 1914 building.	nq	good	-		A	Yes	Primer on block walls in other areas of the building should be presumed to contain asbestos.	Maintain in good condition. Implement safe work procedures in accordance with the requirements of O. Reg. 278/05 if the primer is likely to be disturbed.

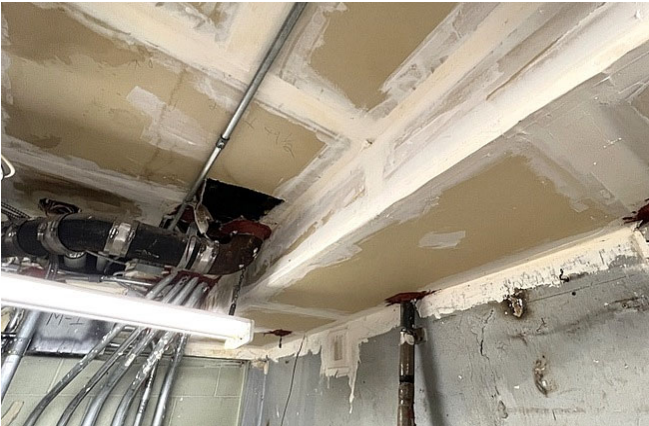
Samples: 019A to C
Lab Result: None detected
Comment: Drywall joint-fill compound tested does not contain asbestos.

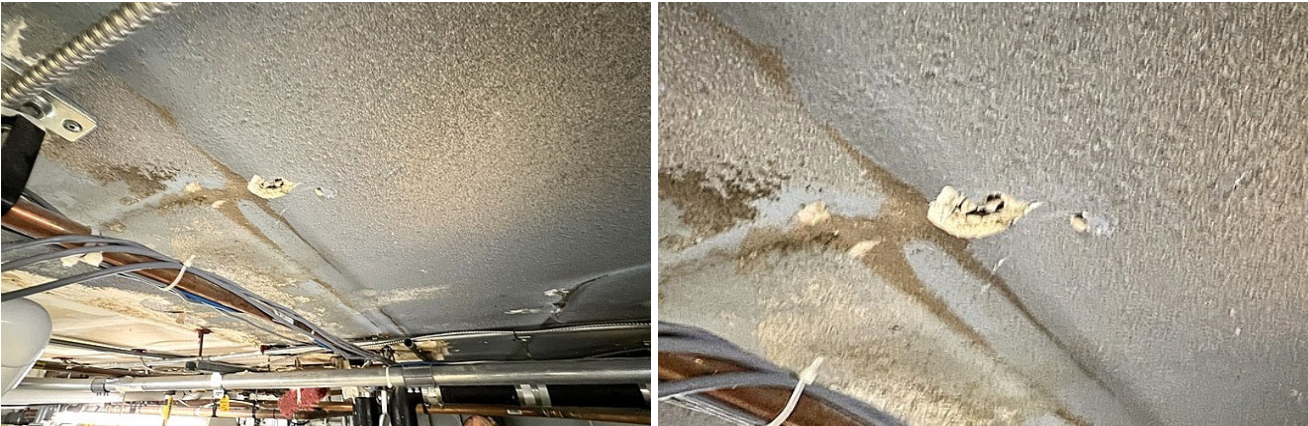
Samples: 020A to C
Lab Result: *None detected*
Comment: Textured plaster tested does not contain asbestos.

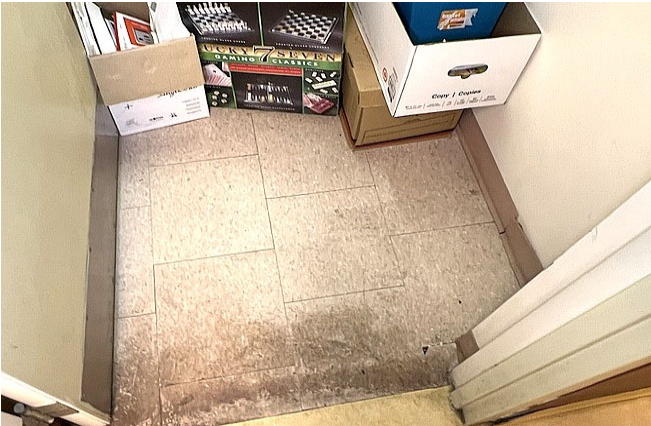
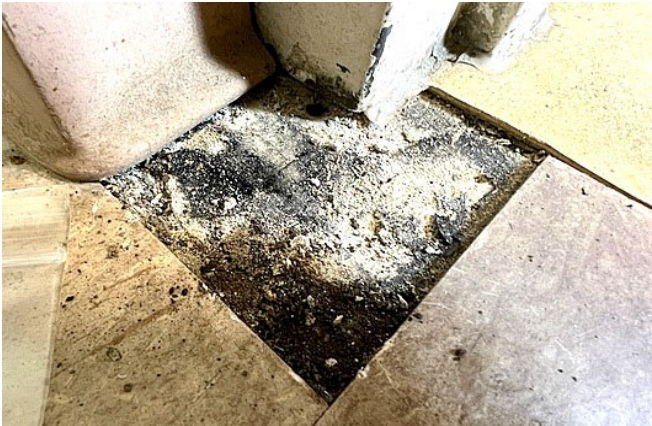
Comment: *Mastic and levelling compound tested do not contain asbestos. Vinyl floor tile does not contain asbestos (2007 installation).*

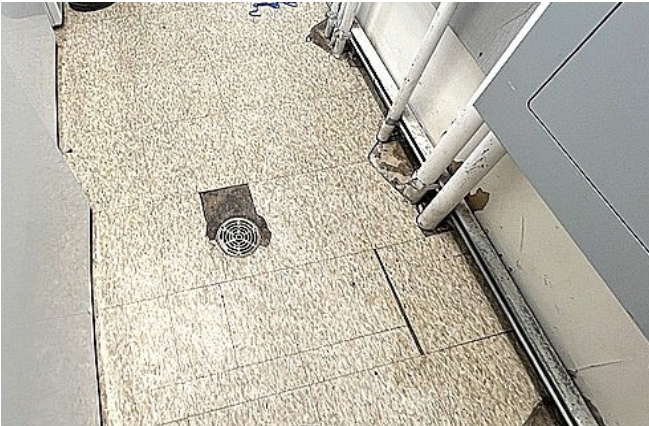
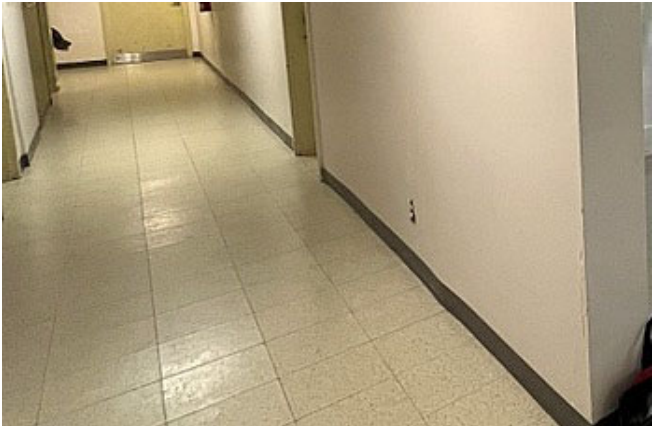
Samples: ns
Lab Result: na
Comment: Vinyl floor tile does not contain asbestos (2007 installation).

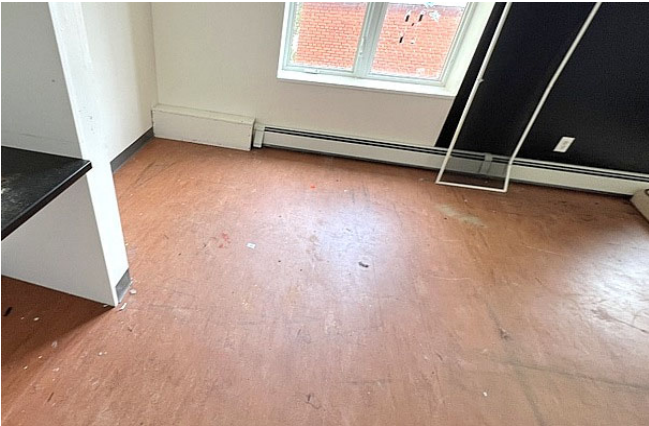
Comment: VSF does not contain asbestos (2007 installation).

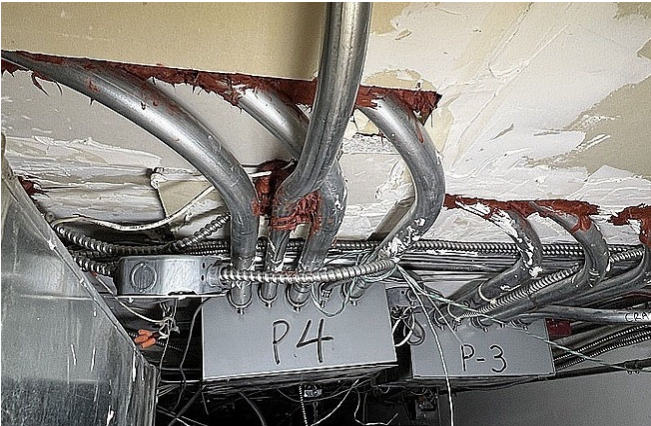
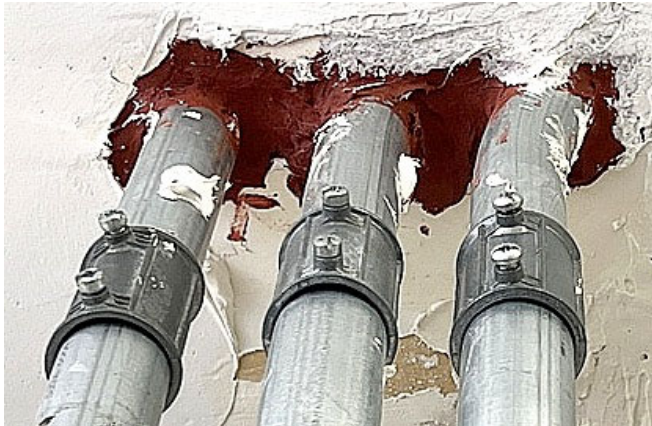
Comment: Fire stop is not expected to contain asbestos (new installation). Other older forms of fire stop may contain asbestos.

Location #	Area Description	Quantity	Condition	Damaged Qty.	Acc.	Vis.	Comments	Recommendation
								If encountered and likely to be disturbed, test older forms of fire stop for asbestos.

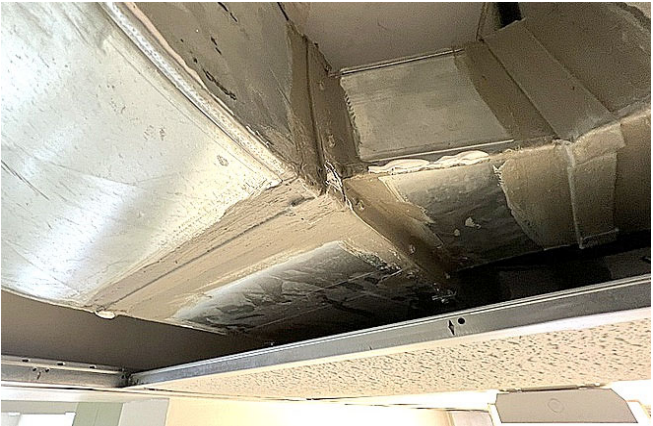
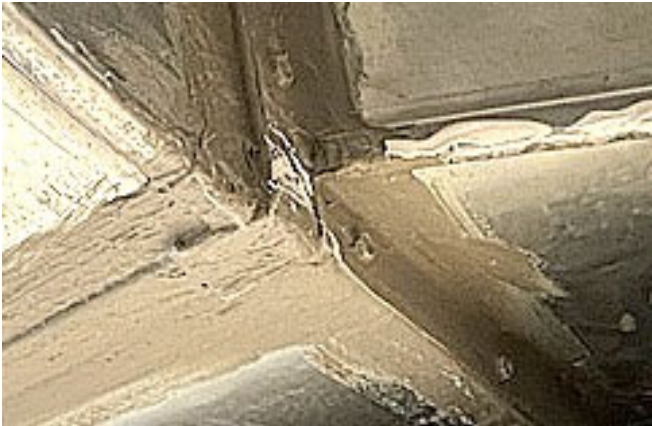
Samples: *ns*
Lab Result: *na*
Comment: *Sealant is not expected to contain asbestos (installed during 2007 renovations).*

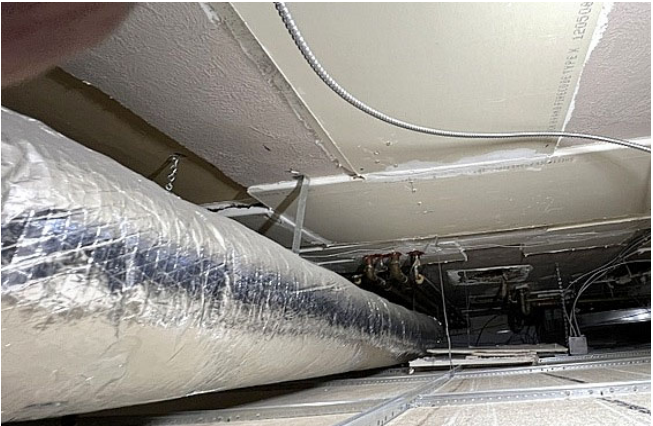
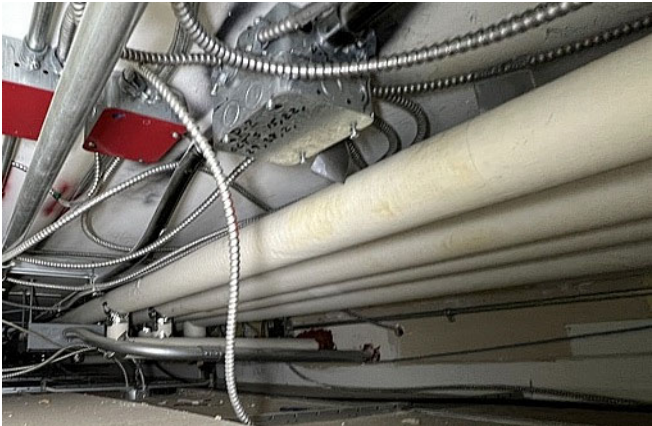
Samples: ns
Lab Result: na
Comment: Pipes and ducts are either bare or insulated with fibreglass (non-asbestos).

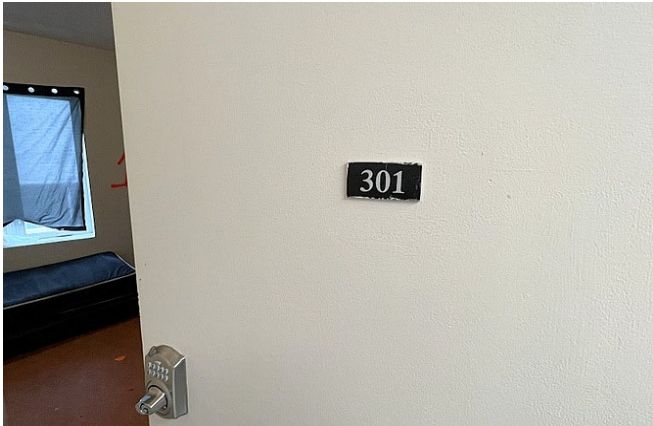
Friable: PFM

Lab Result: PACM

Location #	Area Description	Quantity	Condition	Damaged Qty.	Acc.	Vis.	Comments	Recommendation
Various	Where present in the 1914 building	nq	good	-	D	No	Cores of fire-rated doors are presumed to contain asbestos insulation until intrusive inspection and testing prove otherwise.	Intrusive testing of door core for insulation should be undertaken when door is removed or insulation may be disturbed to determine if it contains asbestos. Dispose of door in accordance with O. Reg. 278/05 requirements if core contains asbestos.

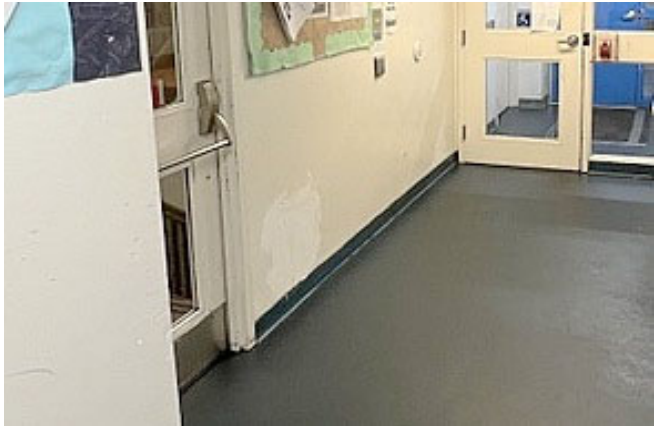
Comment: *Baseboard mastic is not expected to contain asbestos (2007 installation).*

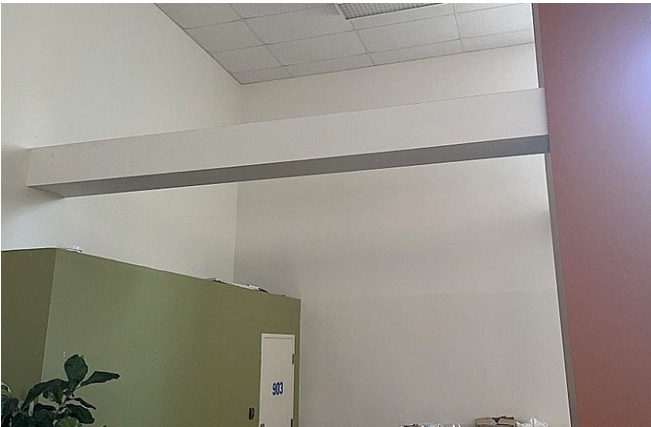
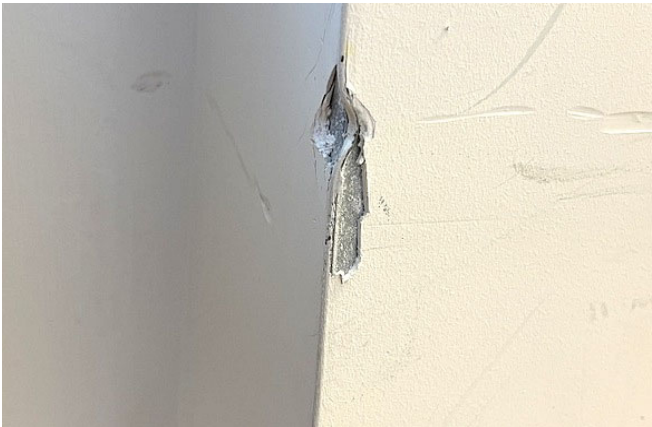
Comment: Drywall joint-fill compound tested does not contain asbestos.

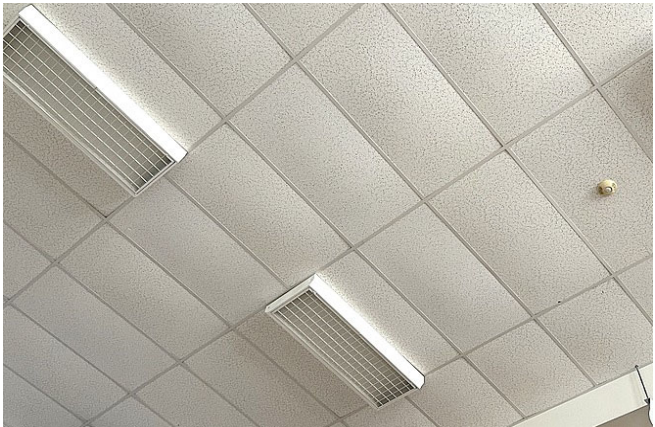
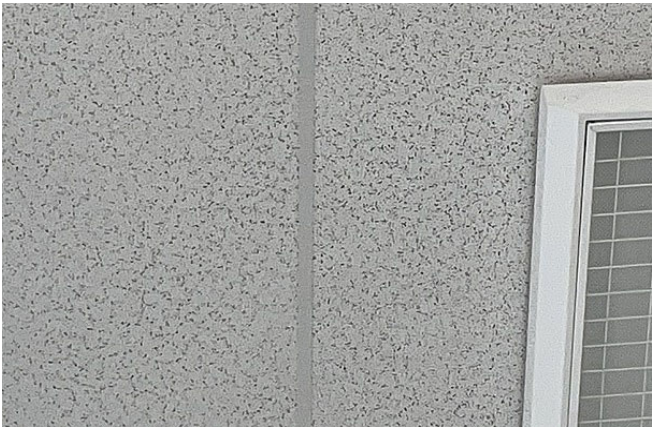
Comment: Ceiling tiles are not expected to contain asbestos (2007 installation).

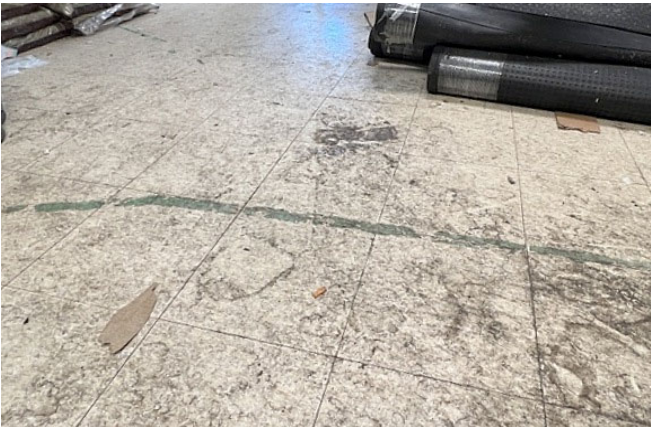
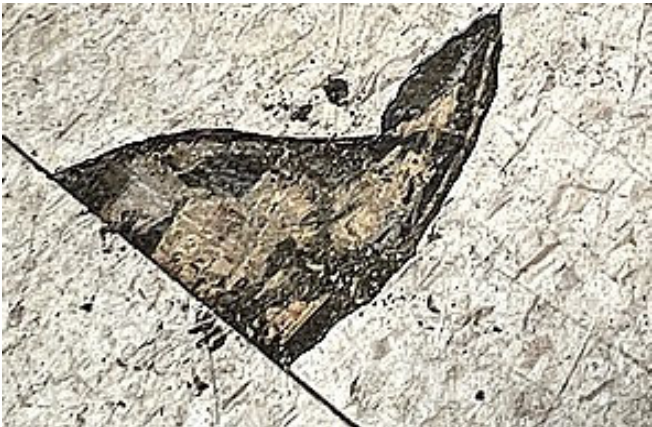
Comment: *Mastic and levelling compound tested do not contain asbestos. Vinyl floor tile does not contain asbestos (2007 installation).*

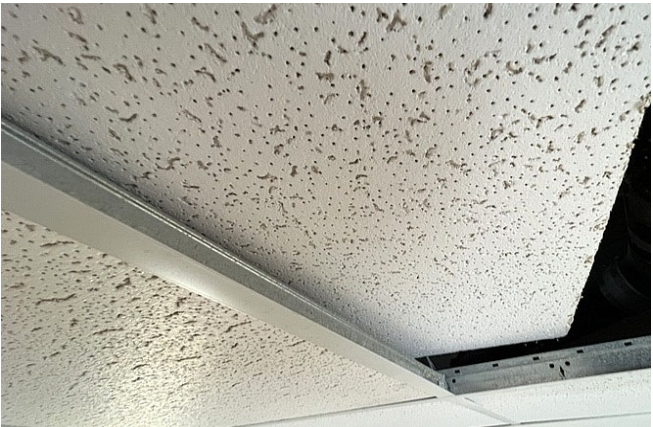
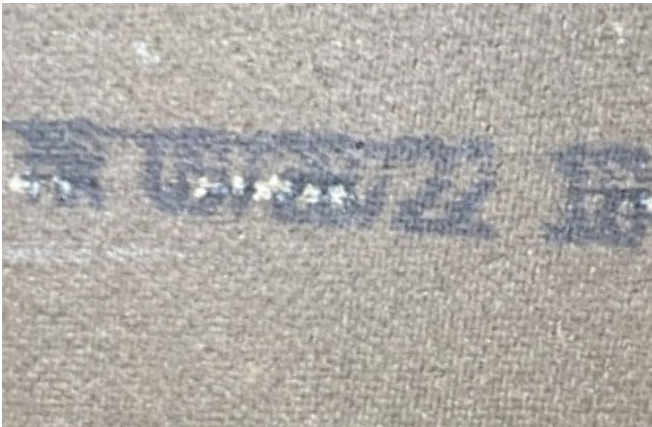
Comment: Ceiling tile does not contain asbestos (date stamped 09/28/22).

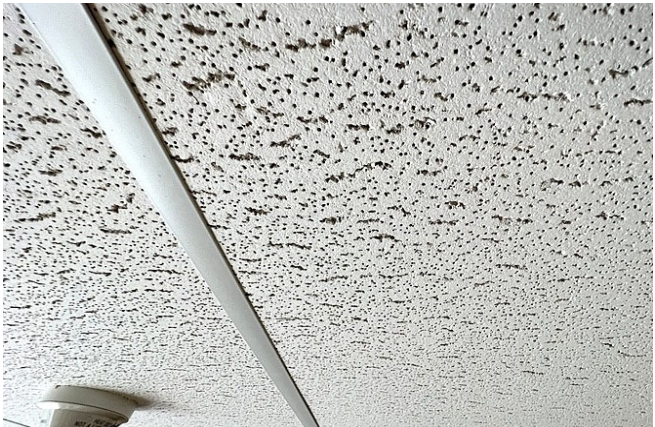
Comment: Ceiling tile does not contain asbestos (date stamped 03/03/07).

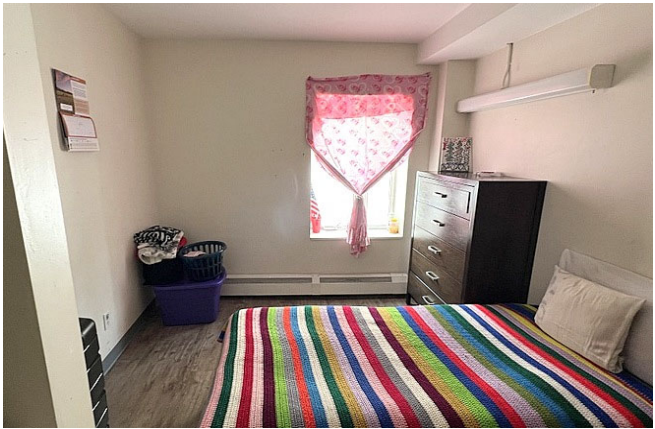
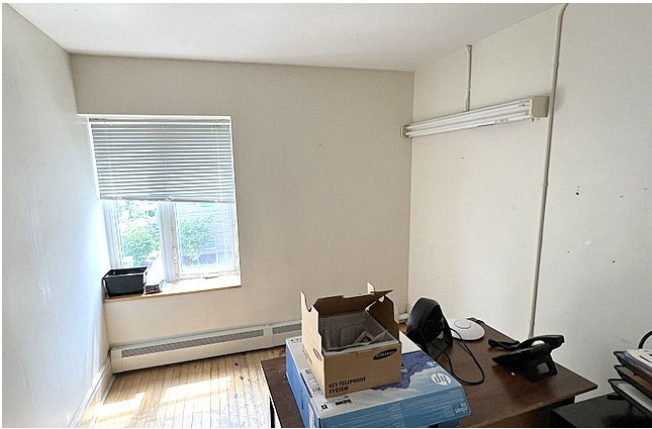
Comment: Drywall joint-fill compound tested does not contain asbestos.

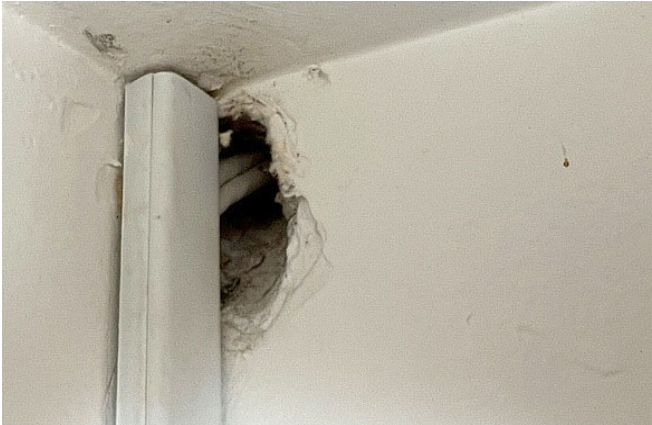
Comment: Plaster tested does not contain asbestos.

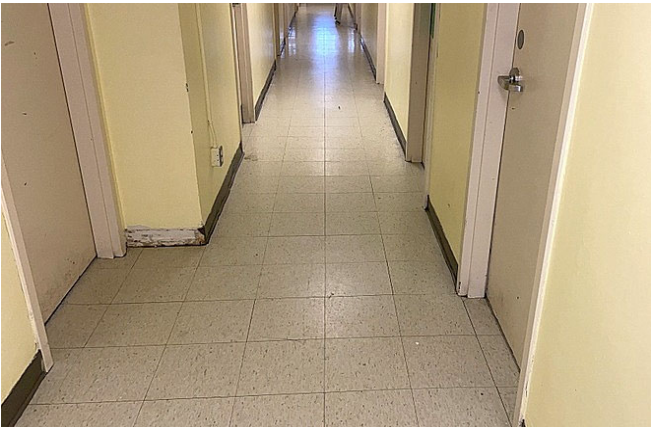
Comment: Mastic and levelling compound tested do not contain asbestos. Vinyl floor tile does not contain asbestos (2007 installation).

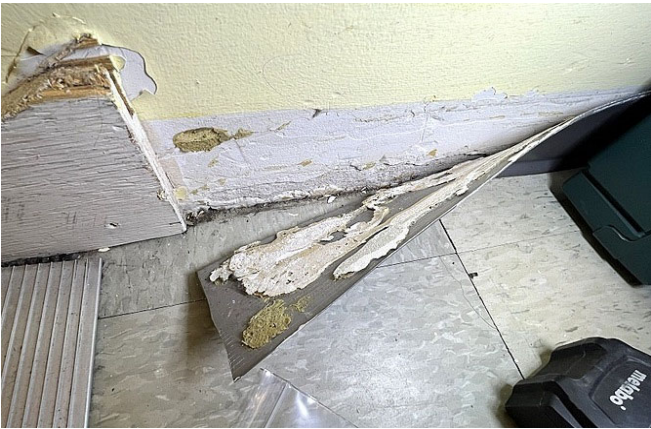
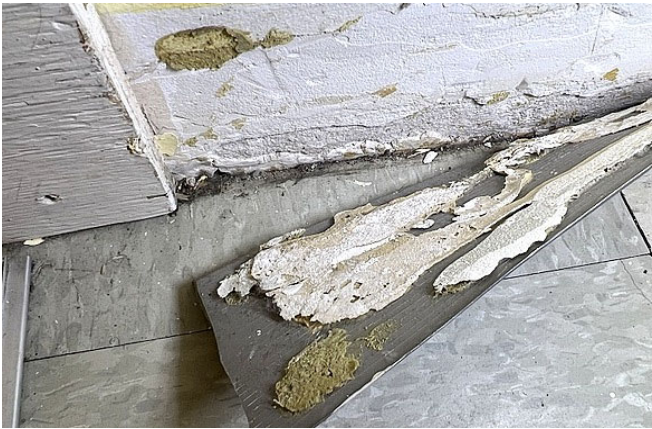
Comment: Mastic tested does not contain asbestos.

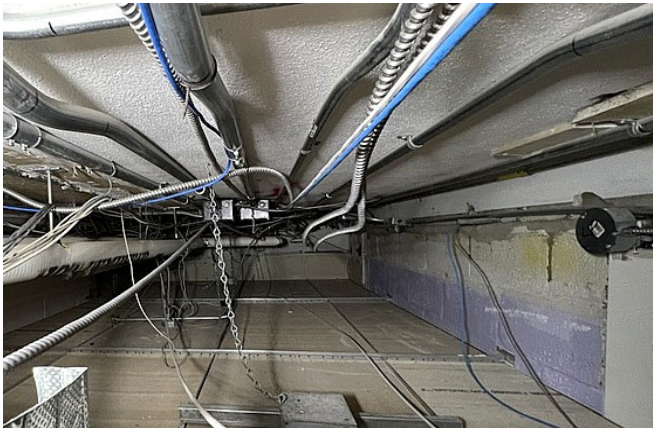
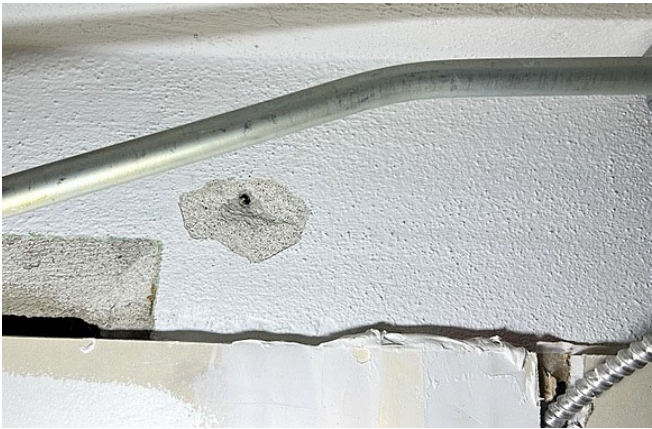
Lab Result: *None detected*

Comment: Textured plaster tested does not contain asbestos.

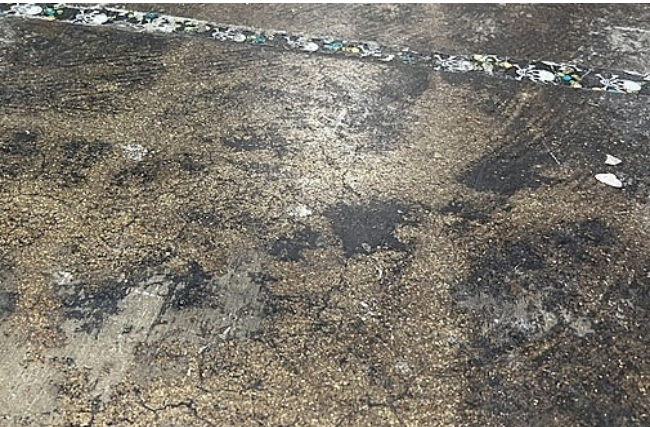
Lab Result: 2% Chrysotile

Comment: Mastic tested contains asbestos. Similar asbestos mastic is likely present concealed beneath flooring in other areas of the 1937 addition.

Location #	Area Description	Quantity	Condition	Damaged Qty.	Acc.	Vis.	Comments	Recommendation
L0-27 L0-37	Heritage Hall (B33) Corridor.	nq	good	-	A	Yes	Similar asbestos mastic is likely present concealed beneath flooring in other areas of the 1937 addition.	Remove mastic following O. Reg. 278/05 Type 1 operations using only non-powered handheld tools while wetting the material. Or remove following O. Reg. 278/05 Type 2 operations using HEPA filtered grinding equipment otherwise Type 3 operations apply.

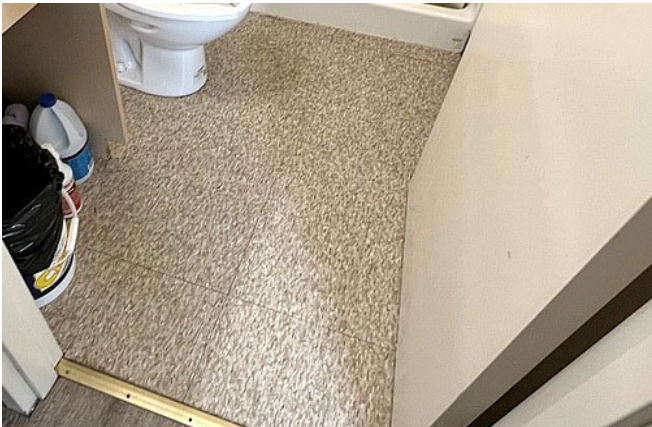
Lab Result: na

Comment: VFT does not contain asbestos (2007 installation).

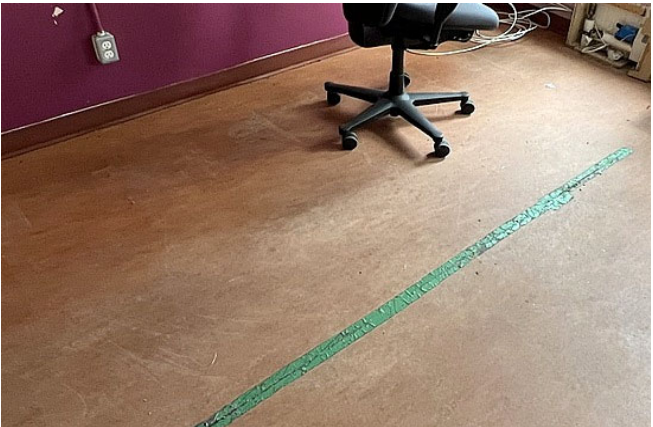
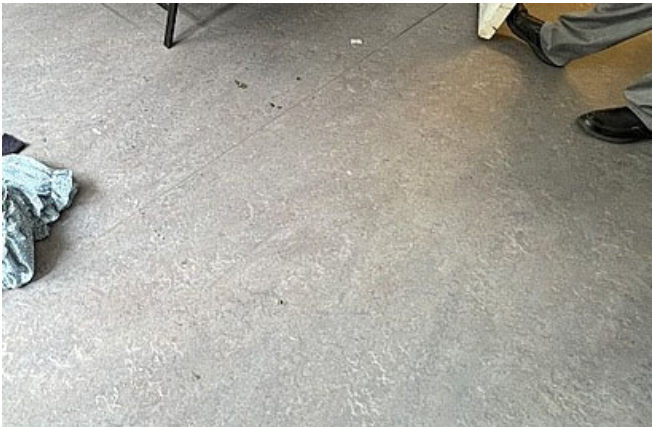
Lab Result: na

Comment: VSF does not contain asbestos (2007 installation).

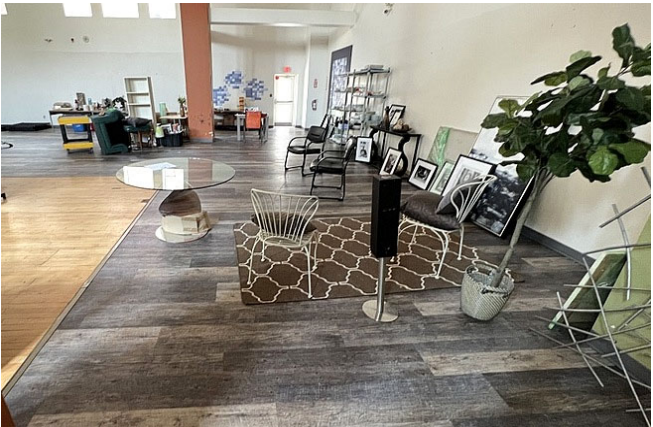
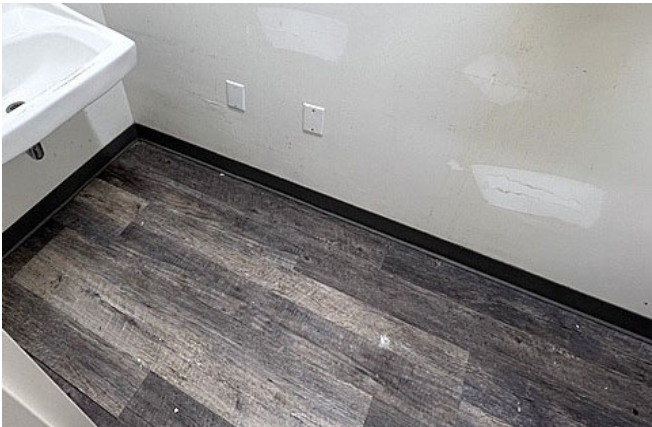
Lab Result: na

Comment: VPF is not expected to contain asbestos.

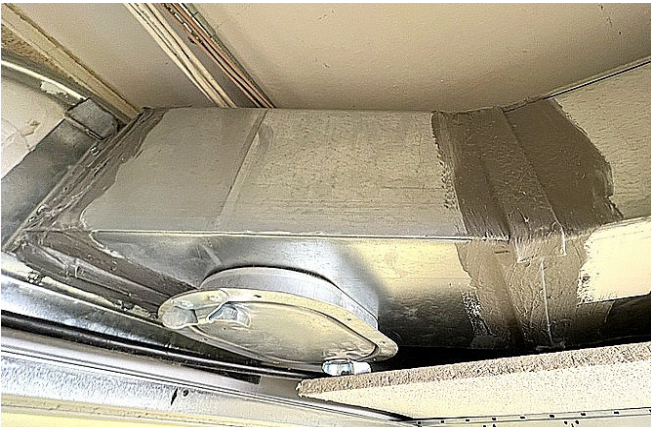
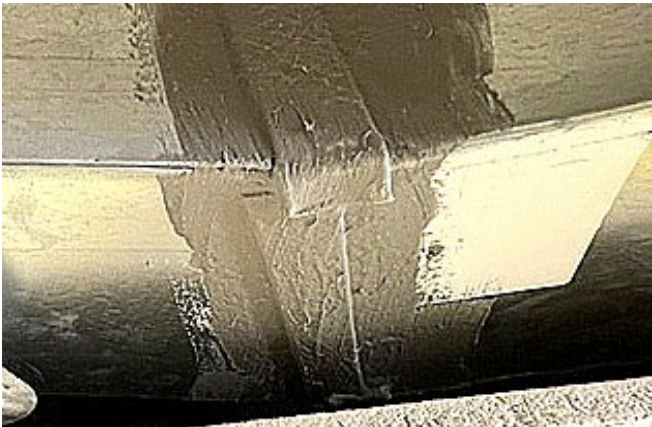
Lab Result: na

Comment: Sealant is not expected to contain asbestos (installed during 2007 renovations).

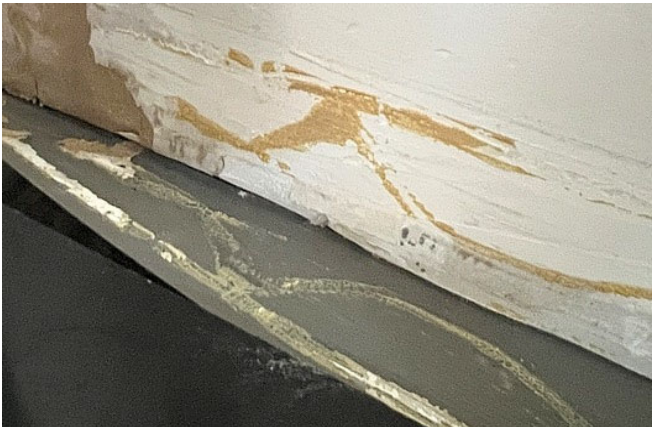
Lab Result: na

Comment: Baseboard mastic is not expected to contain asbestos (2007 installation).

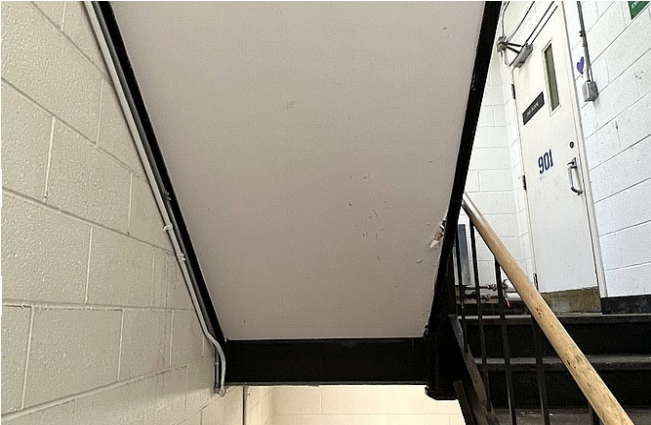
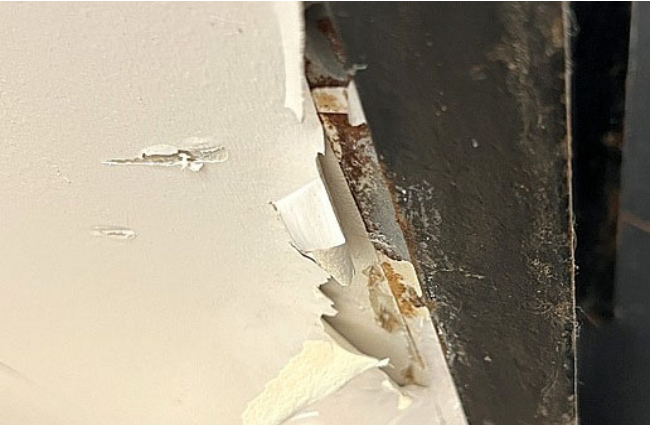
Lab Result: *None detected*

Comment: *Drywall joint-fill compound tested does not contain asbestos.*

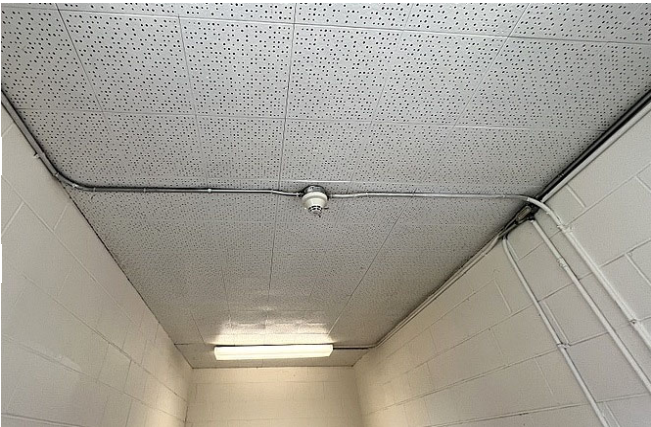
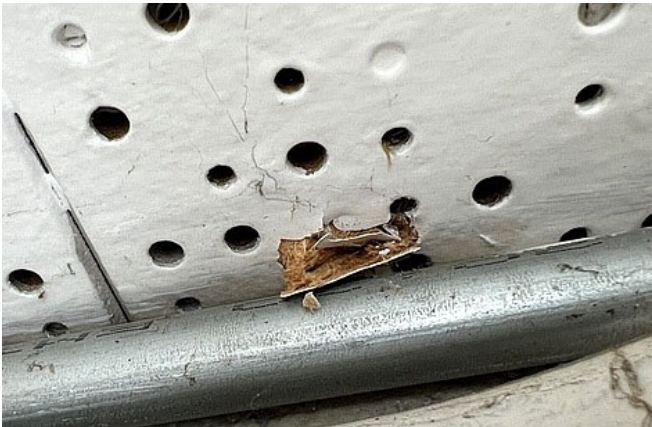
Samples: ns
Lab Result: na
Comment: Ceiling tiles are cellulose-based (non-asbestos).

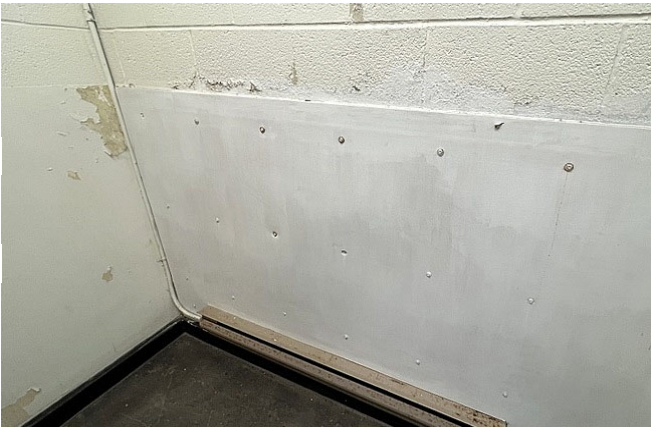
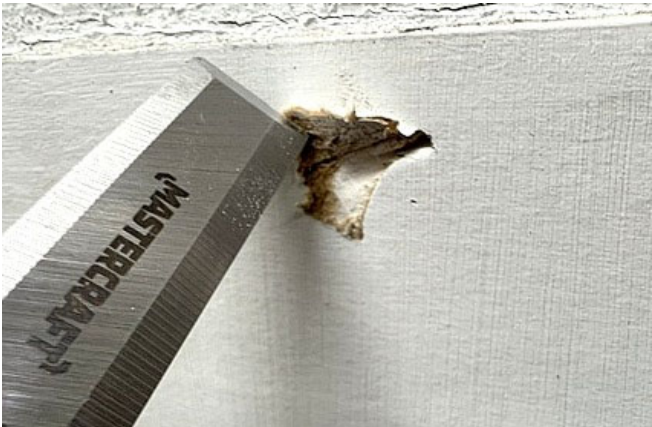
Samples: ns
Lab Result: na
Comment: Panel is drywall (non-asbestos).

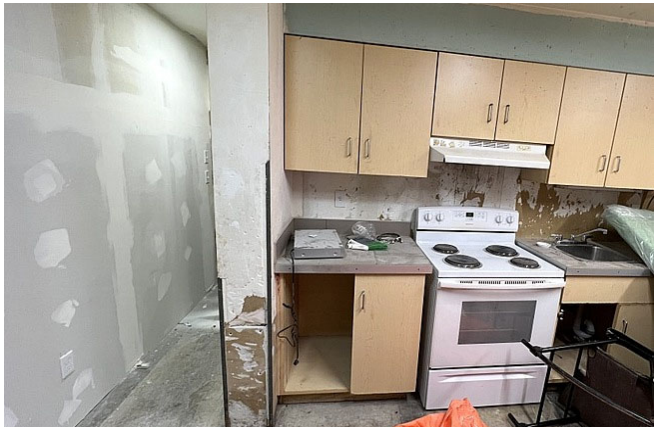
Samples: *016A to E*
Lab Result: *None detected*
Comment: *Drywall joint-fill compound tested does not contain asbestos.*

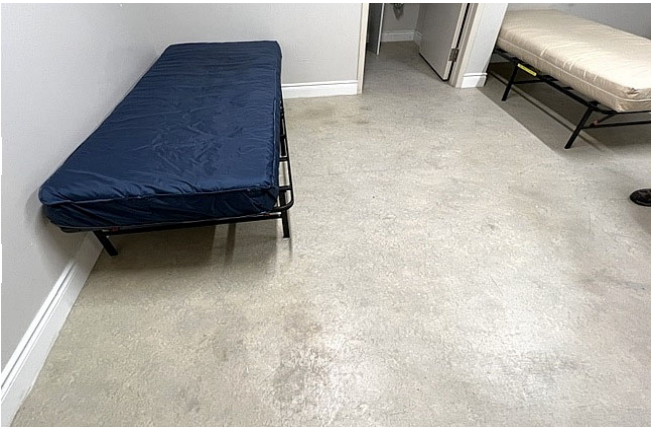
Lab Result: na

Comment: VSF does not contain asbestos (2007 installation).

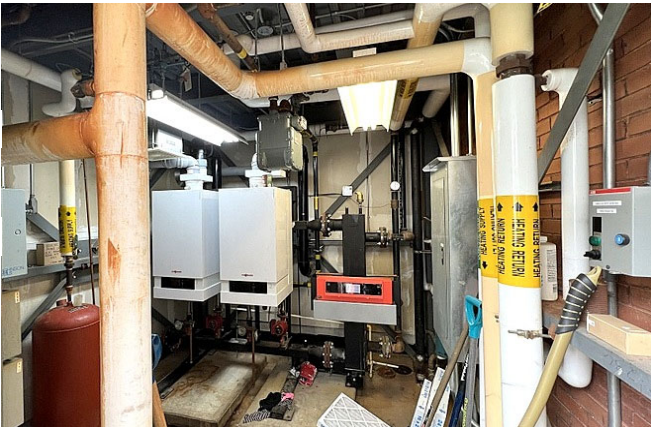
Lab Result: na

Comment: Pipes and ducts are either bare or insulated with fiberglass (non-asbestos).

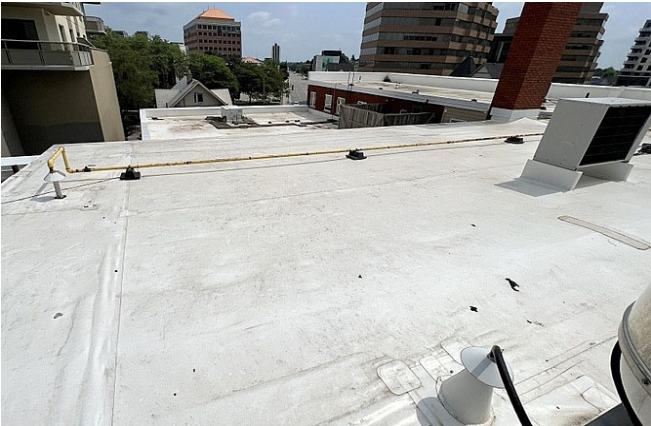
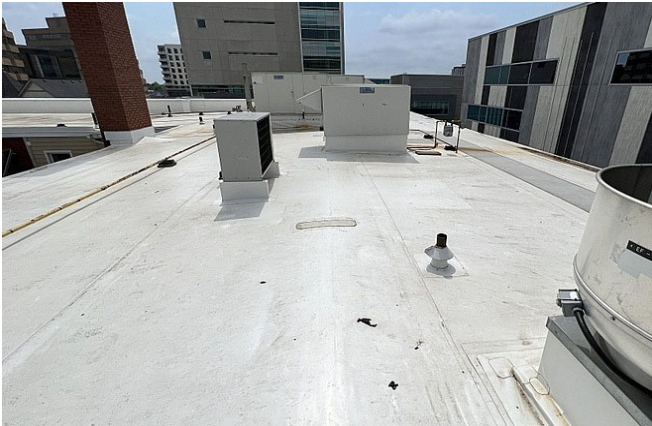
Lab Result: na

Comment: Roofing is not expected to contain asbestos (approximately 17 years of age).

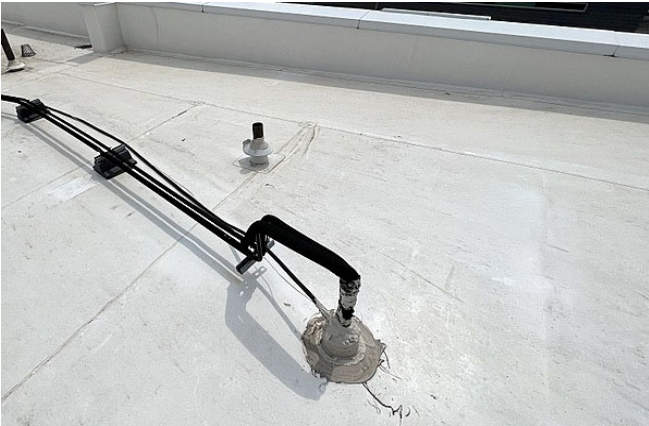
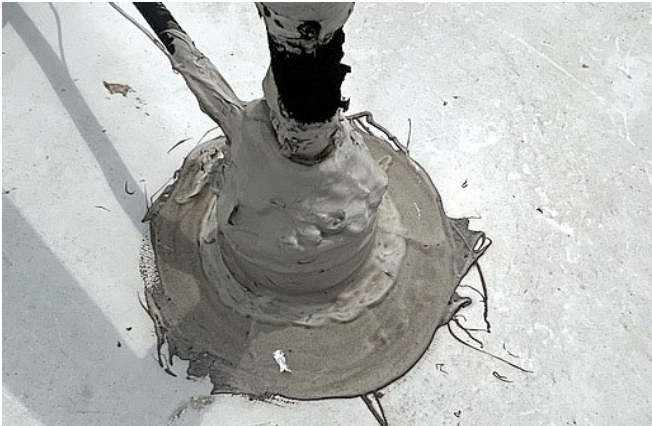
Samples: ns
Lab Result: na
Comment: *Caulking is silicone (non-asbestos).*

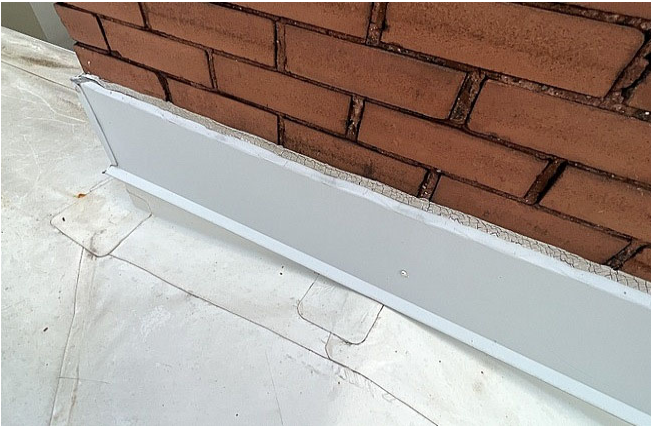
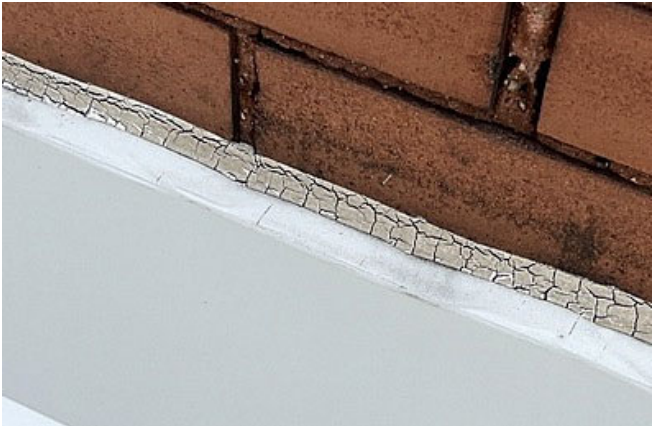
Lab Result: *na*

Comment: *Caulking is silicone (non-asbestos).*

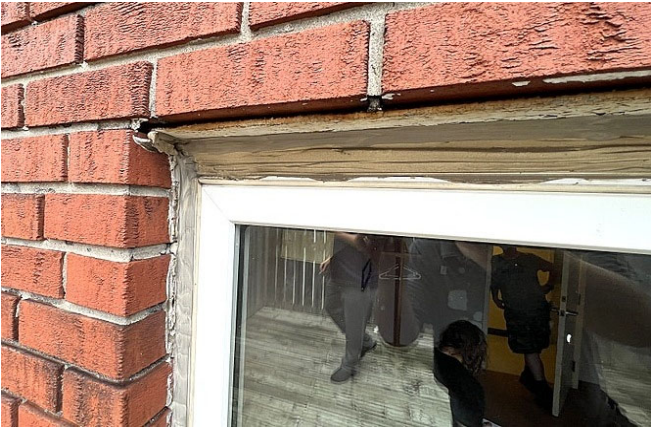
Lab Result: *na*

Comment: *Caulking is silicone based (non-asbestos).*

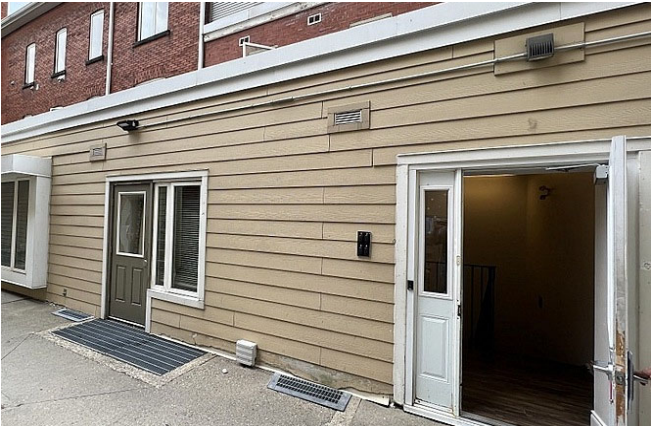
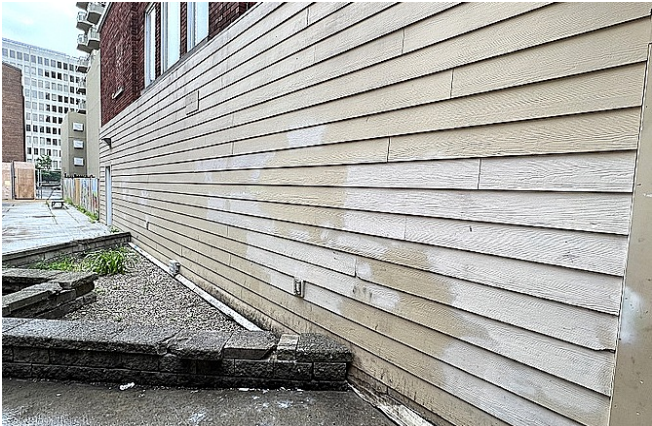
Lab Result: *None detected*

Comment: Cement board tested does not contain asbestos.

Location #	Area Description	Quantity	Condition	Damaged Qty.	Acc.	Vis.	Comments	Recommendation
								No action required.

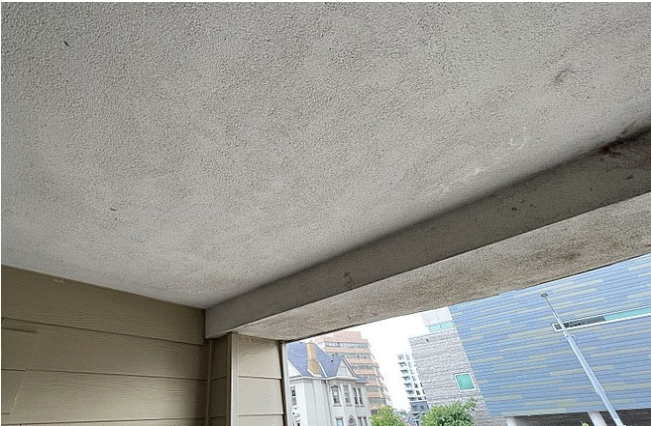
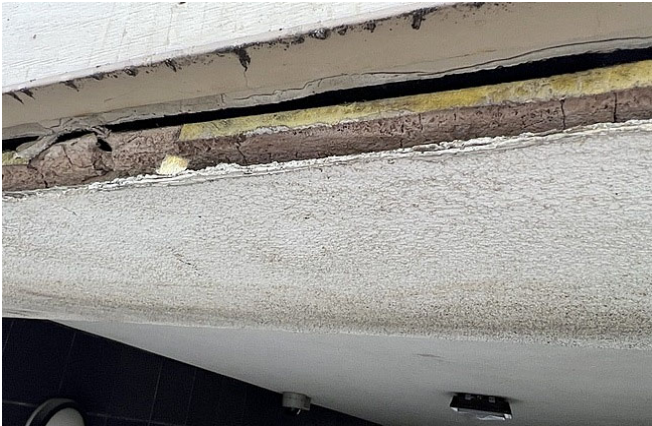
Lab Result: *None detected*

Comment: *Texture coat, plaster and underlying fibrous material tested do not contain asbestos.*

Location #	Area Description	Quantity	Condition	Damaged Qty.	Acc.	Vis.	Comments	Recommendation
								No action required.

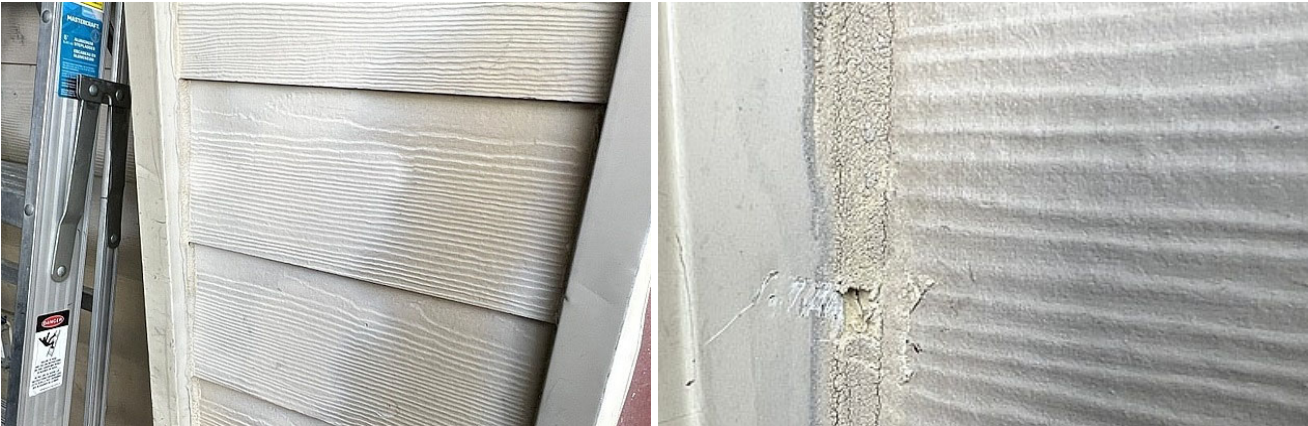
Lab Result: *None detected*

Comment: Caulking tested does not contain asbestos.

Location #	Area Description	Quantity	Condition	Damaged Qty.	Acc.	Vis.	Comments	Recommendation
								No action required.

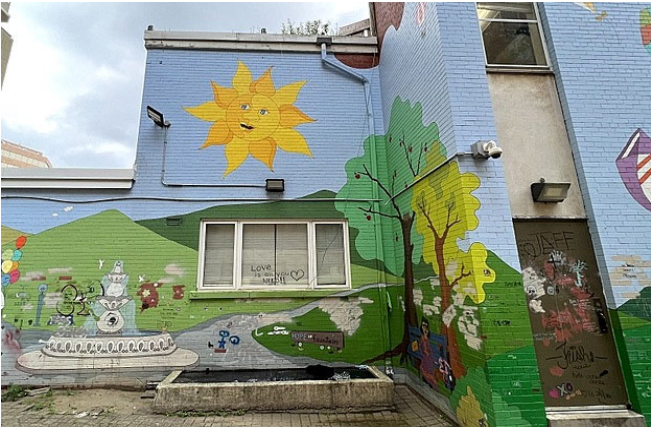
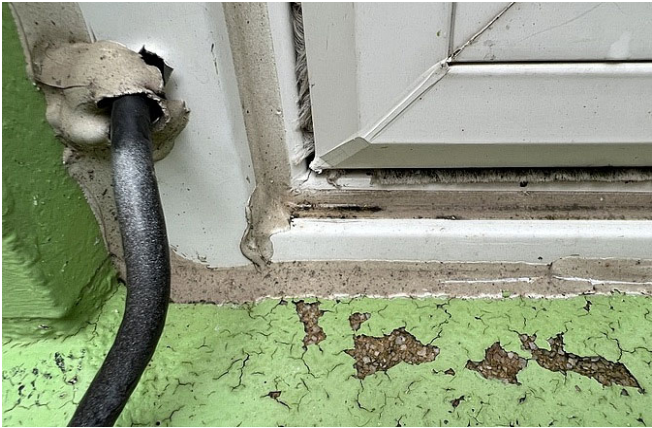
Lab Result: na

Comment: Caulking is silicone (non-asbestos).

Location #	Area Description	Quantity	Condition	Damaged Qty.	Acc.	Vis.	Comments	Recommendation
								No action required.
