DESIGNATED SUBSTANCES AND HAZARDOUS BUILDING MATERIALS ASSESSMENT

FINAL REPORT

YWCA Kitchener-Waterloo, Emergency Shelter
84 Frederick Street, Kitchener, Ontario

July 5, 2024

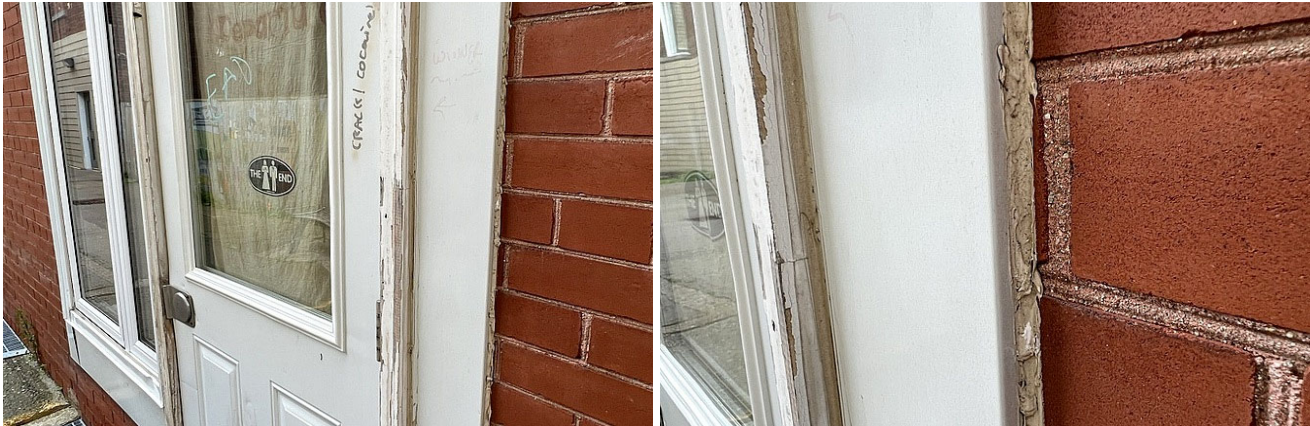
Lab Result: na

Comment: Caulking is silicone (non-asbestos).

Location #	Area Description	Quantity	Condition	Damaged Qty.	Acc.	Vis.	Comments	Recommendation
								No action required.

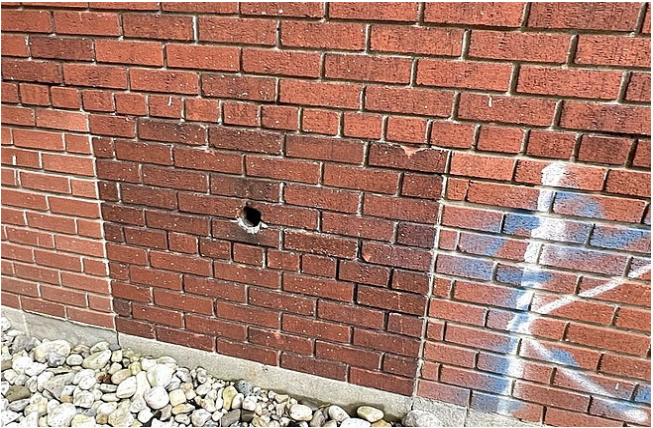
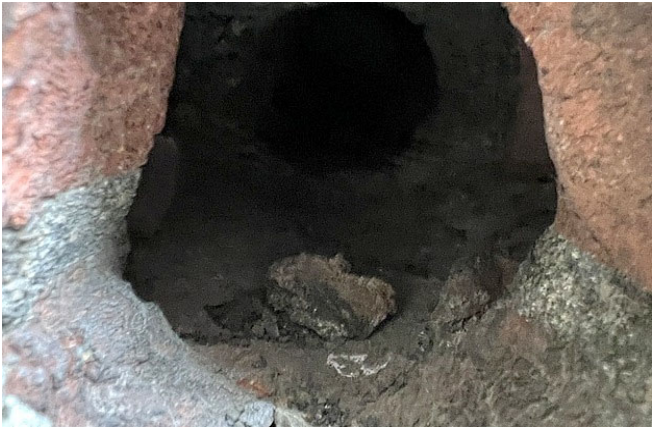
Samples: ns
Lab Result: na
Comment: Wall cavities are empty (no vermiculite observed at locations where intrusive openings were made).

Location #	Area Description	Quantity	Condition	Damaged Qty.	Acc.	Vis.	Comments	Recommendation
							A limited number of openings were made.	No action required.
