Facility Condition Assessment

Toronto Public Libraries

**Pleasant View
575 Van Horne Ave
Toronto, ON**

Date of Report: August 17, 2020

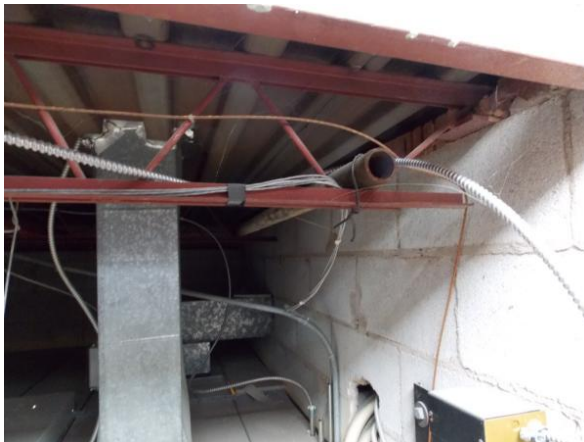
The building structure performing as intended. Deficiencies that indicate structural movement, such as cracks in the exterior wall system or floor finishes, were not observed.

Superstructure observed at the roof hatch

It is reasonable to expect that major repairs will be required in the future. As such an allowance has been included in the long term.

Uniformat	Component Description	Quantity	Unit Cost	Plan Type	Priority	Year	Expenditures
B10	Replace SuperStructure	1 SF	\$50,000.00	MREP	4	2030	\$50,000

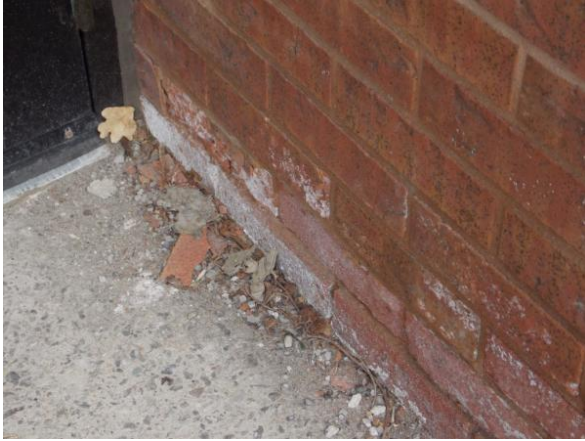
In general the exterior wall system is in good condition overall, with the exception of the spalling brick and efflorescence observed near the main entrance door.

Close-up of spalling brick and efflorescence

An allowance has been included for replacement of the spalled masonry in the short term.

Unifomat	Component Description	Quantity	Unit Cost	Plan Type	Priority	Year	Expenditures
B2011	Replace Brick Masonry	1,000 SF	\$85.00	MREP	2	2020	\$85,000

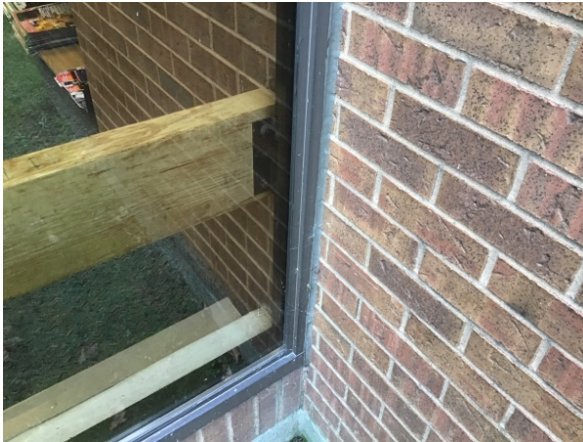
The exterior wall sealant was generally in fair condition. Craziing has begun to form on the sealant, particularly at the window perimeters. Sealants around the metal cap flashings are completely deteriorated.

An allowance is included to replace the sealants in the short term.

Uniformat	Component Description	Quantity	Unit Cost	Plan Type	Priority	Year	Expenditures
B2011.1	Replace Exterior Sealant	1,000 SF	\$12.00	LCR	2	2020	\$12,000

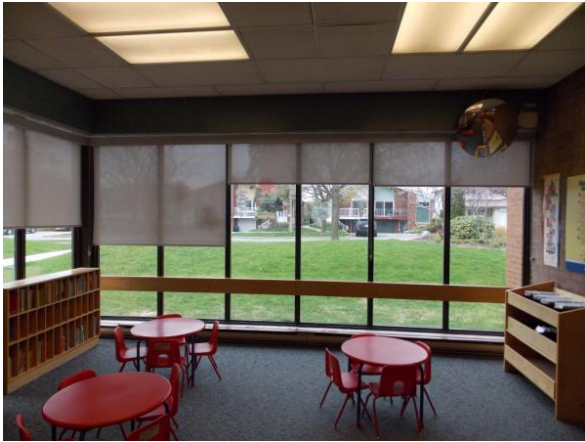
The windows generally are performing as intended. No air/water infiltration was reported by the site representative.

Typical windows

Windows are constructed to provide a life cycle of approximately 32 years, which is consistent with the observed condition. Further deterioration of the windows is anticipated with continued exposure to the elements. A proactive replacement of the 1975 and 1983 windows is recommended to minimize the potential of air/water infiltration, which could cause damage to interior finishes.

Uniformat	Component Description	Quantity	Unit Cost	Plan Type	Priority	Year	Expenditures
B2021	Replace Windows	1 LS	\$168,000.00	LCR	2	2020	\$168,000

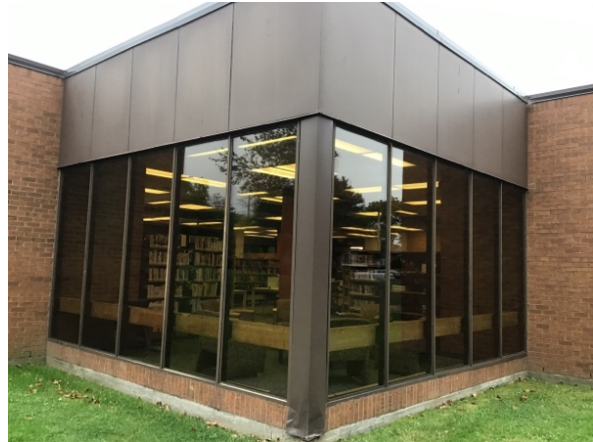
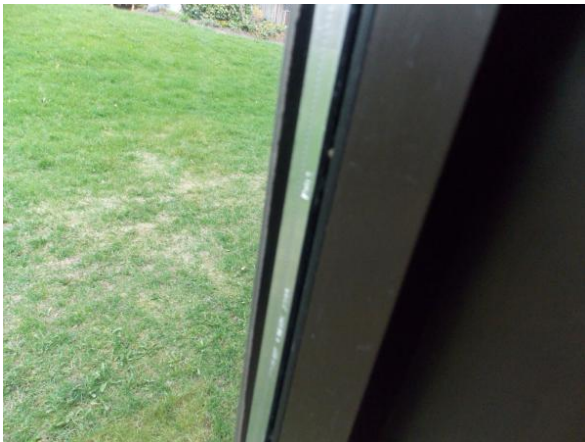
Close-up of typical window metal spacer and glazing seal

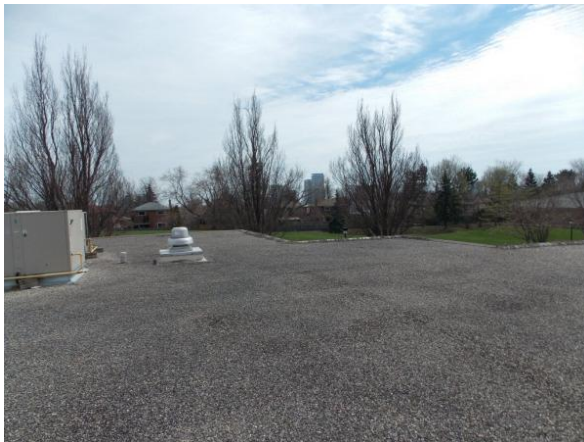
No major deficiencies were observed or reported at the time of the site review.

Overview of roof

An allowance has been included for replacement of the roof at the end of its expected service life.

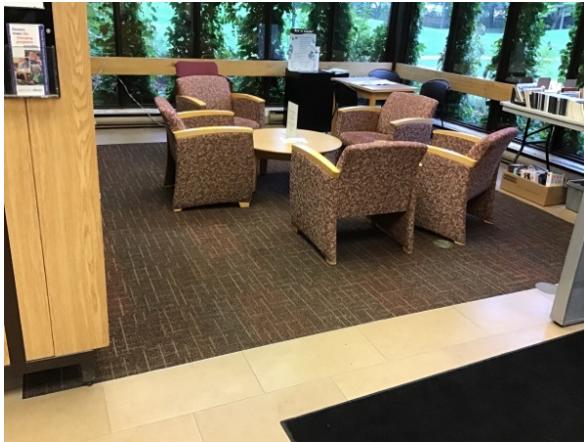
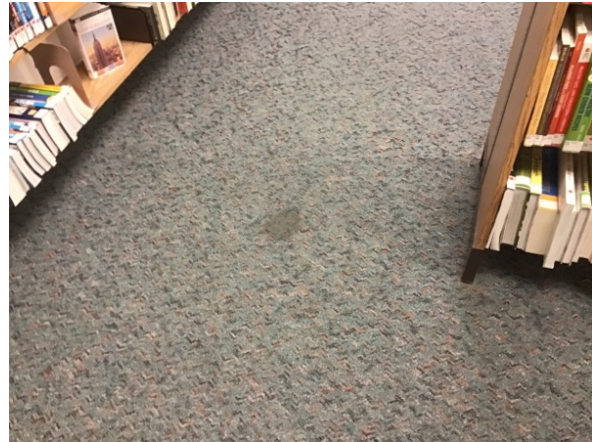
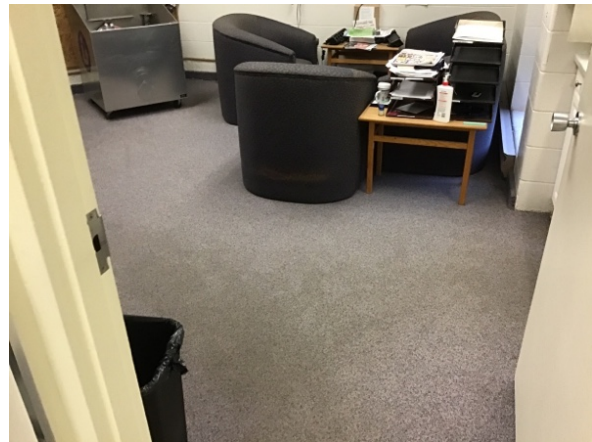
No major deficiencies were observed or reported at the time of the site review. The carpet is worn and stained in localized areas.

Increased foot traffic may eventually cause premature deterioration of the carpet. Torn seams or damaged carpet may arise as a result of deterioration. A proactive replacement of the high traffic carpet is recommended to minimize tripping hazards caused by torn or damaged carpet.

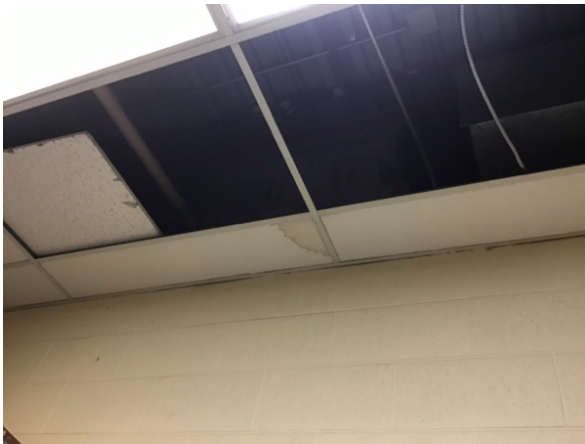
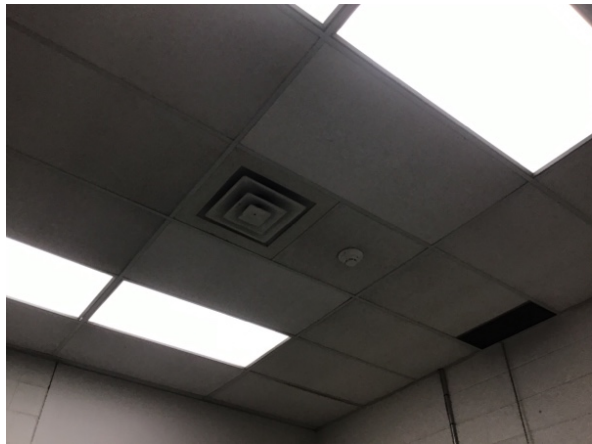
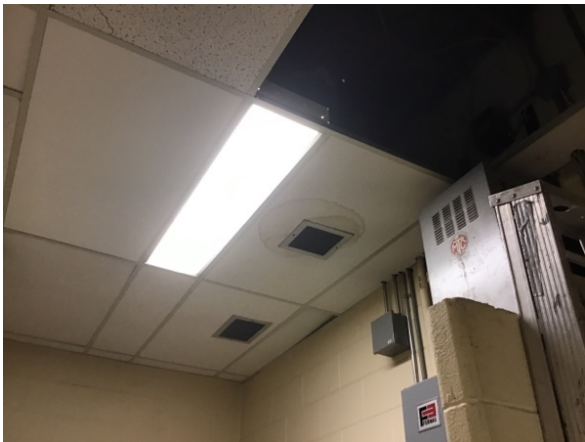
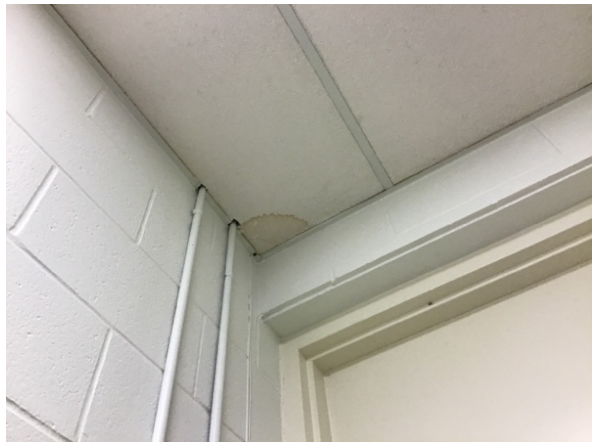
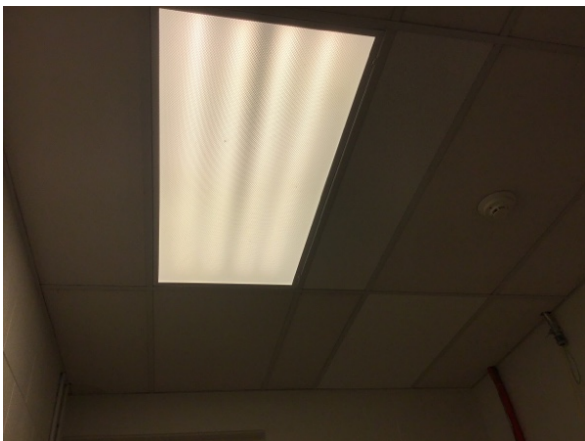
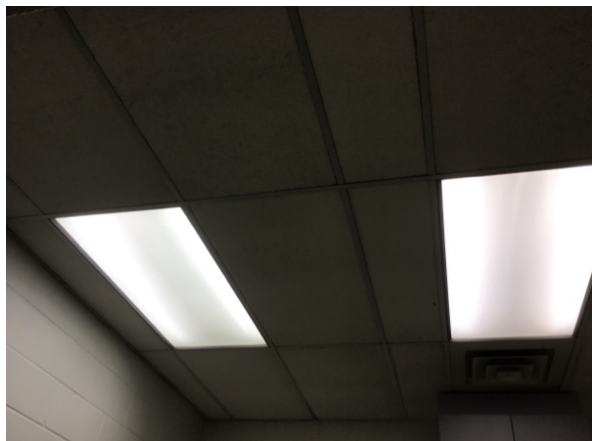
The suspended acoustic ceiling panels are in fair condition overall. Discolouration, broken panels, missing panels, and stains at isolated locations were observed on the ceiling panels.

As the suspended acoustic ceiling panels continue to age, deterioration, which may detract from the overall aesthetics, is anticipated to increase. Provisions have been made for suspended acoustic ceiling panel lifecycle replacement.

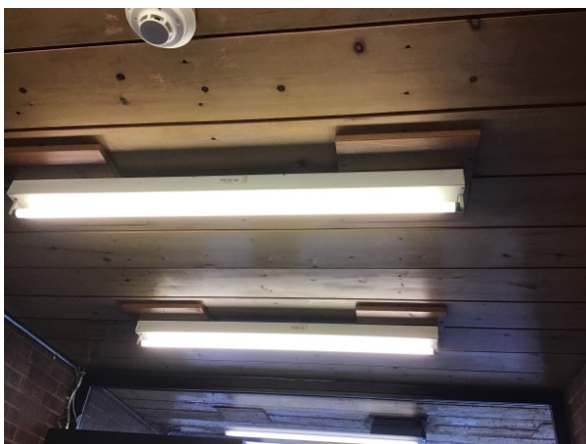
No major deficiencies were observed or reported at the time of the site review.

An allowance has been included for refinishing of the wood ceiling at the end of its expected service life.

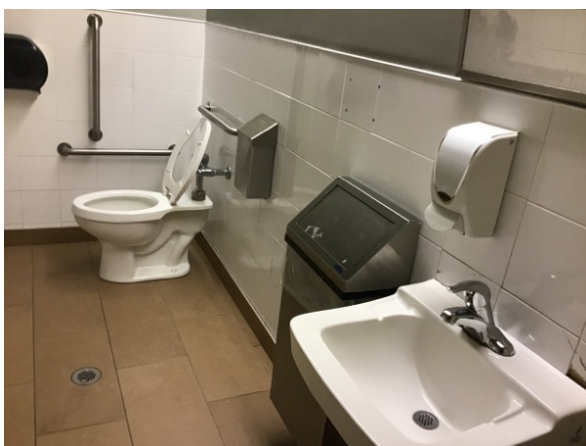
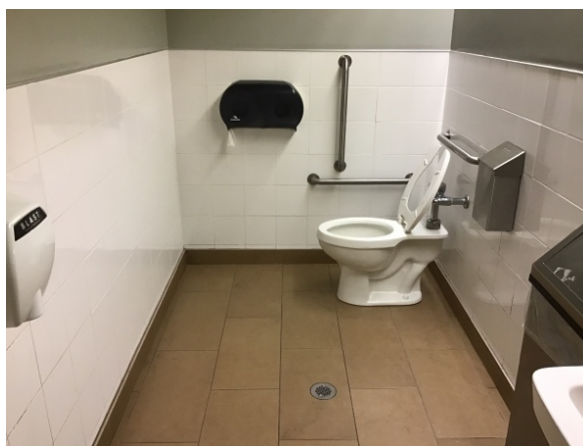
No major deficiencies were observed or reported at the time of the site review.

An allowance has been included for replacement of the plumbing fixtures at the end of their expected service life.

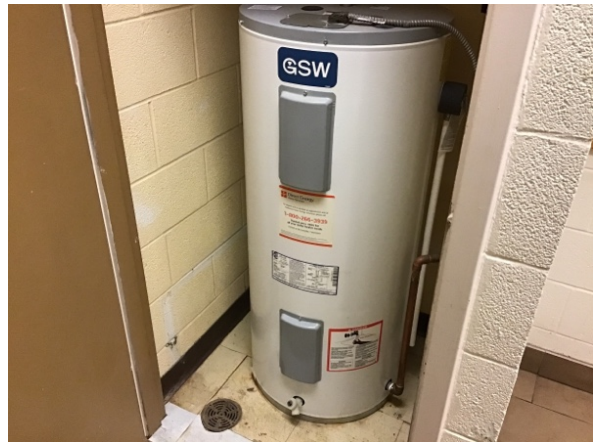
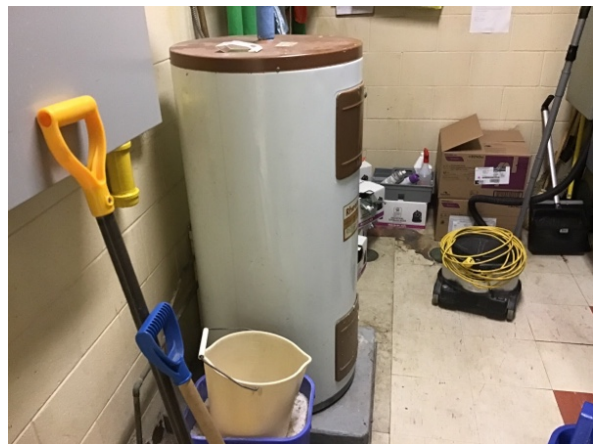
No major deficiencies were observed or reported at the time of the site review, however the tank heater by Rheem has exceeded its expected service life and it is reasonable to expect that it will require replacement in the near future.

An allowance has been included for replacement of the domestic water tank heater by Rheem in the short term. The tank heater by GSW is a rental unit and as such no replacement allowance has been included.

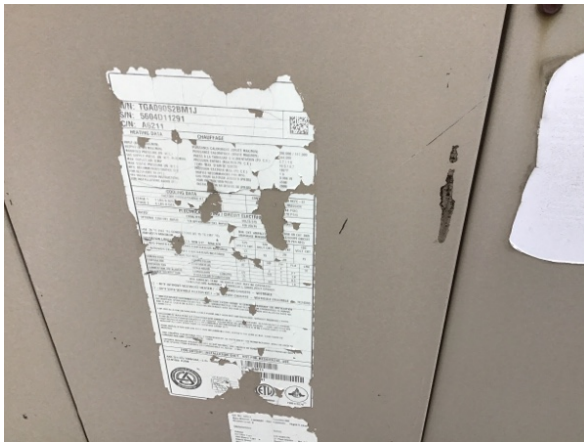
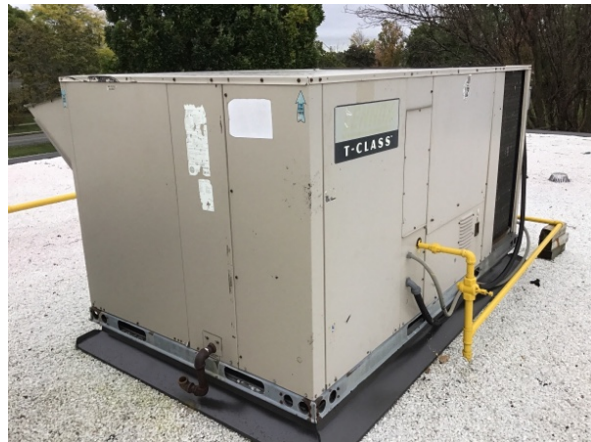
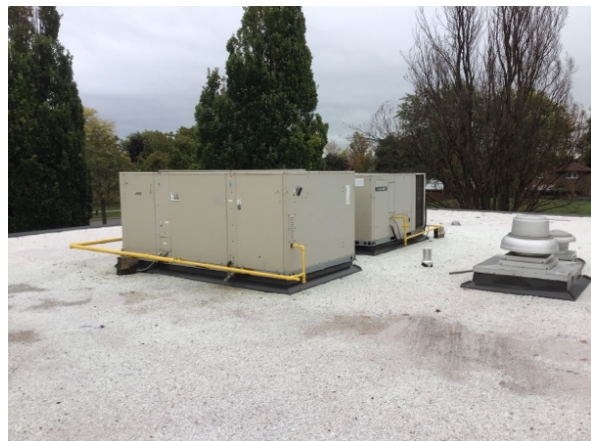
The rooftop units (RTUs) are functioning as intended. No issues were reported in regards to the thermal comfort in the building. However, the fins were observed to be damaged.!

R-22 refrigerant is utilized by both units. According to the noted serial numbers, it is estimated that the units were manufactured and installed in approximately 2004.

Although the HVAC units are anticipated to remain functional within the evaluation period, they utilize R-22 type refrigerant as part of their cooling cycle. This refrigerant type is being phased out in accordance with the Montreal Protocol and will no longer be commercially available for purchase after 2020. Re-charging of the HVAC units during the future repair work (if necessary) may then become cost prohibitive or non-permissible.

as such the replacement of the packaged units are to be scheduled at end of service life. costing includes for both units.

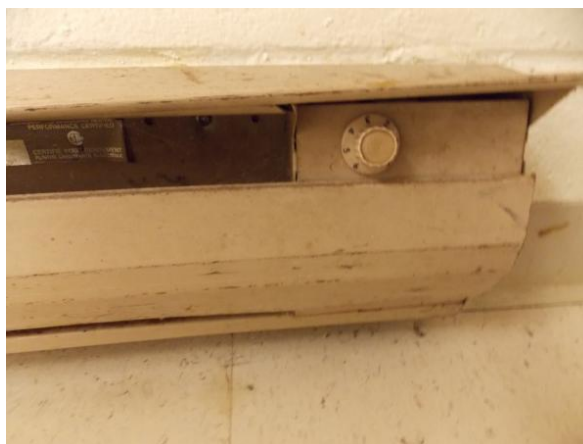
The baseboard heaters were observed to be damaged and aged. The forced flow heater was reportedly not in use because it activates the fire alarm. Even though it is not in use, heating appears to be sufficient within the building. No issues were reported by the staff.

Close-up of aged baseboard heater

Based on observed condition, replacement of the baseboard heaters is recommended to maintain thermal comfort for building occupants. The removal/decommissioning of the forced flow heater may be considered, as it does not appear to be necessary for heating.

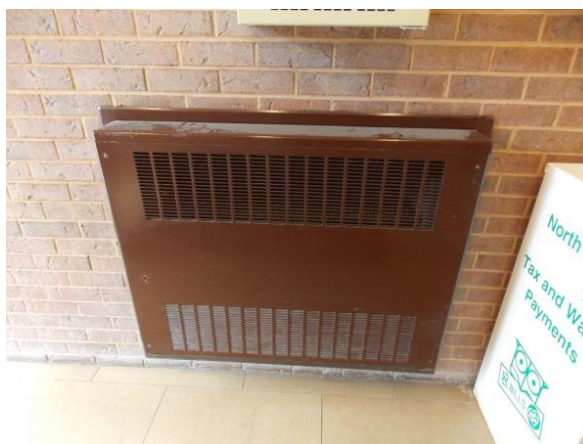
Forced flow heater in the main entrance vestibule

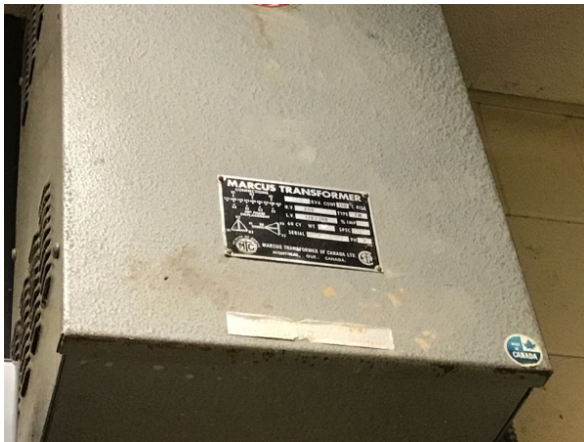
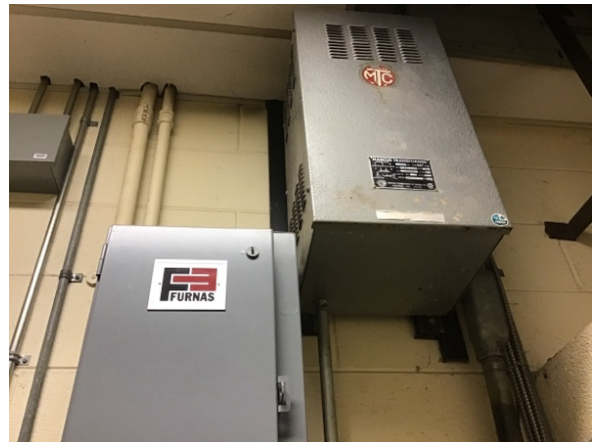
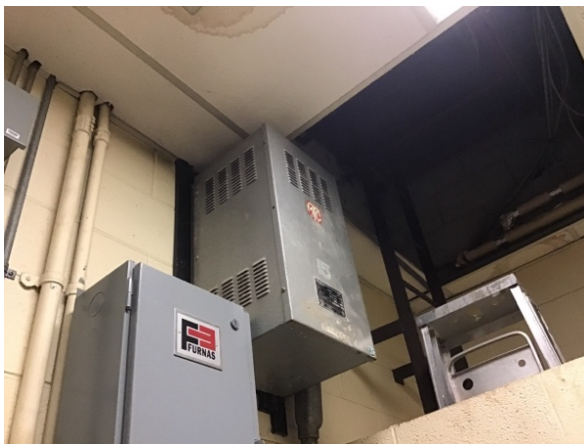
Given the estimated age of the transformer, the potential for failure increases as it continues to age. A proactive replacement is recommended to maintain electrical service to the building components.

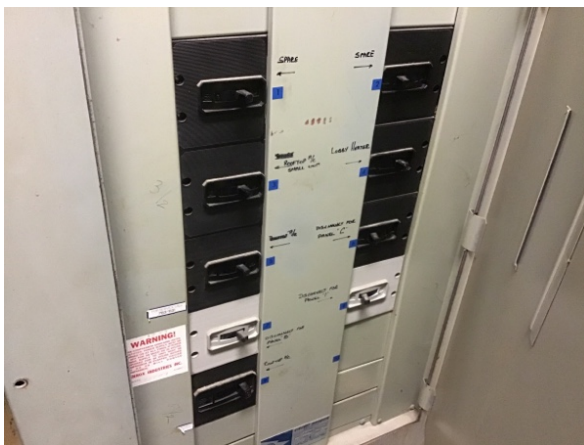
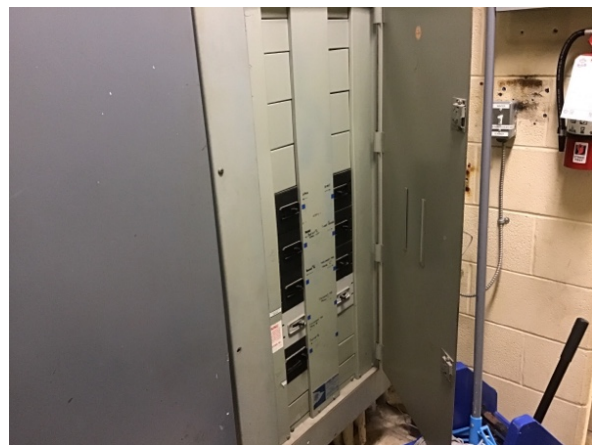
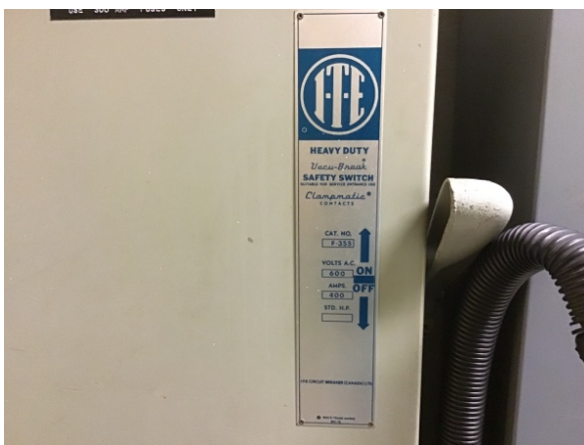
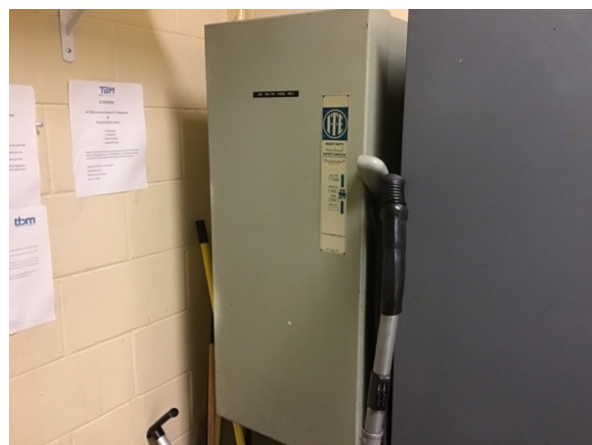
Although the electrical disconnect and distribution panel are currently functioning as intended, they are approaching the end of its expected useful life of 40 years, which is based on typical industry standards. The potential for failure may increase after the end of its expected useful life. Provisions have been allocated for electrical disconnect and distribution panel replacement to minimize the possibility of service disruption.

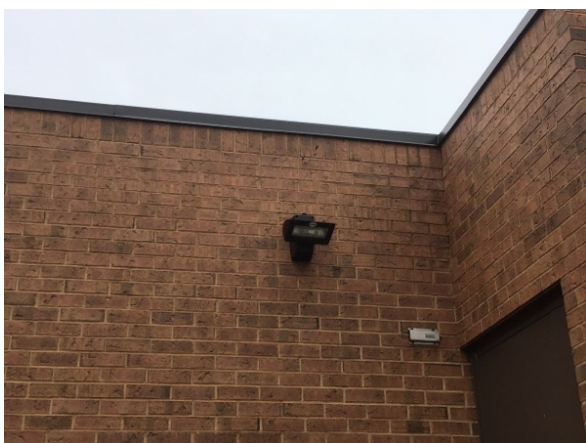
An allowance has been included for replacement of the lighting at the end of its expected service life.

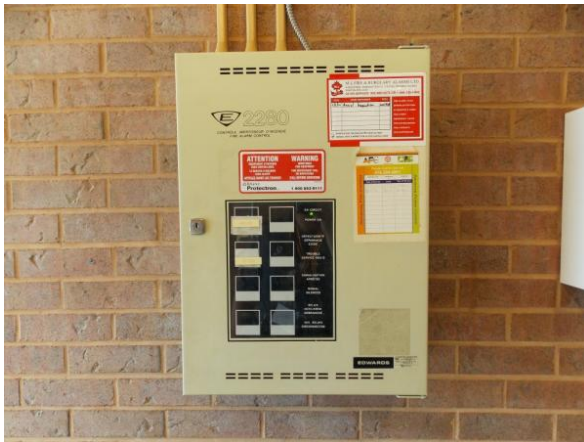
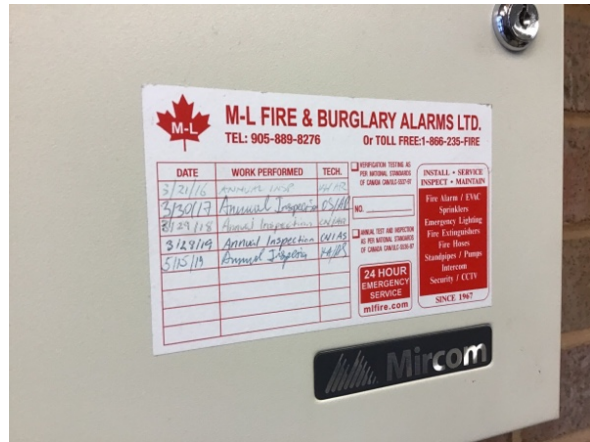
No major deficiencies were observed or reported at the time of the site review, however the fire alarm panel has exceeded its expected service life.

General view of fire alarm control panel

Based on current condition and age, the fire alarm panel may deteriorate beyond repair within the near future. A proactive replacement is recommended to maintain sufficient fire detection within the building.

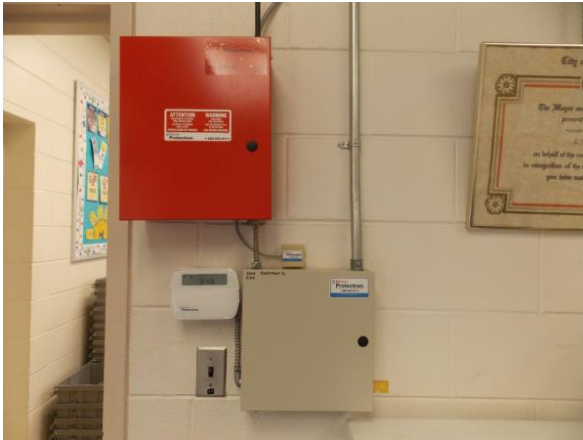
Security system control panel in the Staff Room

An allowance has been included for replacement of the security system at the end of its expected service life.

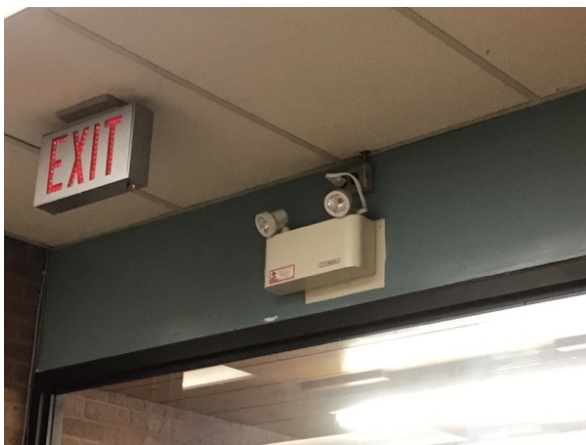
Batteries of the emergency lighting typically have reduced power storage and charge capability with the passage of time. The lamp fixtures of the emergency lighting may also deteriorate. A proactive replacement of the emergency lighting is recommended to minimize safety hazards during emergency evacuations.

Uniformat	Component Description	Quantity	Unit Cost	Plan Type	Priority	Year	Expenditures
D5092.3	Replace Emergency Lighting and Exit Signs	1 LS	\$3,000.00	LCR	2	2020	\$3,000

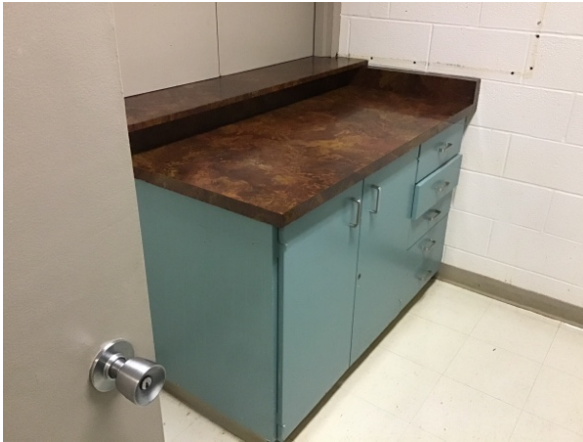
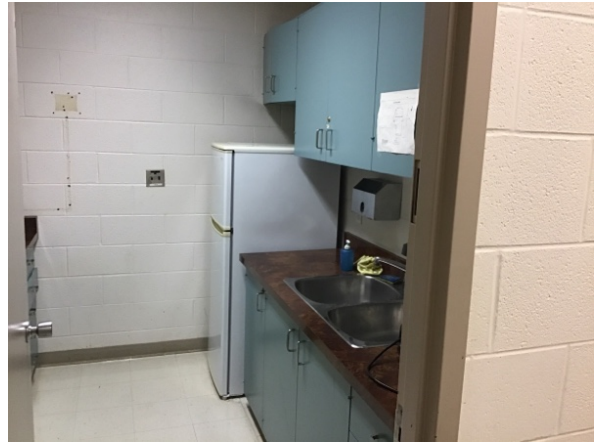
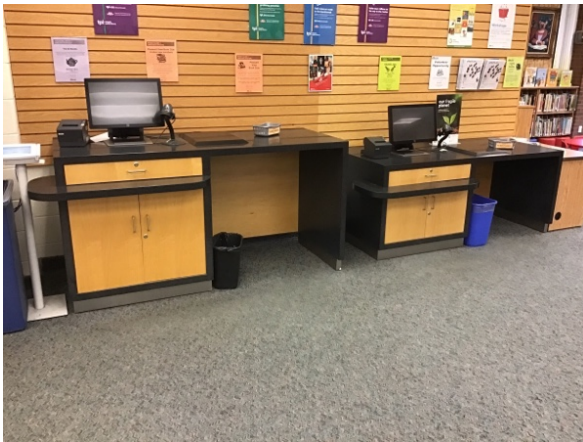
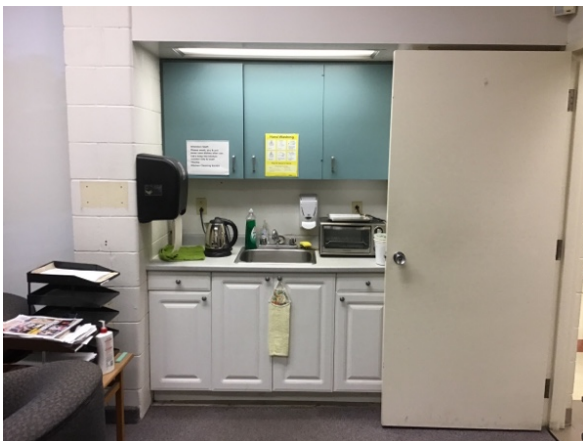
The millwork is worn with age. No major deficiencies were observed.

Based on its age an allowance has been included for replacement of the millwork in the short term.

Uniformat	Component Description	Quantity	Unit Cost	Plan Type	Priority	Year	Expenditures
E2010	Replace Millwork	1 LS	\$80,000.00	LCR	3	2021	\$80,000

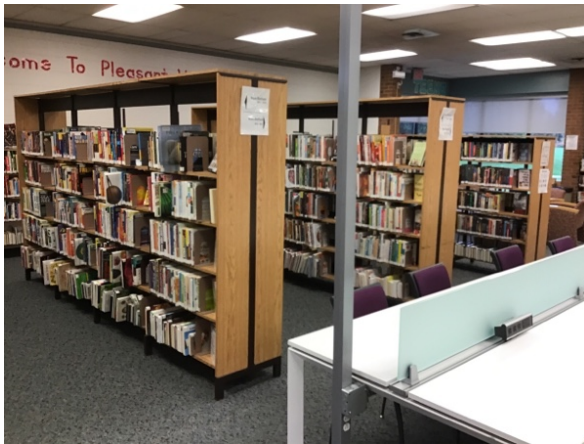
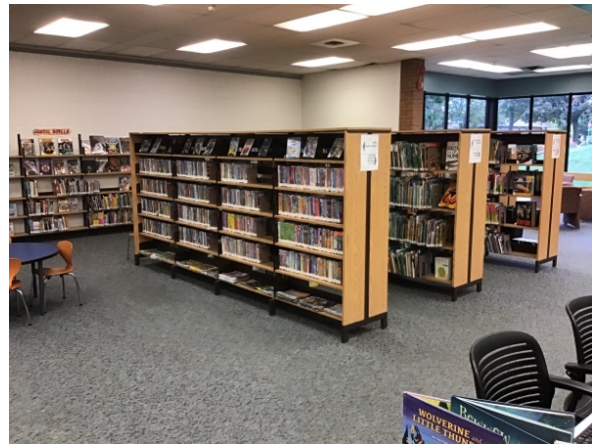
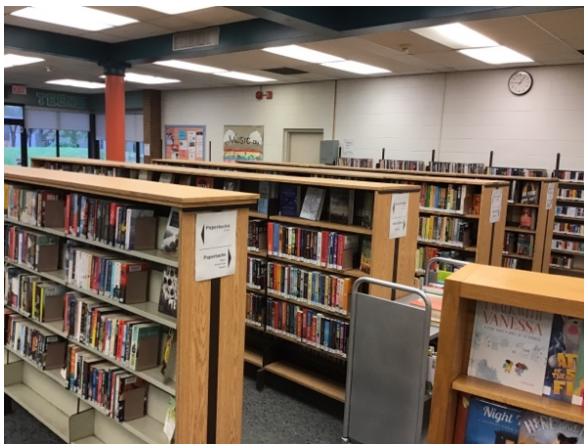
The shelving is worn with age. No major deficiencies were observed.

Deterioration of the library shelving is anticipated with repeated usage and accidental damage. A proactive replacement of the library shelving is recommended to maintain patron satisfaction and functionality of the library.

Uniformat	Component Description	Quantity	Unit Cost	Plan Type	Priority	Year	Expenditures
E2010	Replace Library Shelving	75 EA	\$6,000.00	LCR	3	2021	\$450,000

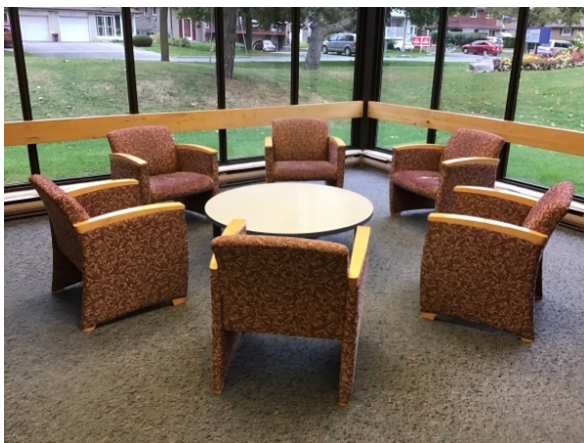
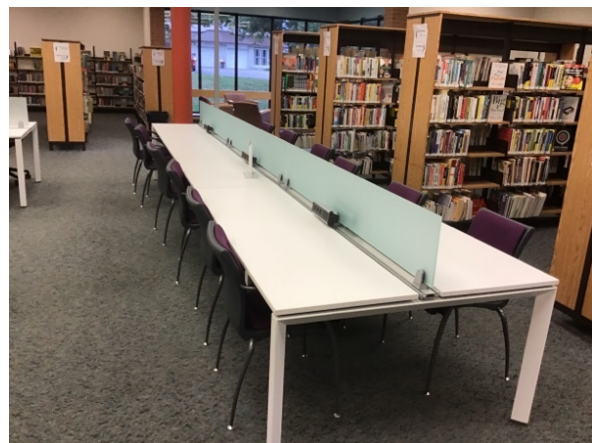
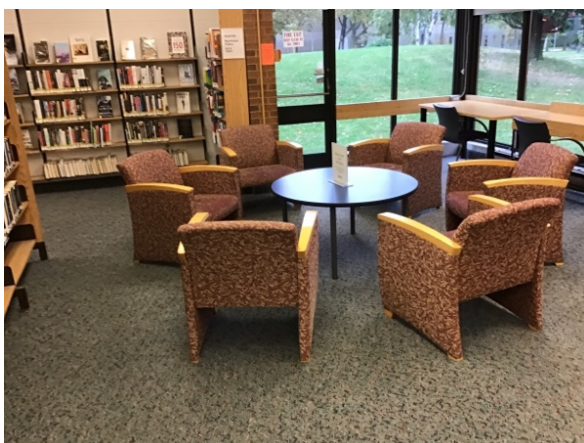
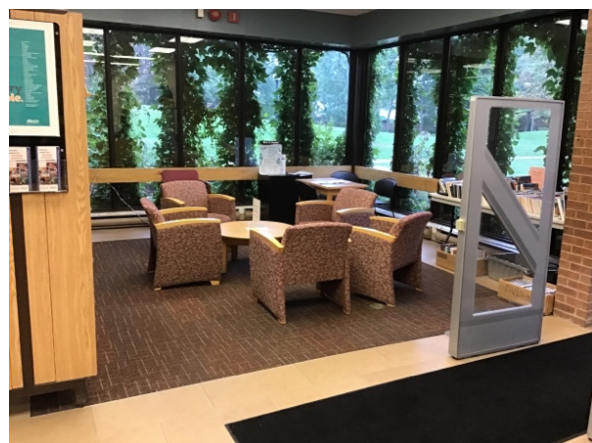
No major deficiencies were observed or reported at the time of the site review.

The moveable furnishings are anticipated to deteriorate with frequent usage. Proactive replacement of the furnishings is recommended to maintain patron satisfaction and minimize safety hazards caused by broken furnishings.

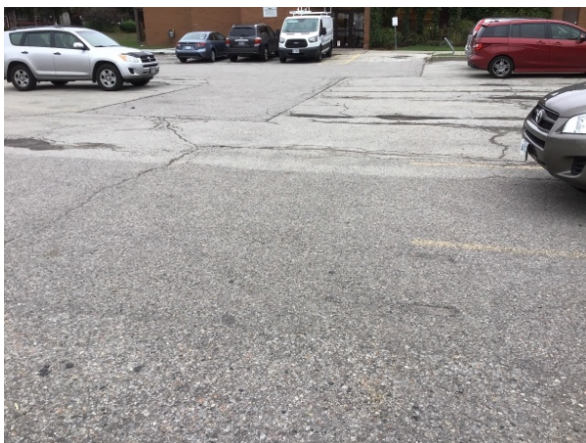
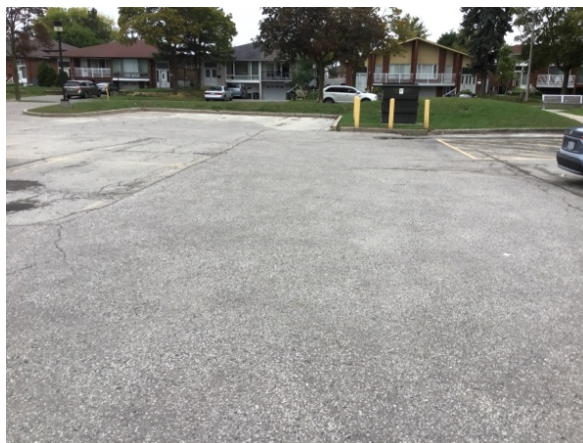
The asphalt pavement is in poor condition overall. Unsealed alligator cracks and potholes were observed.

As the parking lot experiences weathering and repeated wheel loads, deficiencies such as raveling or cracks may occur. A proactive replacement of the parking lot is recommended to minimize vehicular damage.

Unifomat	Component Description	Quantity	Unit Cost	Plan Type	Priority	Year	Expenditures
G2020	Replace Parking Lots & Roadways	20,000 SF	\$5.00	LCR	3	2020	\$100,000

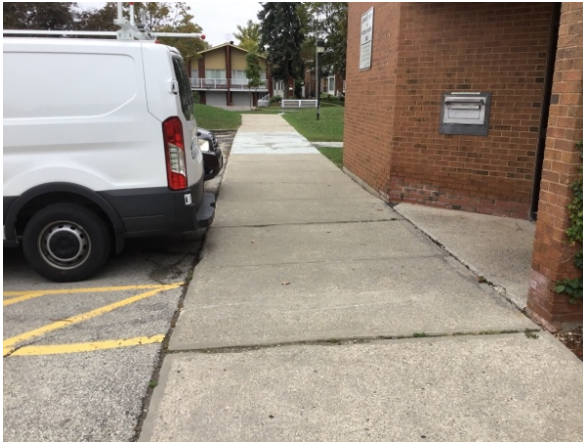
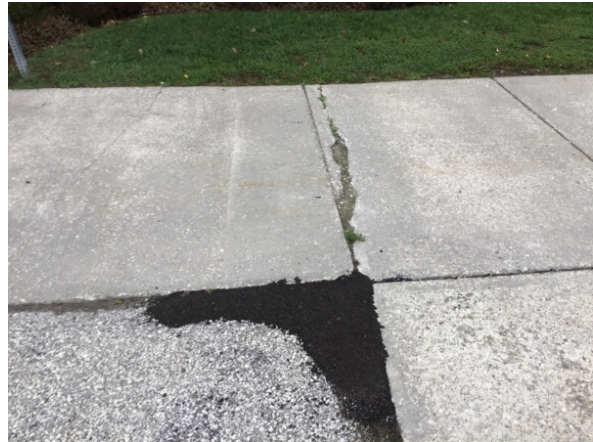
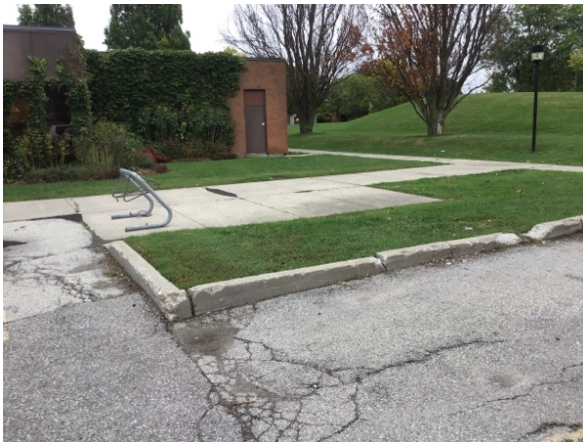
The concrete walkways are considered to be in fair condition overall. Raveling was observed on the surface of the walkways. The walkways also exhibit cracks at various locations.

With frequent foot traffic and the use of de-icing salts, further deterioration of the walkways is anticipated. Based on current condition, replacement is recommended.

Uniformat	Component Description	Quantity	Unit Cost	Plan Type	Priority	Year	Expenditures
G2030	Replace Concrete Walkway	1,300 SF	\$9.00	MREP	4	2025	\$11,700

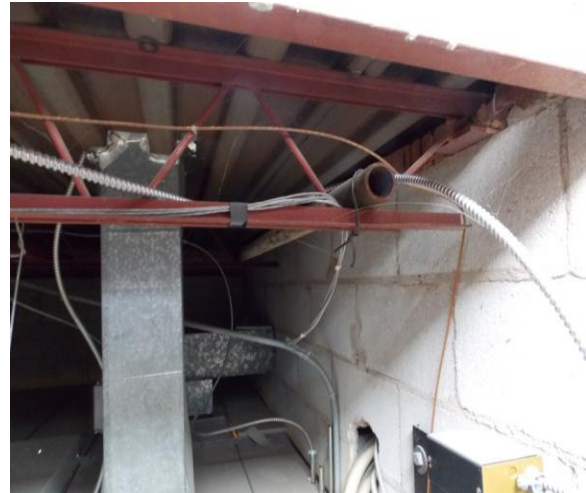
B10 SuperStructure:- Superstructure observed at the roof hatch

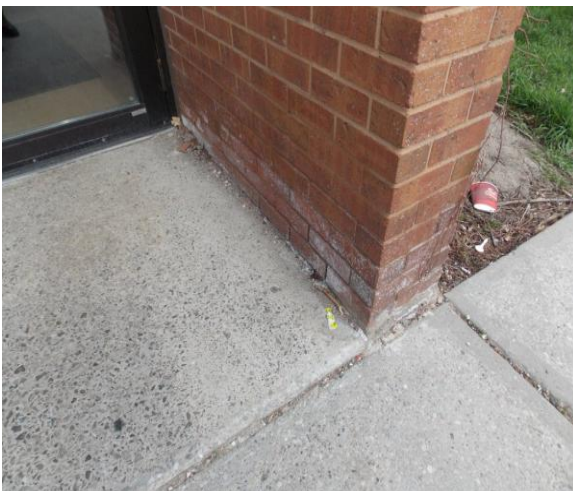
B2011 Exterior Wall Construction:- Efflorescence near the main entrance

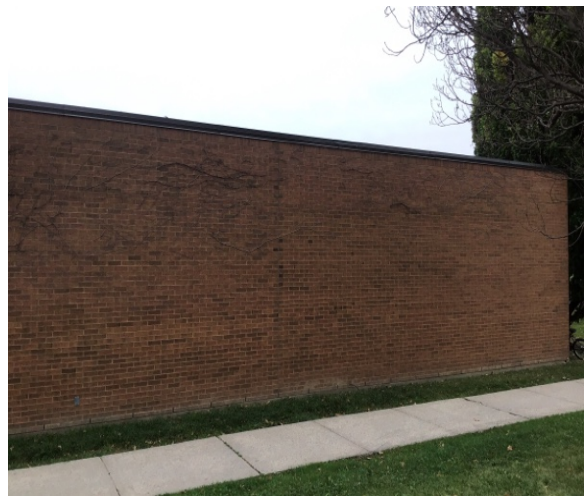
B2011 Exterior Wall Construction:- View of Brick Masonry

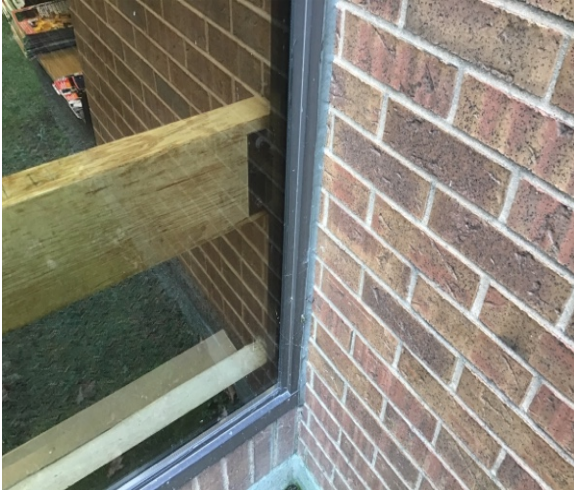
B2011 Exterior Wall Construction:- View of Brick Masonry

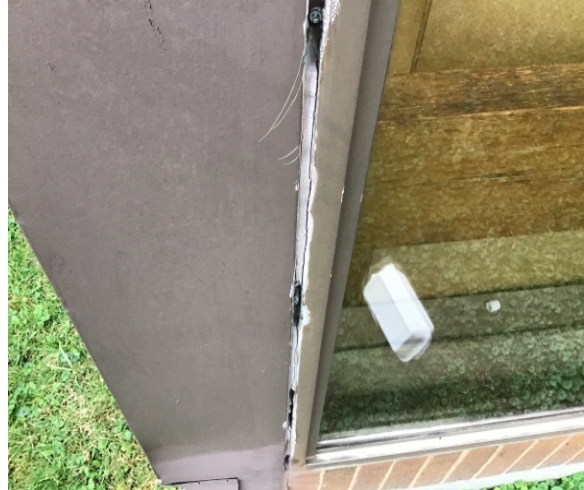
B2011.1 Exterior Wall Sealant:- View of Exterior Sealant

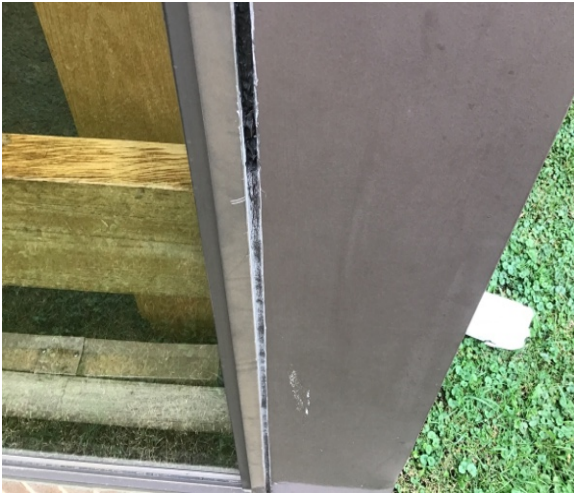
B2011.1 Exterior Wall Sealant:- View of Exterior Sealant

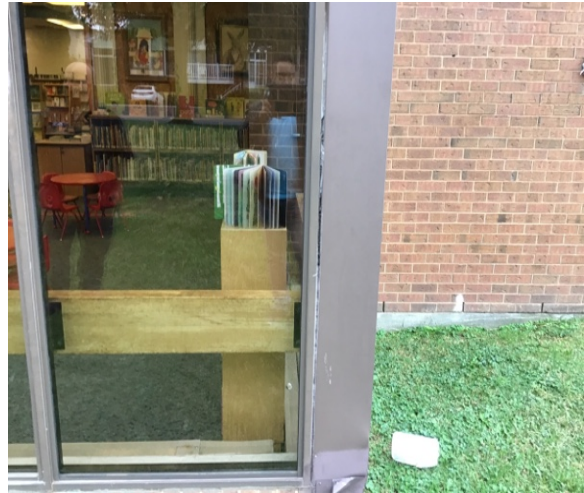
B2011.1 Exterior Wall Sealant:- View of Exterior Sealant

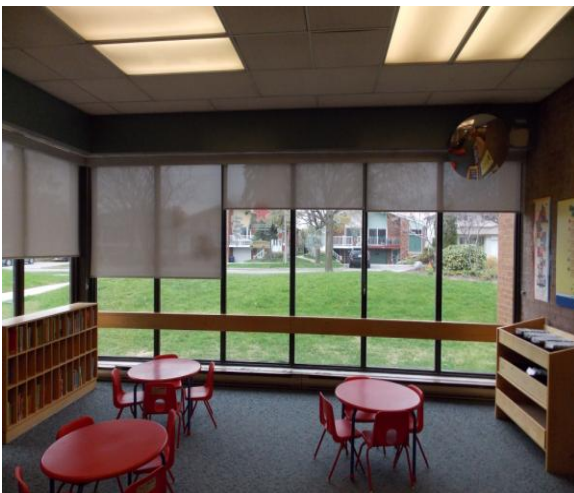
B2011.1 Exterior Wall Sealant:- View of Exterior Sealant

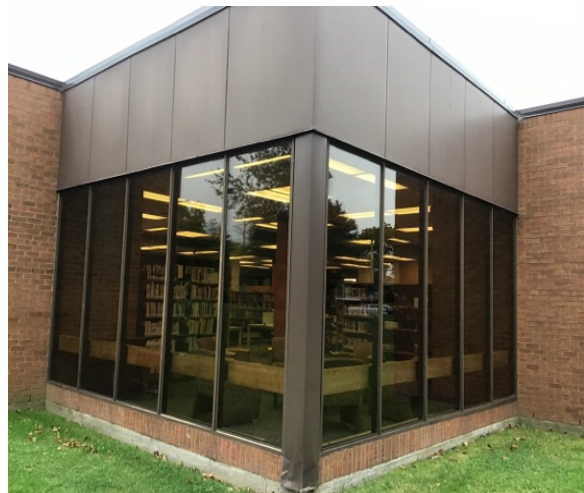
B2021 Windows:- Typical windows

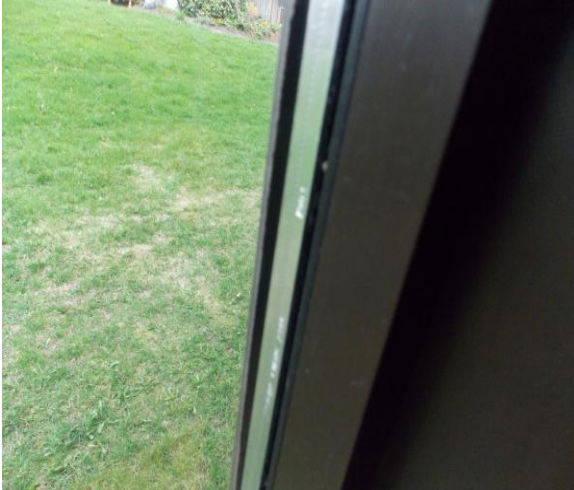
B2021 Windows:- View of Windows

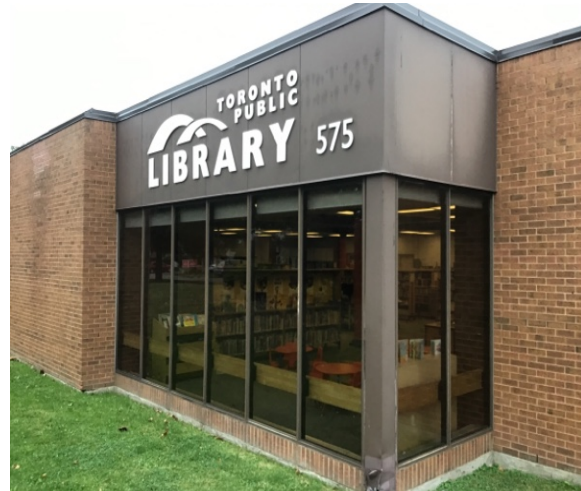
B2021 Windows:- Close-up of typical window metal spacer and glazing seal

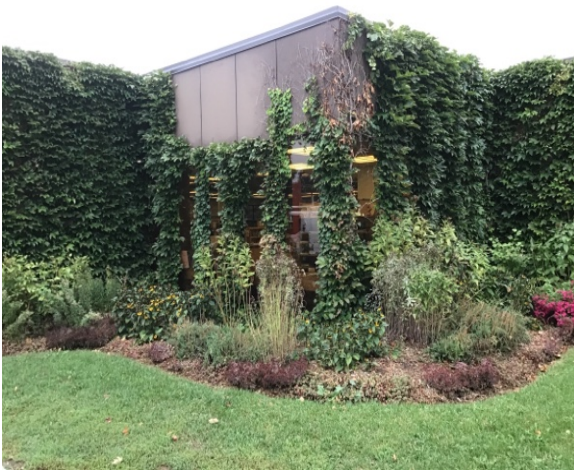
B2021 Windows:- View of Windows

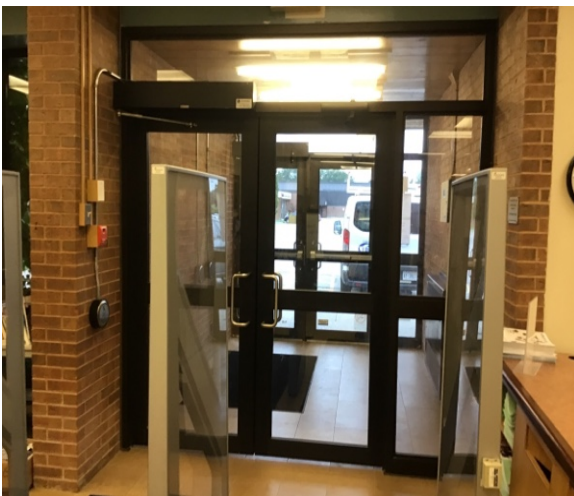
B2031 Glazed Doors & Entrances:- View of Front Entrance Doors

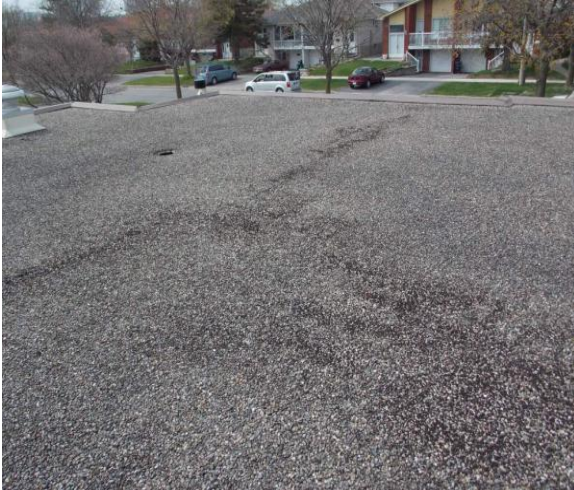
B3011 Roof Finishes:- Overview of roof

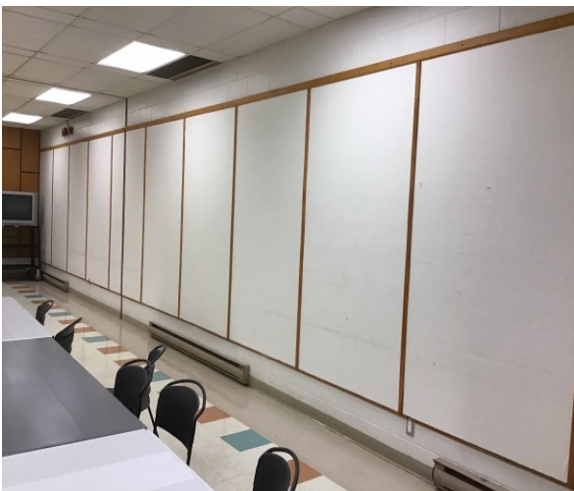
C3010 Wall Finishes:- View of Folding Wood Partition

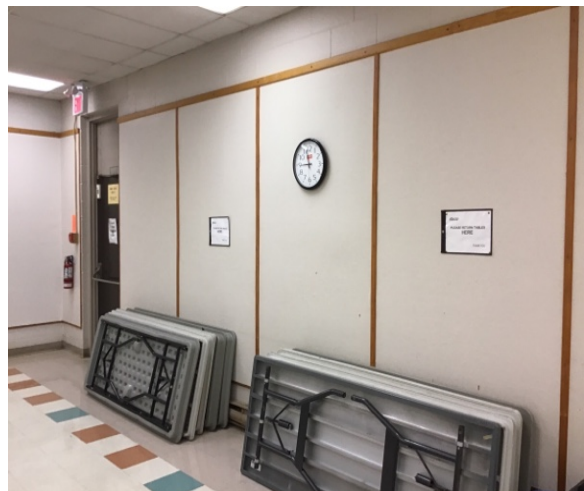
C3012 Wall Finishes to Interior Walls:- View of Paint

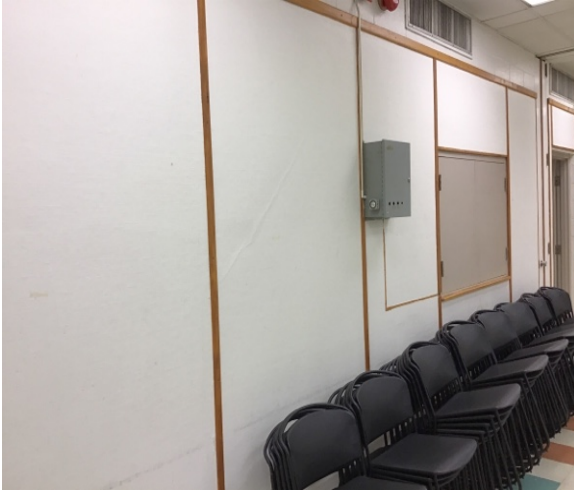
C3012 Wall Finishes to Interior Walls:- View of Paint

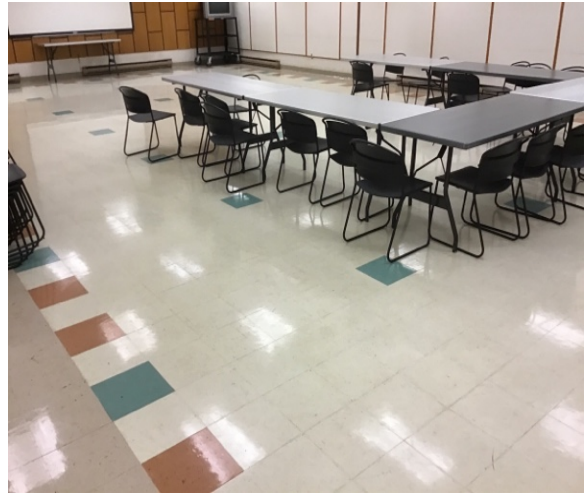
C3024 Flooring:- View of Vinyl Floor Tiles

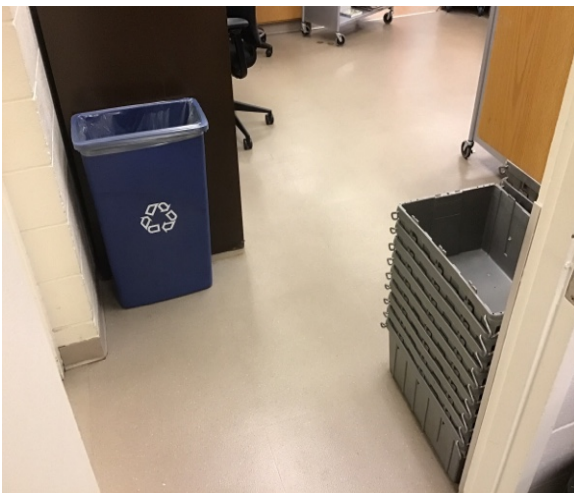
C3024 Flooring:- View of Vinyl Floor Tiles

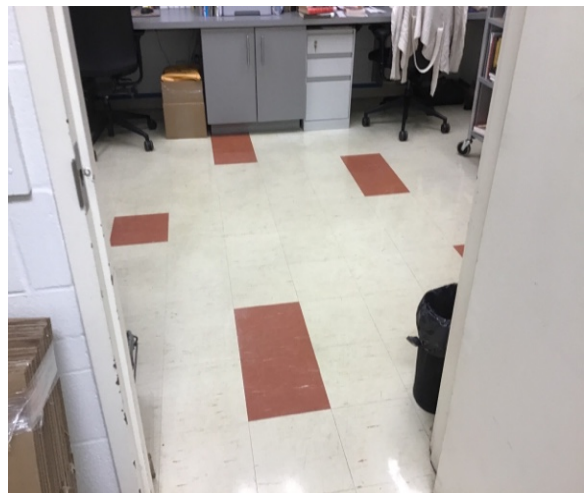
C3024 Flooring:- View of Vinyl Floor Tiles

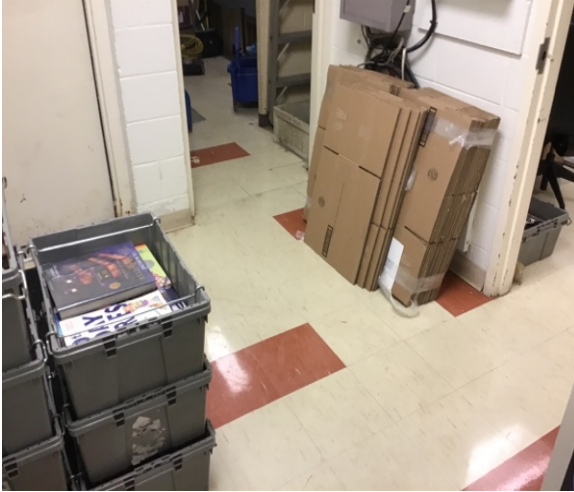
C3024 Flooring:- View of Vinyl Floor Tiles
