Facility Condition Assessment

Toronto Public Libraries

**Pleasant View
575 Van Horne Ave
Toronto, ON**

Date of Report: August 17, 2020

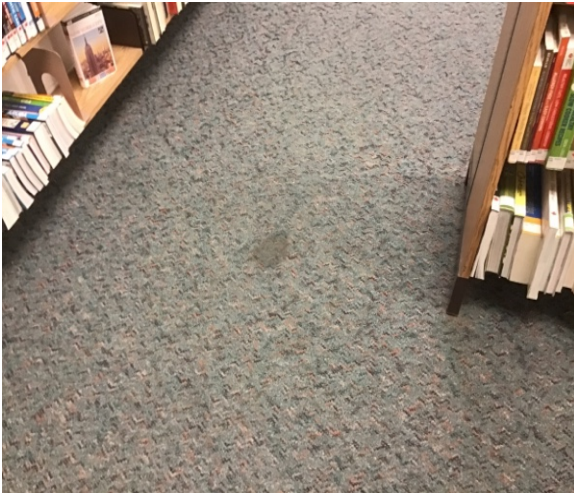
C3025 Carpeting:- View of Carpet

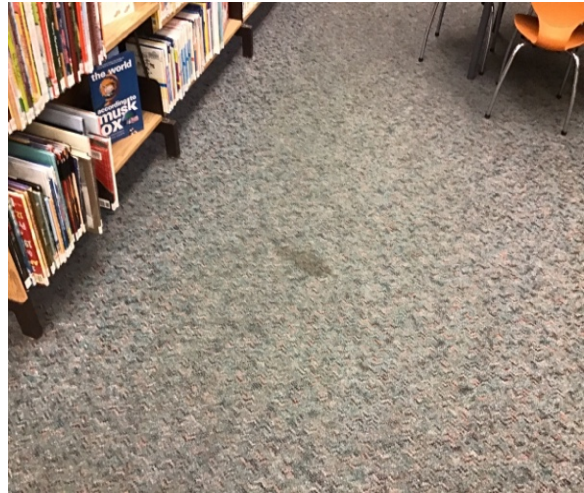
C3025 Carpeting:- View of Carpet

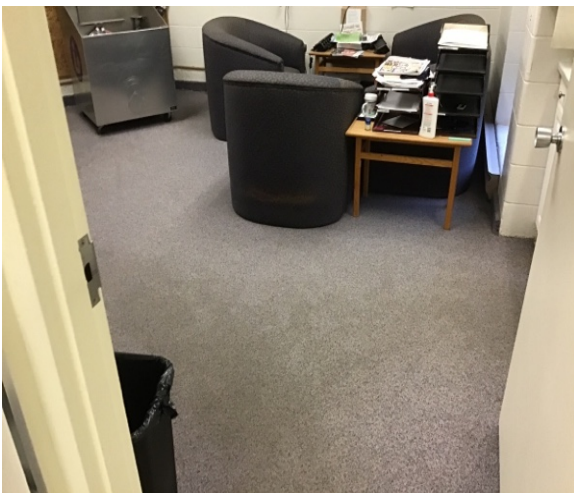
C3025 Carpeting:- View of Carpet

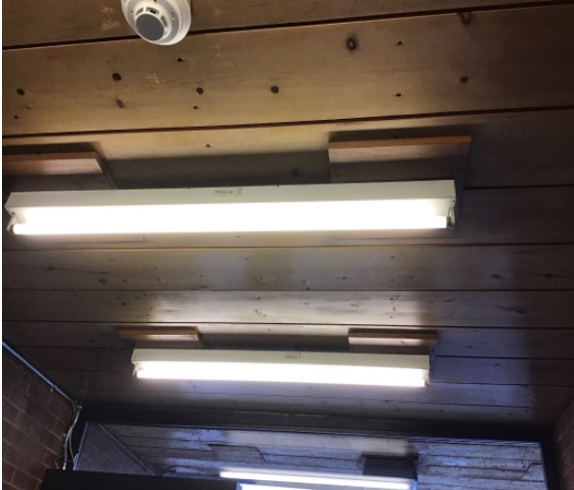
C3031 Ceiling Finishes:- View of Suspended Acoustic Panels

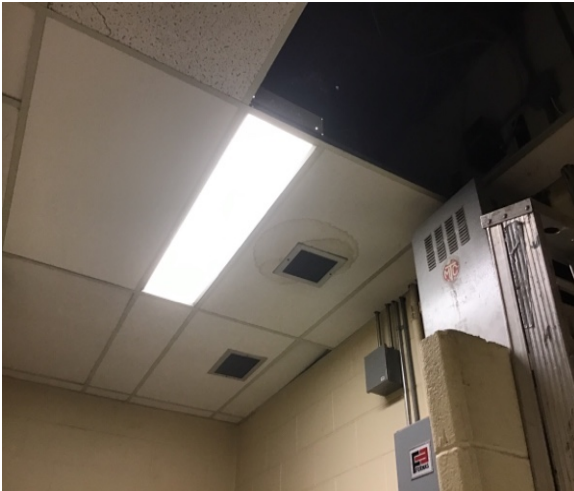
C3031 Ceiling Finishes:- View of Suspended Acoustic Panels

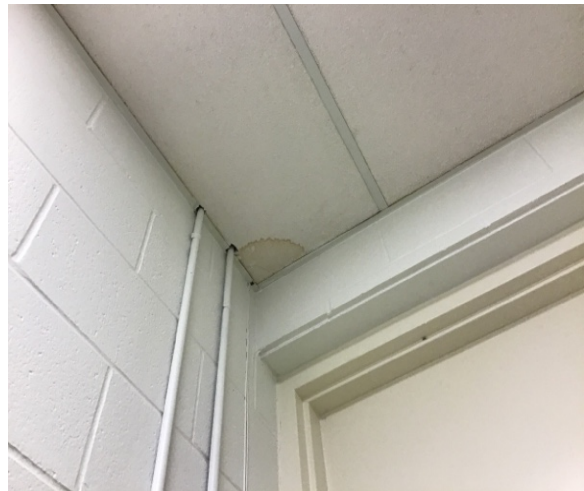
C3031 Ceiling Finishes:- View of Suspended Acoustic Panels

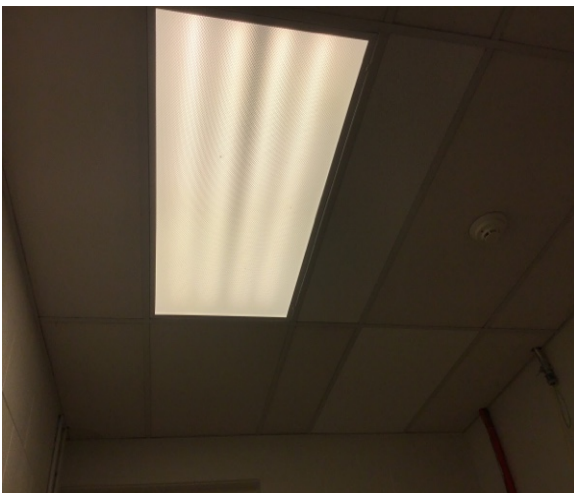
C3031 Ceiling Finishes:- View of Suspended Acoustic Panels

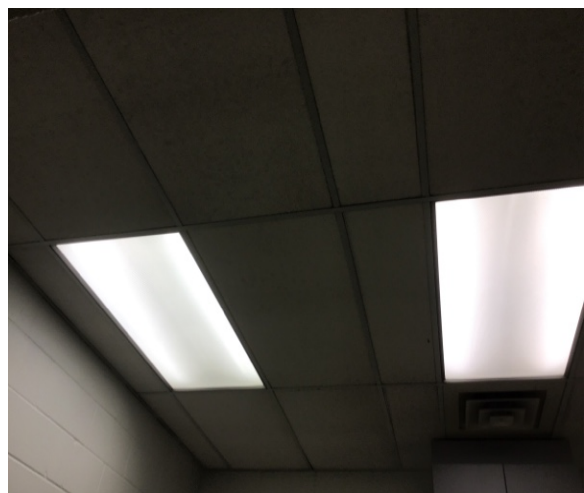
C3031 Ceiling Finishes:- View of Suspended Acoustic Panels

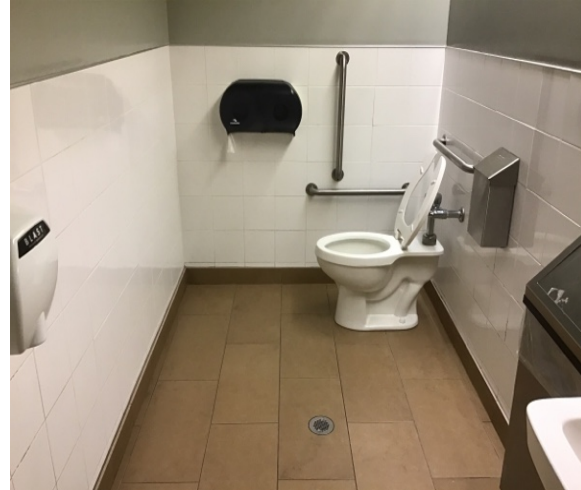
D2010 Plumbing Fixtures:- View of Water Closets, Urinals, Lavatories, etc.

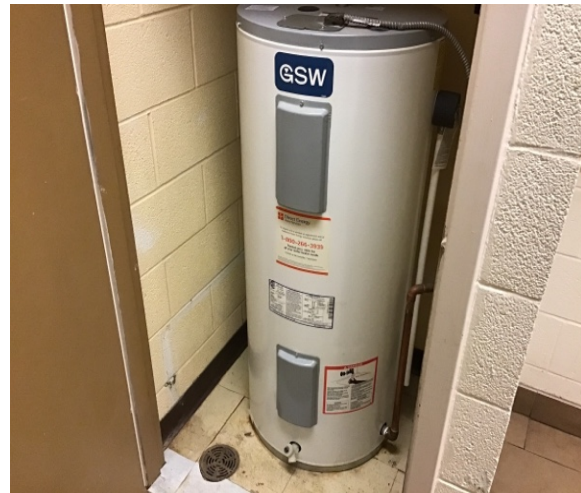
D2020 Domestic Water Distribution:- View of Domestic Hot Water Heater

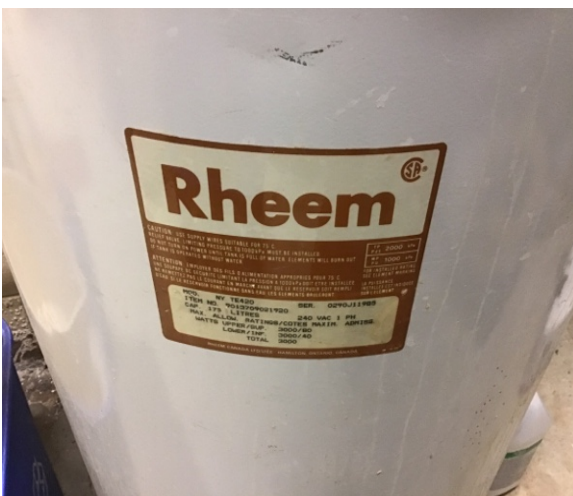
D2020 Domestic Water Distribution:- View of Domestic Hot Water Heater

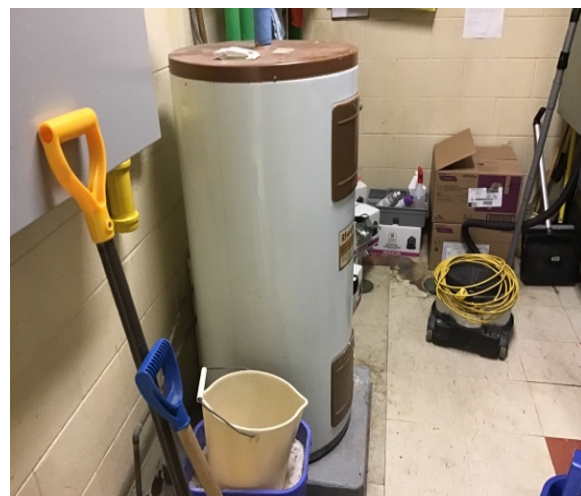
D2020 Domestic Water Distribution:- View of Domestic Hot Water Heater

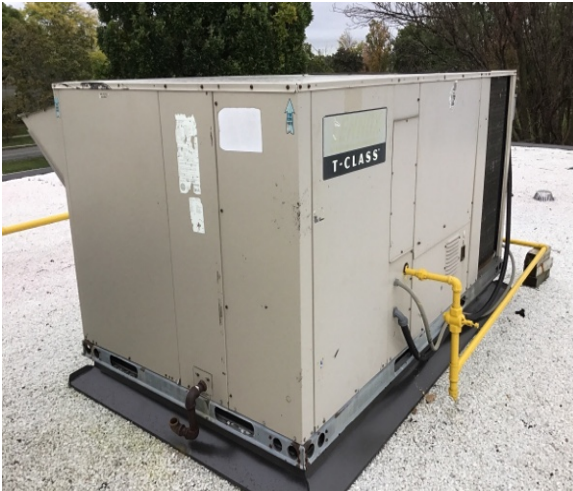
D3040 Heat HVAC Distribution Systems:- View of HVAC Packaged Units

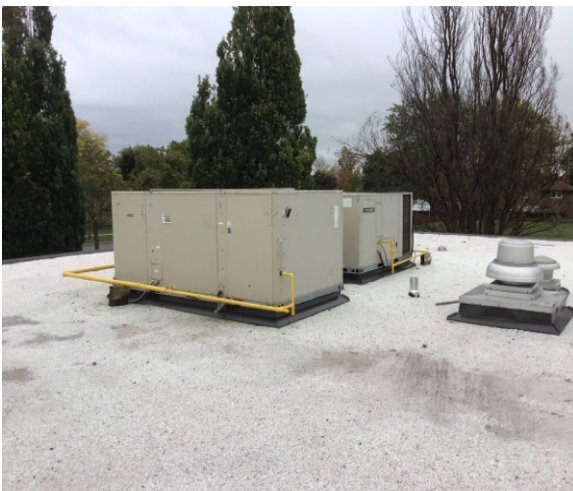
D3040 Heat HVAC Distribution Systems:- View of HVAC Packaged Units

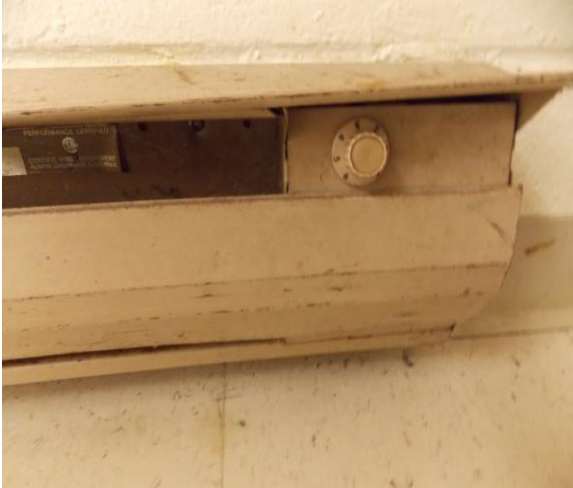
D3050 Heat Transfer Terminal and Packaged Units:- Typical baseboard heater in the Auditorium

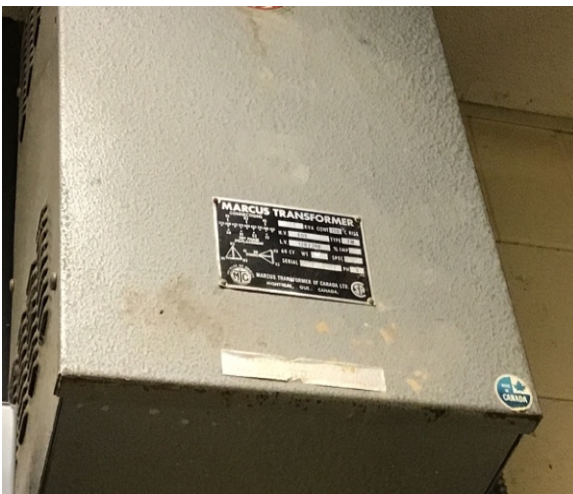
D5010 Electrical Service and Distribution:- View of Disconnects & Distribution Panels

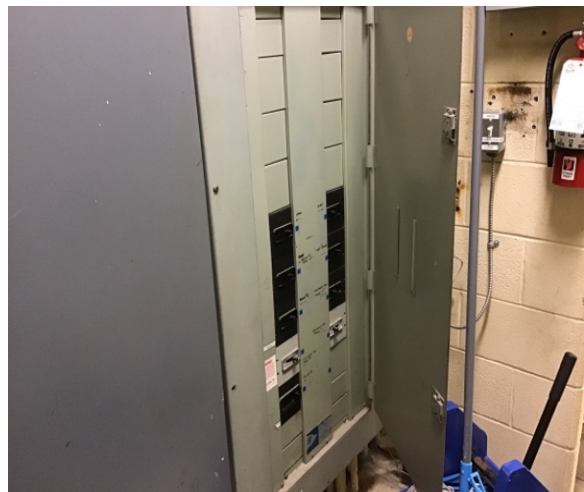
D5010 Electrical Service and Distribution:- View of Transformers

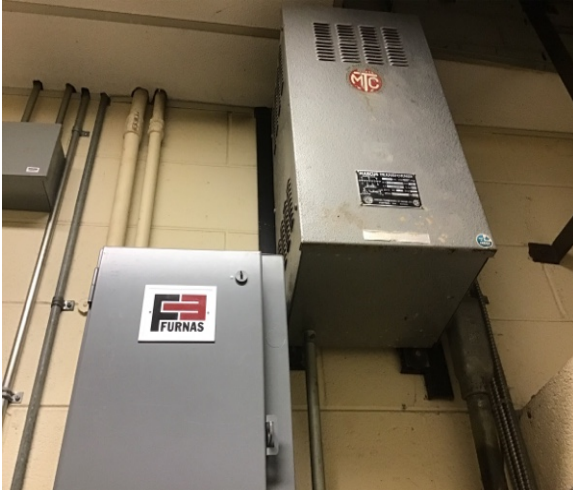
D5010 Electrical Service and Distribution:- View of Disconnects & Distribution Panels

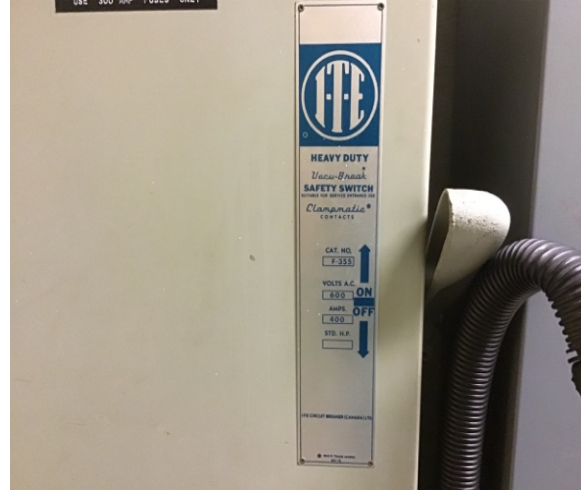
D5010 Electrical Service and Distribution:- View of Transformers

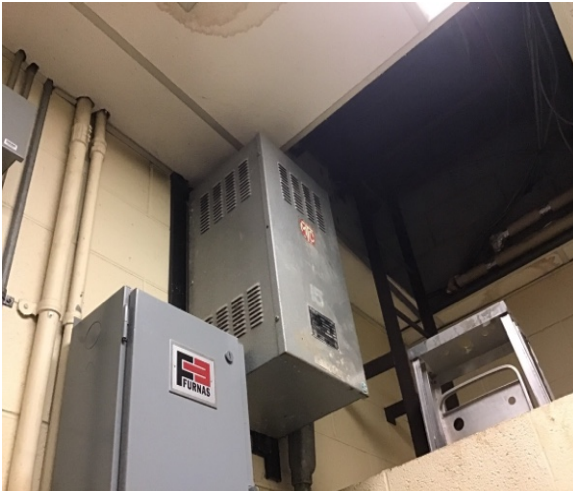
D5010 Electrical Service and Distribution:- View of Disconnects & Distribution Panels

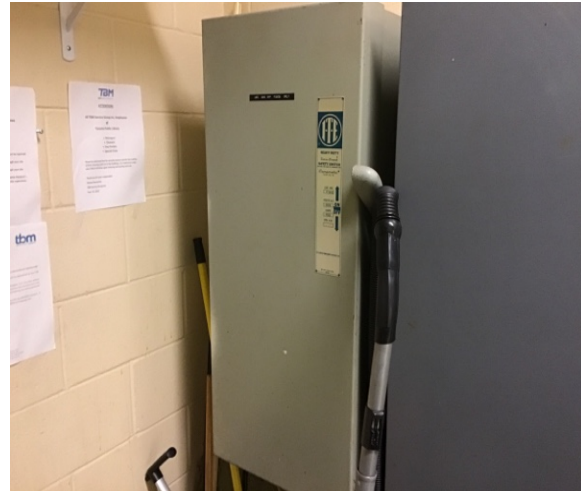
D5010 Electrical Service and Distribution:- View of Transformers

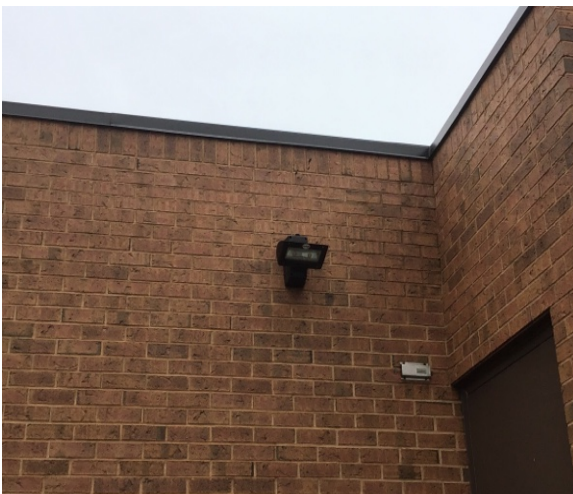
D5010 Electrical Service and Distribution:- View of Disconnects & Distribution Panels

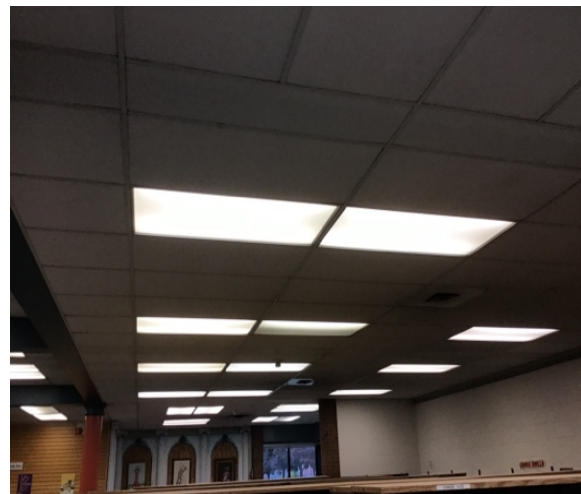
D5020 Lighting and Branch Wiring:- View of Interior & Exterior Lighting

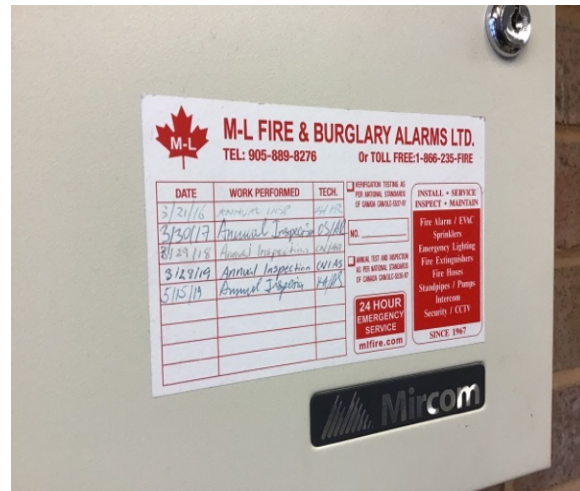
D5030 Communications and Security Systems:- General view of fire alarm control panel

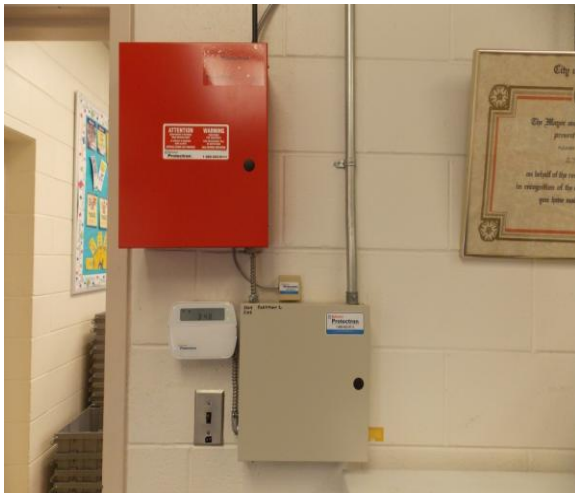
D5030 Communications and Security Systems:- View of Fire Alarm System

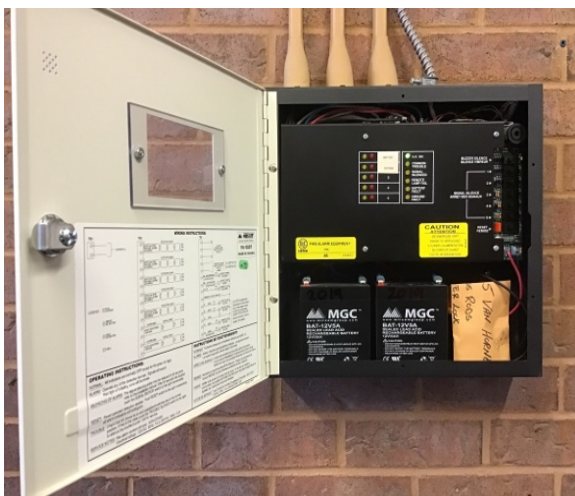
D5030 Communications and Security Systems:- View of Security System

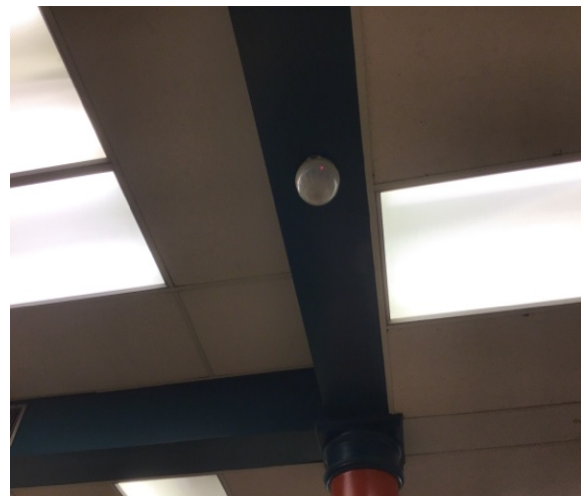
D5030 Communications and Security Systems:- View of Fire Alarm System

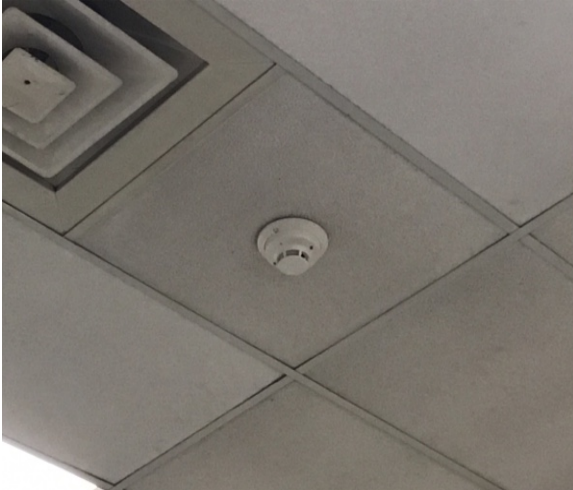
D5030 Communications and Security Systems:- View of Security System

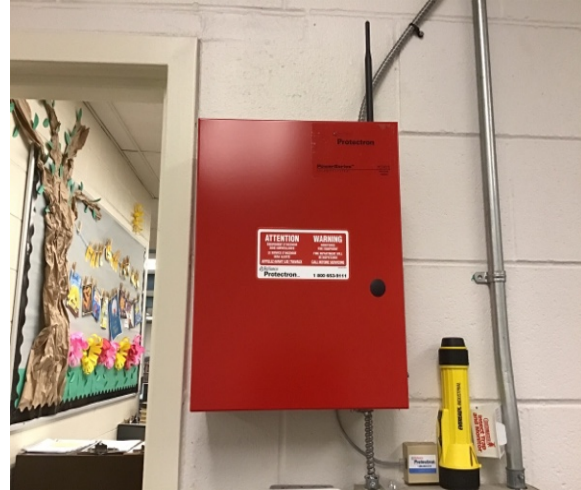
D5030 Communications and Security Systems:- View of Fire Alarm System

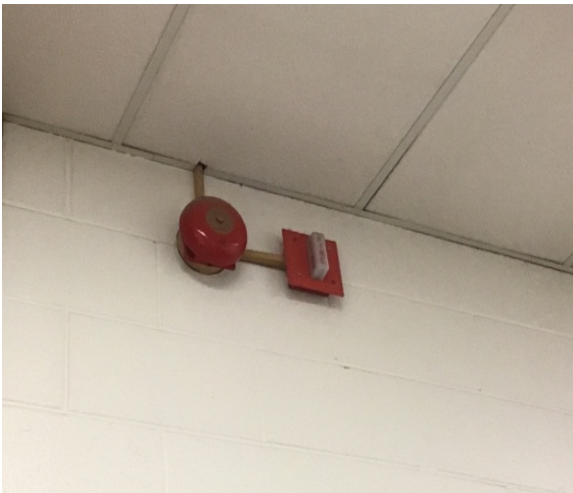
D5030 Communications and Security Systems:- View of Fire Alarm System

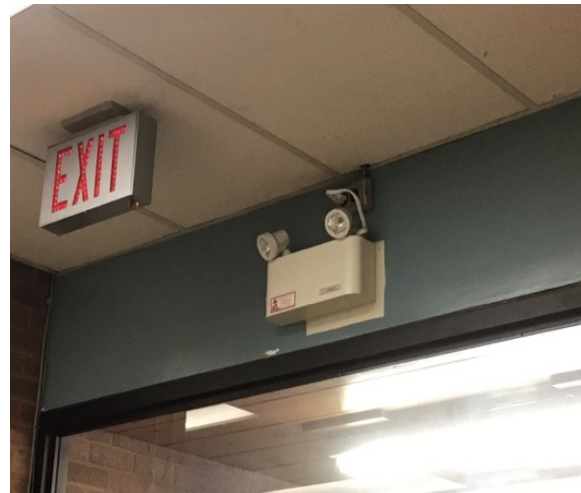
D5030 Communications and Security Systems:- View of Fire Alarm System

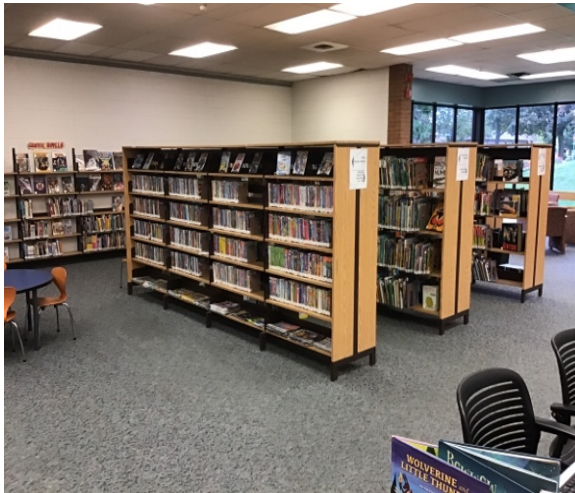
E2010 Fixed Furnishings:- View of Millwork

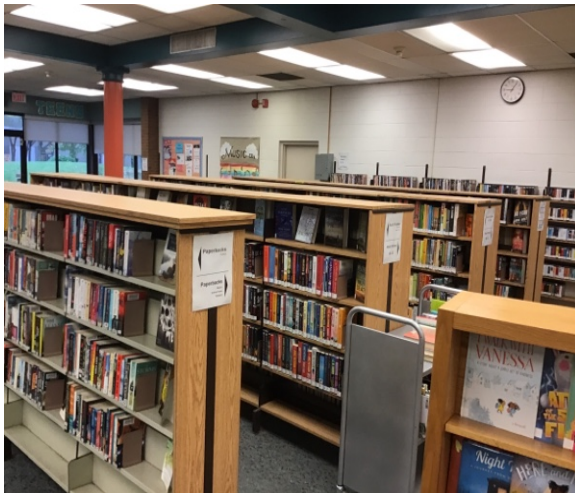
E2010 Fixed Furnishings:- View of Millwork

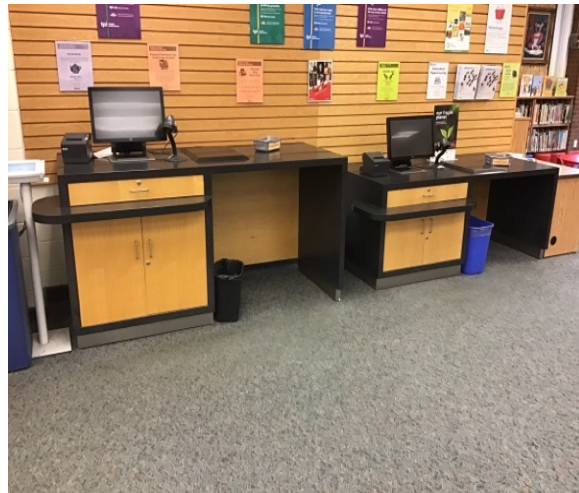
E2010 Fixed Furnishings:- View of Library Shelving

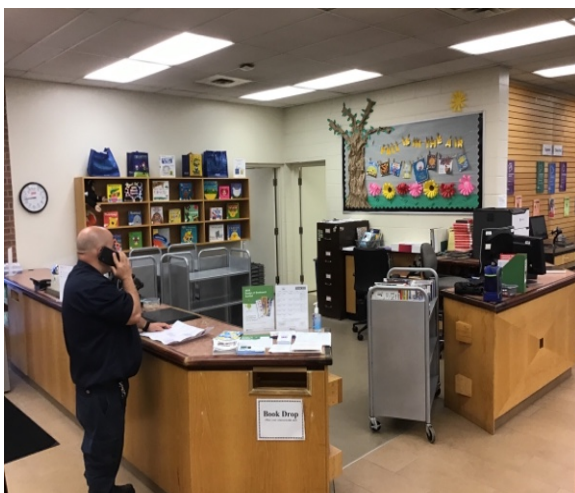
E2010 Fixed Furnishings:- View of Millwork

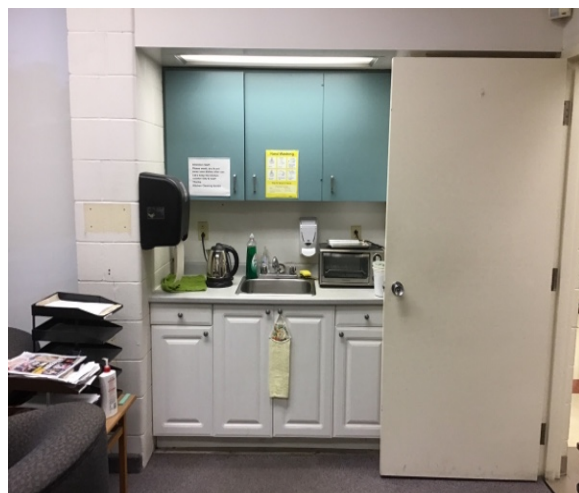
E2010 Fixed Furnishings:- View of Millwork

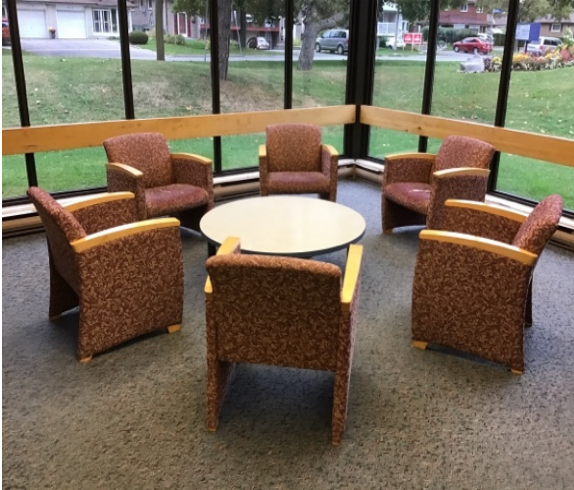
E2010 Fixed Furnishings:- View of Millwork

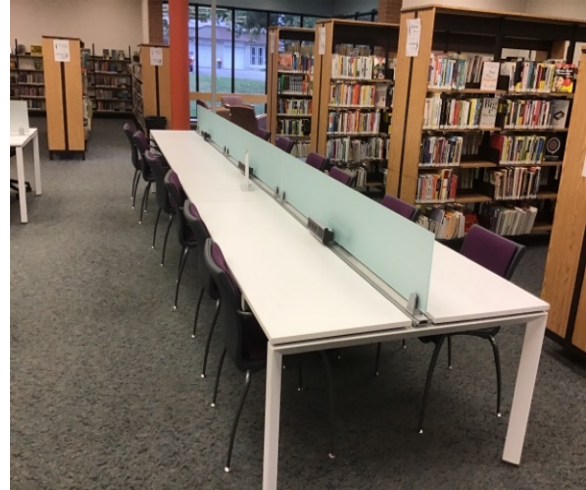
E2020 Moveable Furnishings:- View of Moveable Furnishings

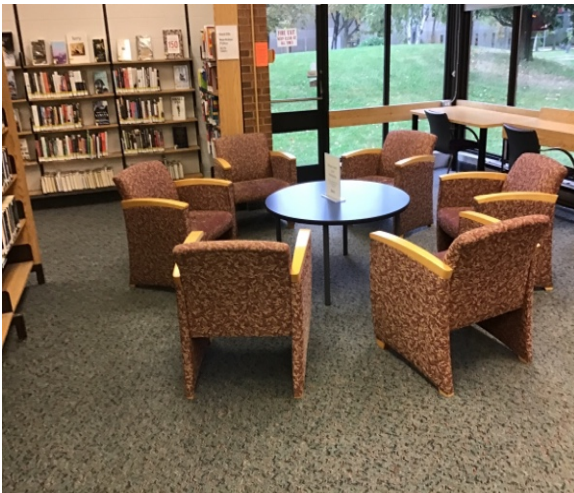
E2020 Moveable Furnishings:- View of Moveable Furnishings

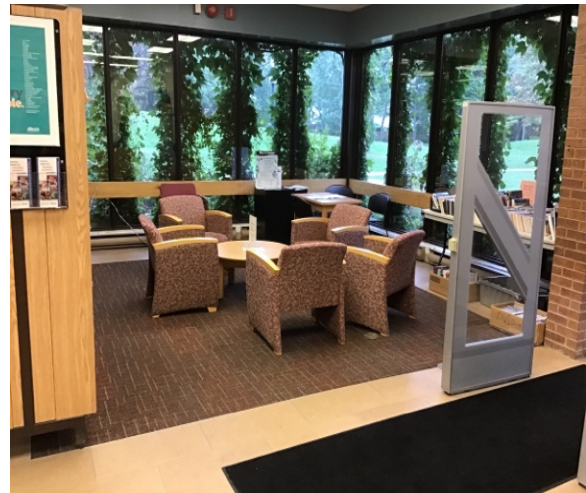
E2020 Moveable Furnishings:- View of Moveable Furnishings

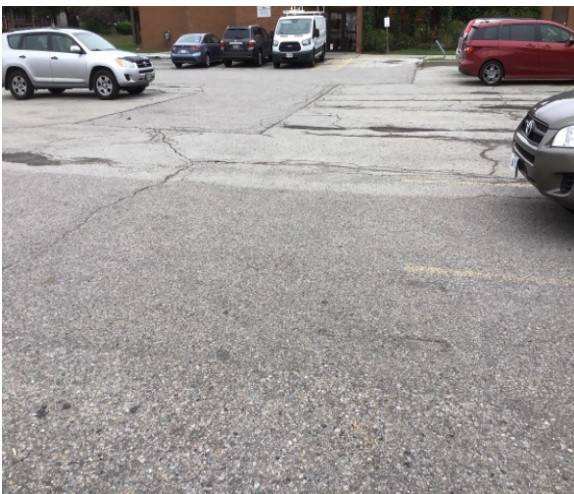
G2020 Parking Lots:- View of Parking Lots & Roadways

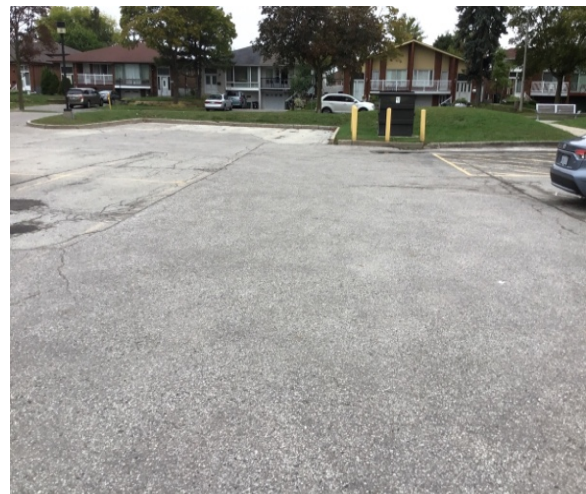
G2020 Parking Lots:- View of Parking Lots & Roadways

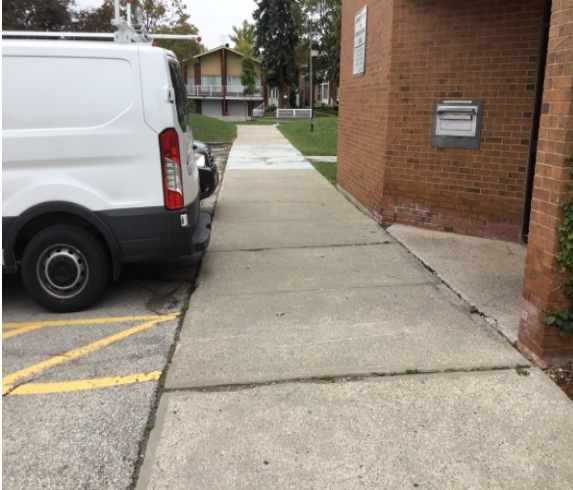
G2030 Pedestrian Paving:- View of Concrete Walkway

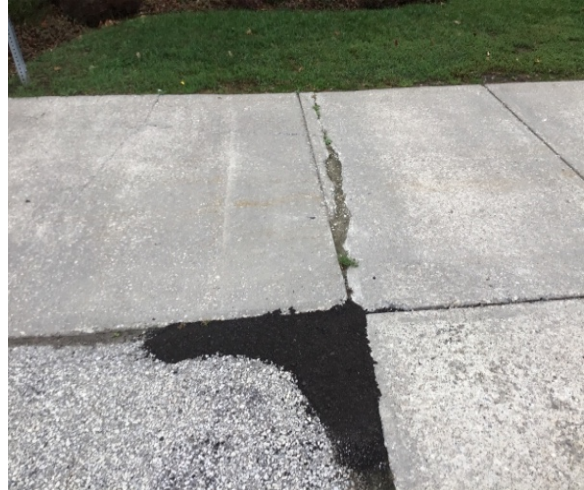
G2030 Pedestrian Paving:- View of Concrete Walkway

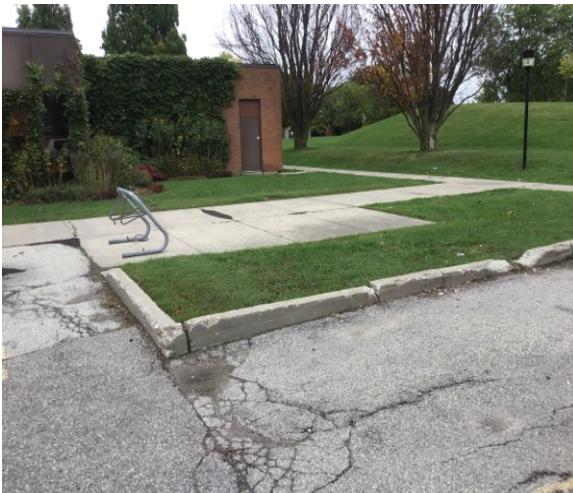
G2030 Pedestrian Paving:- View of Concrete Walkway
